**Sunshine Canyon Landfill
Independent Monitor
Quarterly Site Monitoring Status Report
January 1, 2019 – March 31, 2019**

April 29, 2019

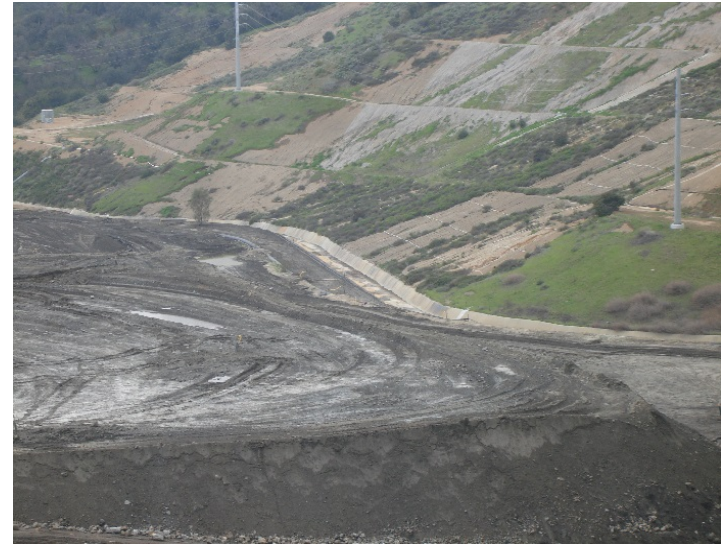
Photo 78: CC4 Part 3 Buttress Construction Area: March 5, 2019

Discipline	City Condition Reference # / Mitigation #	County Condition Reference # / Mitigation #	Responsible Agency	Further Review Needed – Comments
Project Manager	Q – B.2.c		City Planning	<p>I-a through I-d: The CC-4 Part 3 buttress grading and construction was occurring during the 1st Quarter of 2019. This grading and buttress construction is the only grading being done outside of the prior-approved landfill footprint.</p> <p>I-a: A slight movement of the slide in the CC-4 Part 3 buttress area occurred in January, and all grading was stopped and a remediation plan was designed and implemented. Once movement was stopped, the buttress had additional movement detection monitors installed, and grading and construction continued.</p> <p>I-b: The CC-4 Part 3 buttress grading and construction continued. There were no impacts from the heavy rain events that needed repair.</p> <p>I-c: The recent rain events caused significant erosion in the buttress' northern area, and filled the temporary basin. Repairs were underway.</p> <p>I-d: The CC-4 Part 3 buttress had grading and soil placement occurring. A paleontologist was on site monitoring grading in native areas. The buttress construction was about 95% complete.</p>

Discipline	City Condition Reference # / Mitigation #	County Condition Reference # / Mitigation #	Responsible Agency	Further Review Needed – Comments
Project Manager	M - 4.9.3 / 110		City Planning/City LEA	I-c: There was an abandoned car under the I-14 freeway on Sierra Highway.
Civil and Geotechnical Engineer	M - 4.1.1 / 2		City Building and Safety City Planning	I-a through I-d: See M - 4.1.1 / 5 below.
	M - 4.1.1 / 4		City Planning/LARWQCB Cal Recycle	I-a through I-d: See M - 4.1.1 / 5 below.
	M - 4.1.1 / 5		City Planning/ LARWQCB Cal Recycle	I-a through I-d: Out-of-approved landfill footprint grading occurred for a Cell CC-4 Part 3 buttress. Grading plans have been approved by the County Department of Public Works' Civil Engineering and Permitting sections. The only other grading occurring in this quarter was for maintaining areas of Cell CC-4 Part 1 and 2, and the removal of stockpiled soil for waste cover from soil in Cell CC-3A, and from the buttress stockpile area and grading of Cell CC-3A western slopes. These activities are inside the approved landfill footprint. I-d: The CC-4 Part 3 buttress was approximately 95% complete.

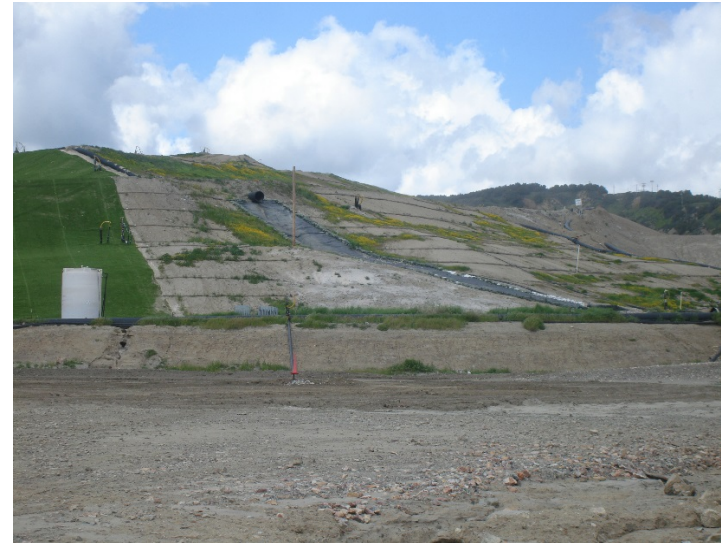
Photo 158: CC-3B South Slopes: March 28, 2019

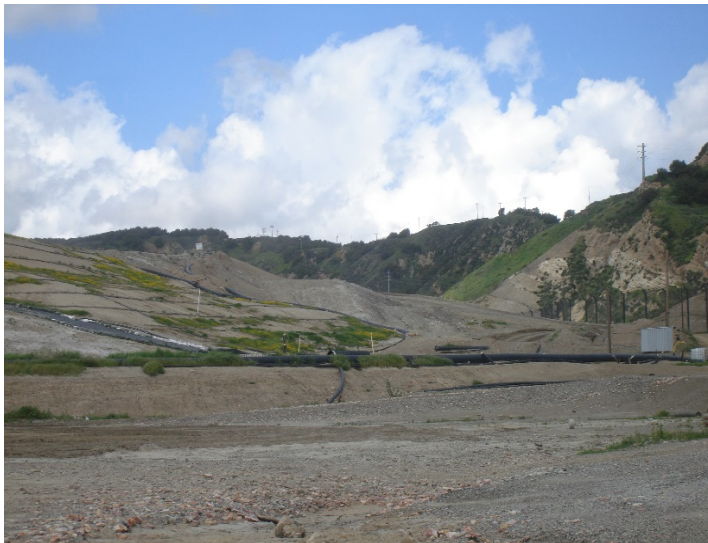
Photo 159: CC-3B South Slopes: March 28, 2019

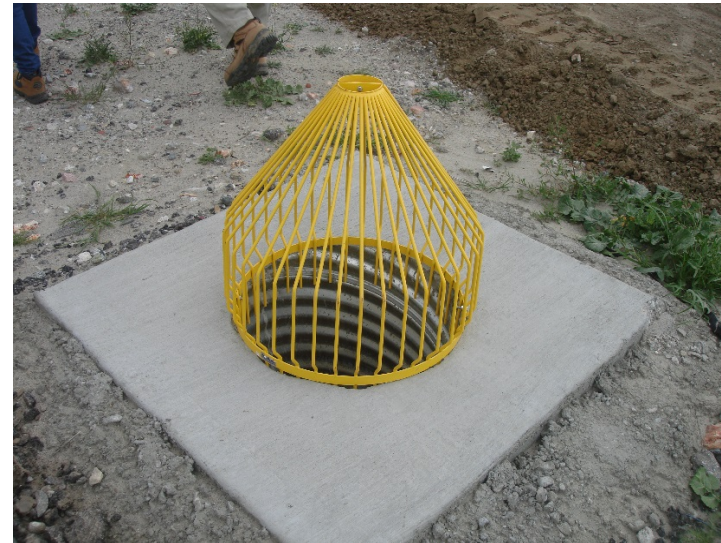
Photo 160: Old City North Top Deck: March 28, 2019

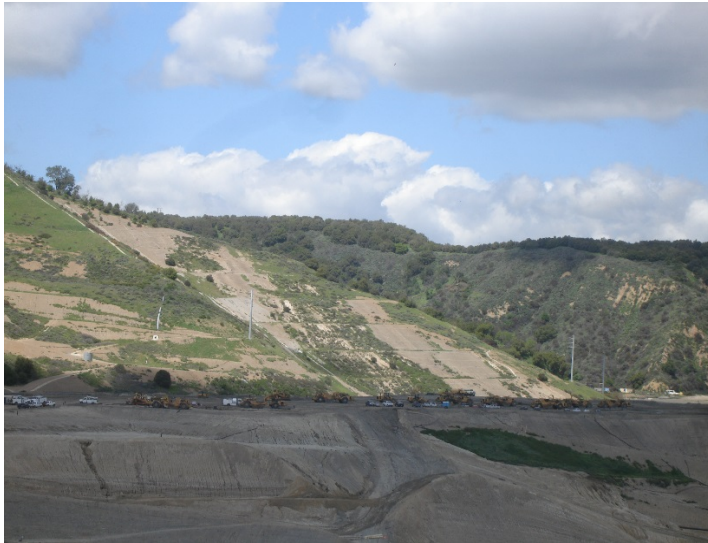
Photo 161: County Sage Mitigation Area: March 28, 2019

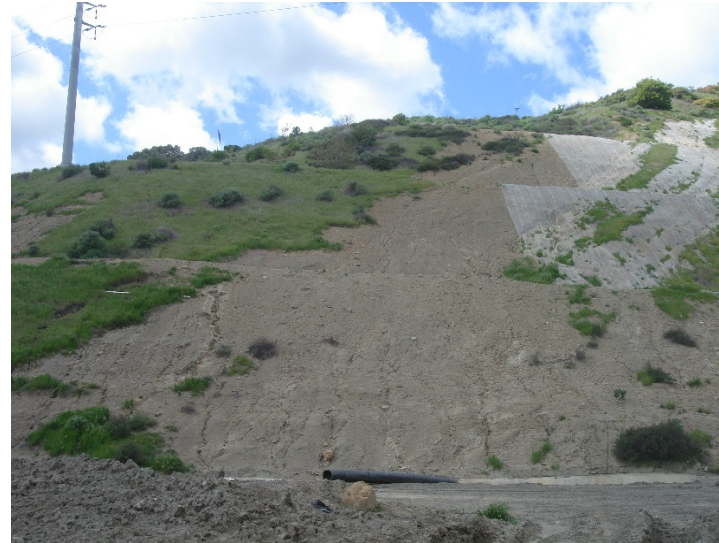
Photo 162: County Sage Mitigation Area: March 28, 2019

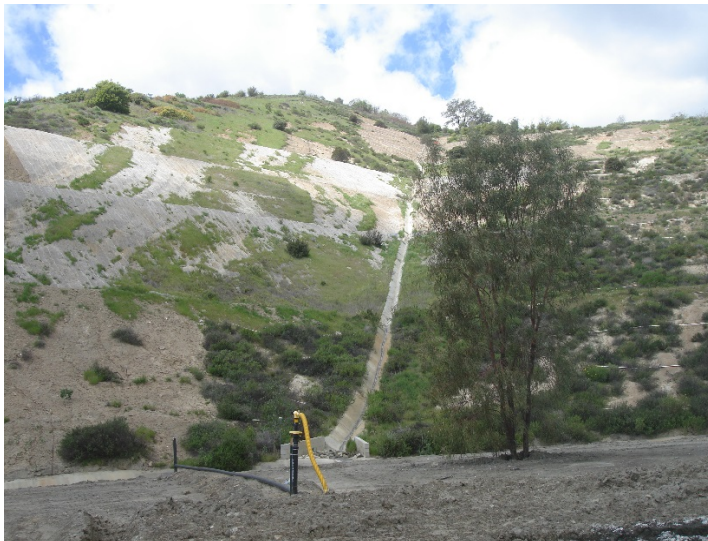
Photo 163: County Sage Mitigation Area: March 28, 2019

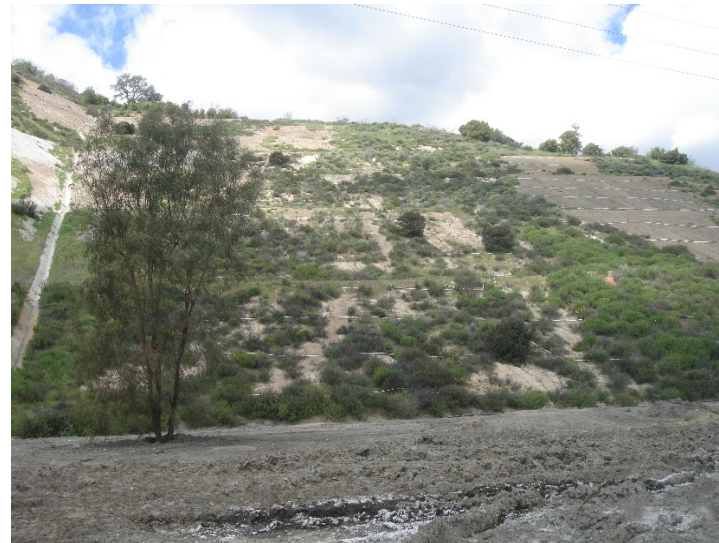
Photo 164: County Sage Mitigation Area: March 28, 2019

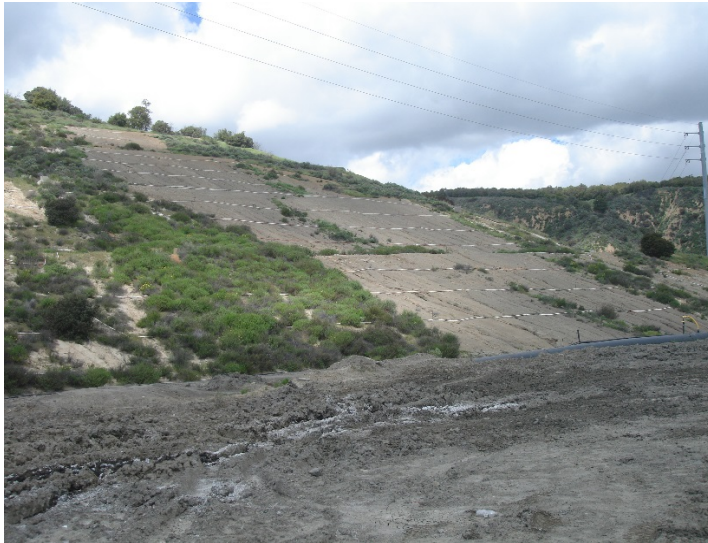
Photo 165: County Sage Mitigation Area: March 28, 2019

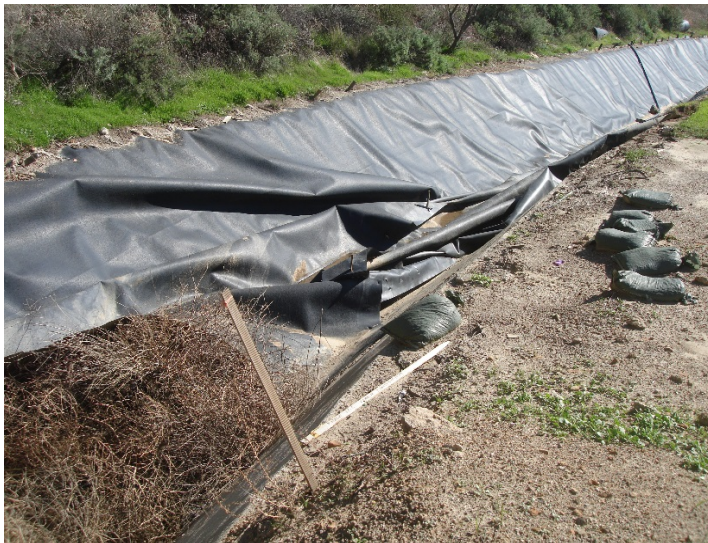
Photo 167: Basin D Outlet Channel: January 22, 2019

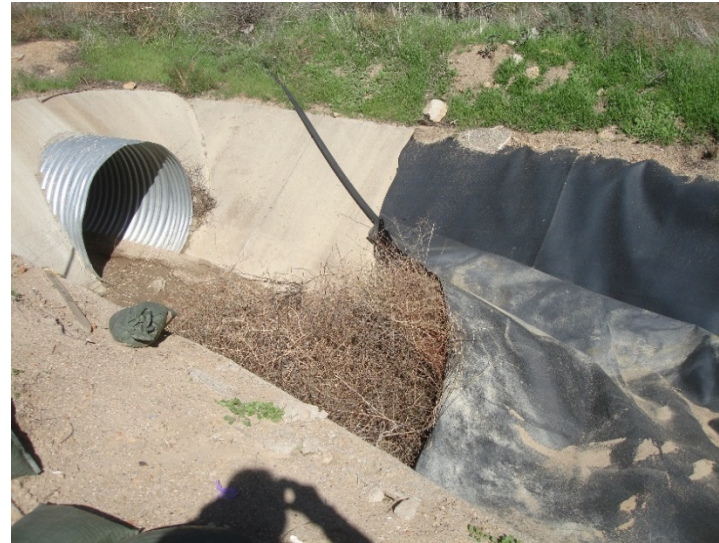
Photo 166: Basin D Outlet Channel: January 22, 2019

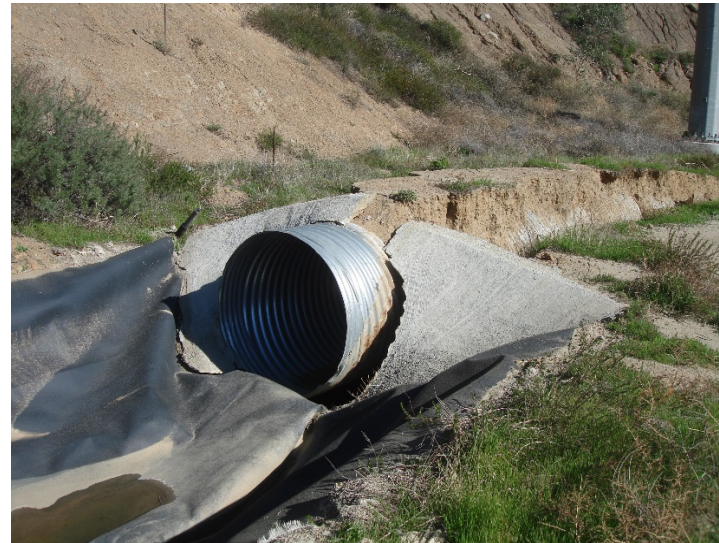
Photo 168: Basin D Outlet Channel: January 22, 2019

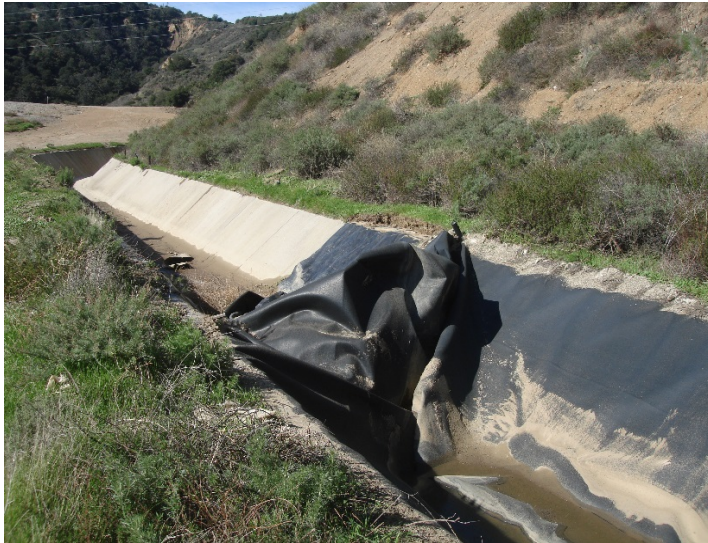
Photo 169: Basin D Outlet Channel: January 22, 2019

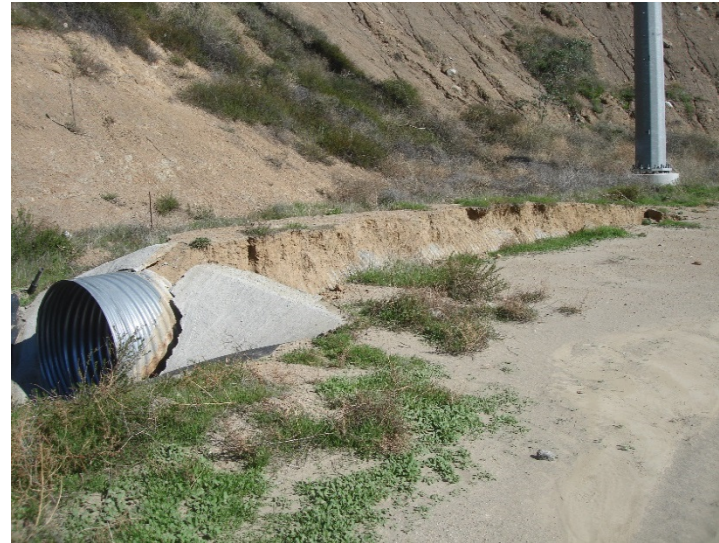
Photo 170: Basin D Outlet Channel: January 22, 2019

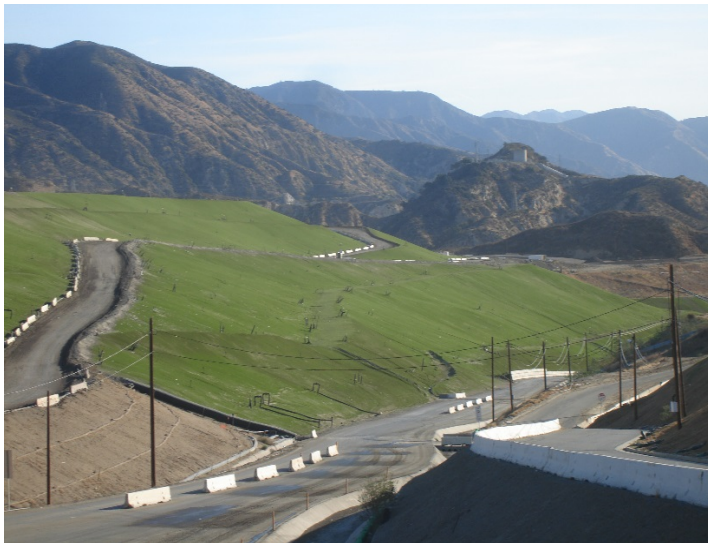
Photo 171: Posi-Shell and Closure Turf: January 22, 2019

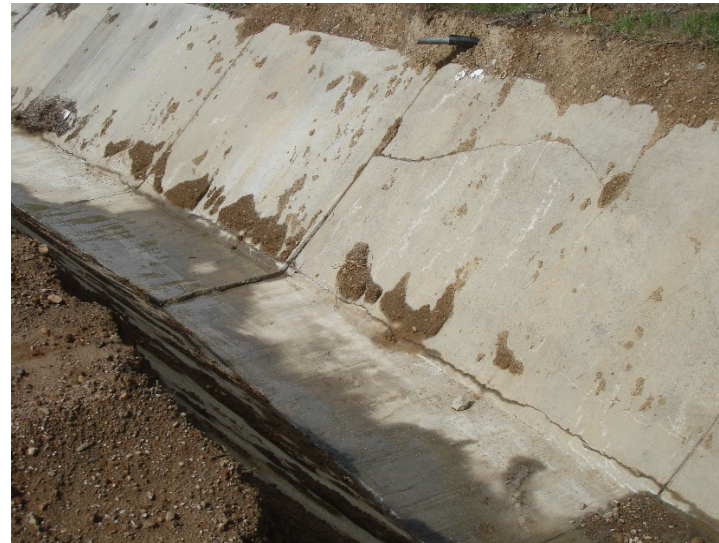
Photo 172: Basin D Outlet Channel: February 21, 2019

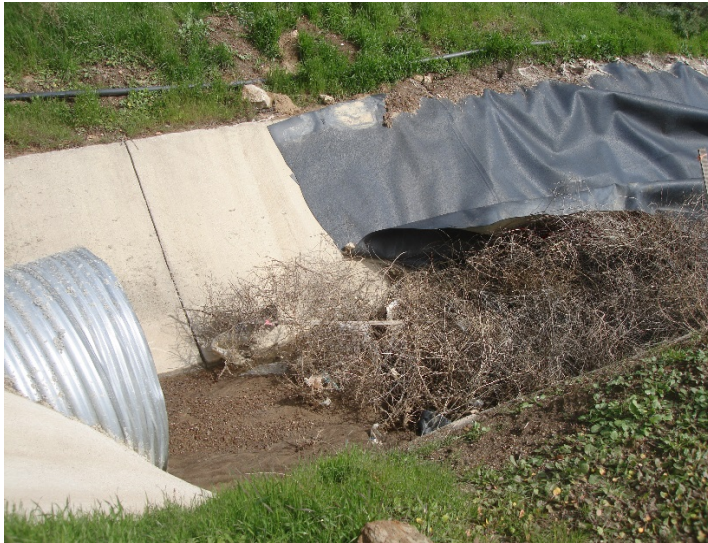
Photo 173: Basin D Outlet Channel: February 21, 2019

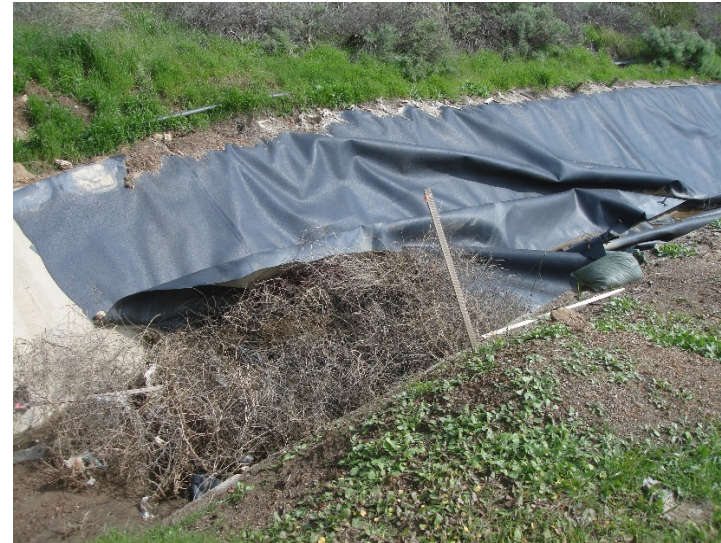
Photo 174: Basin D Outlet Channel: February 21, 2019

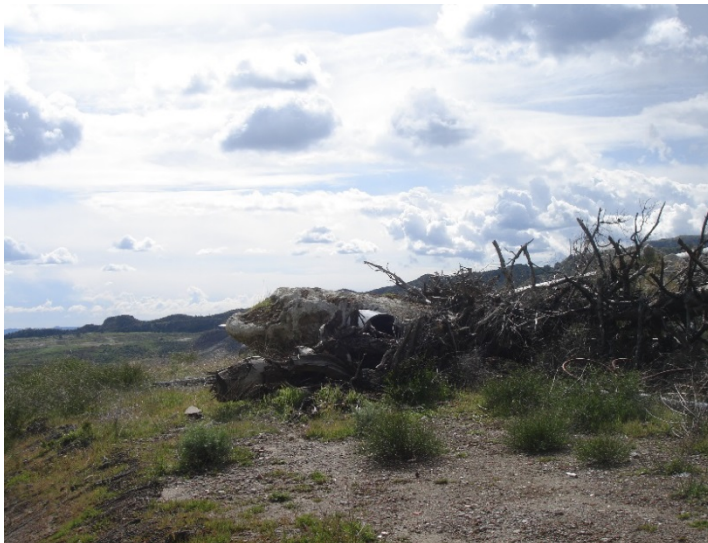
Photo 175: Waste Material on Old Flares 8 Site: February 21, 2019

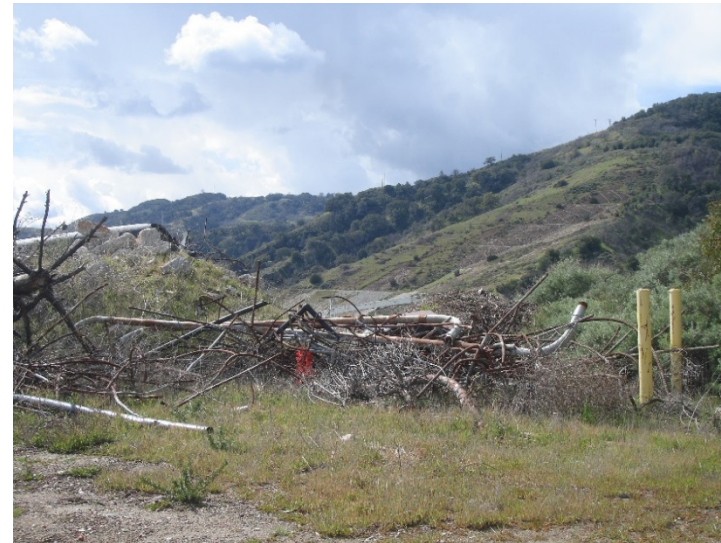
Photo 176: Waste Material on Old Flares 8 Site: February 21, 2019

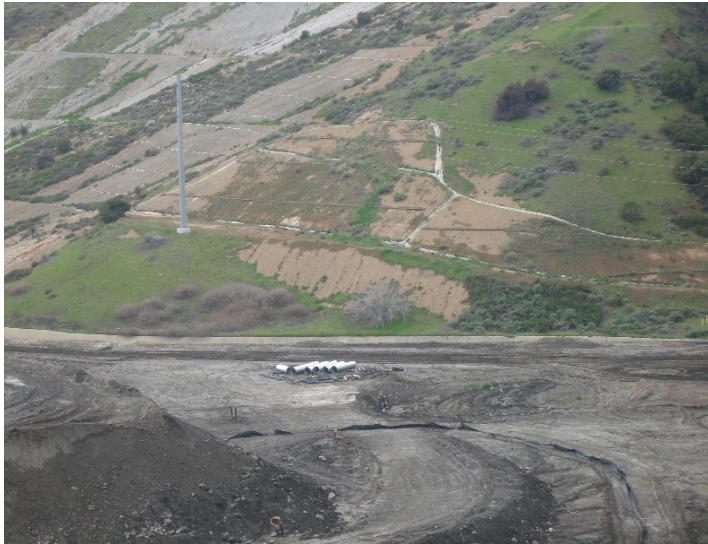
Photo 177: Waste Material on Old Flare 8 Site: March 5, 2019

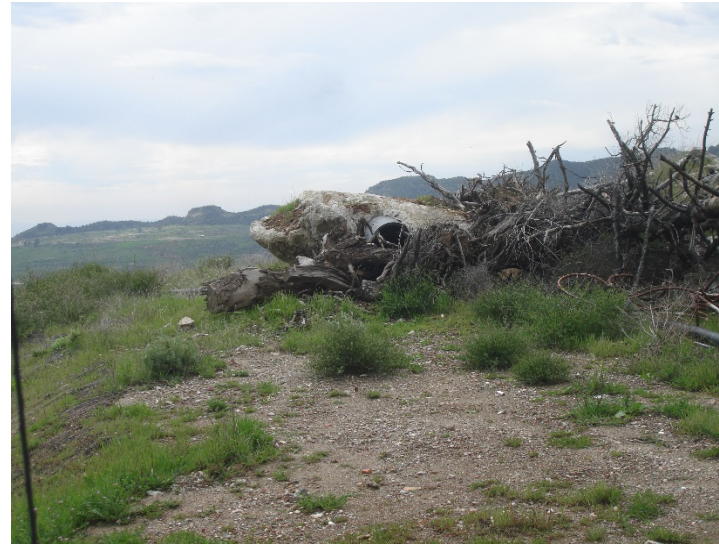
Photo 178: Waste Material on Old Flare 8 Site: March 5, 2019

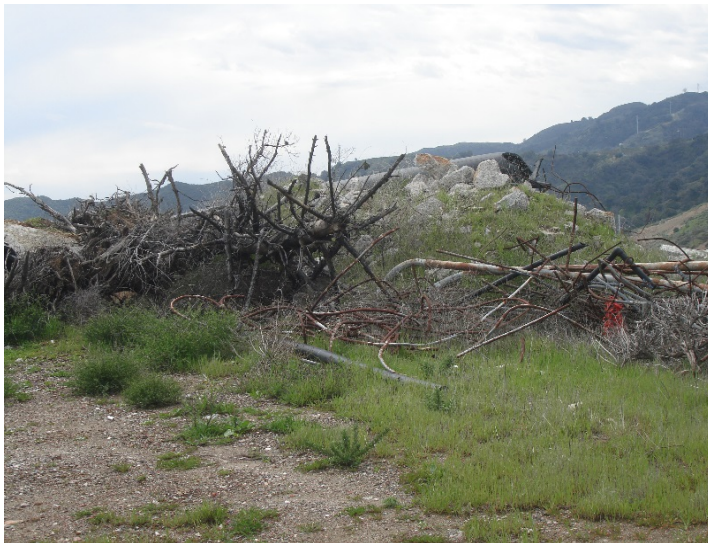
Photo 179: Waste Material on Old Flare 8 Site: March 5, 2019

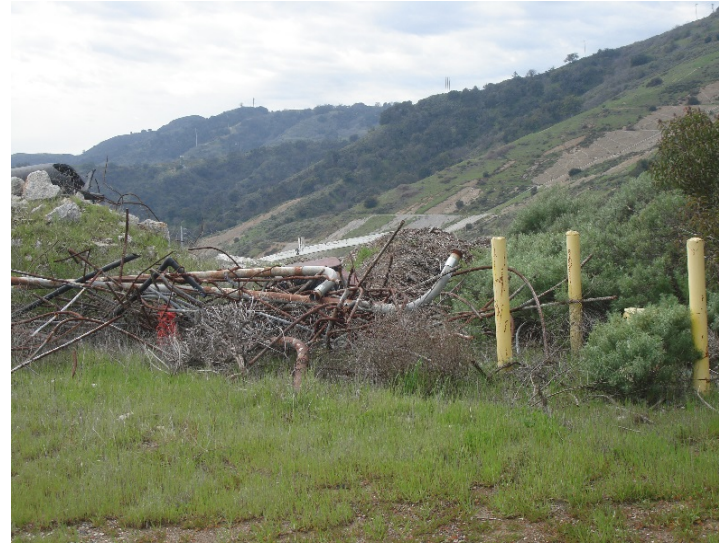
Photo 180: Waste Material on Old Flare 8 Site: March 5, 2019

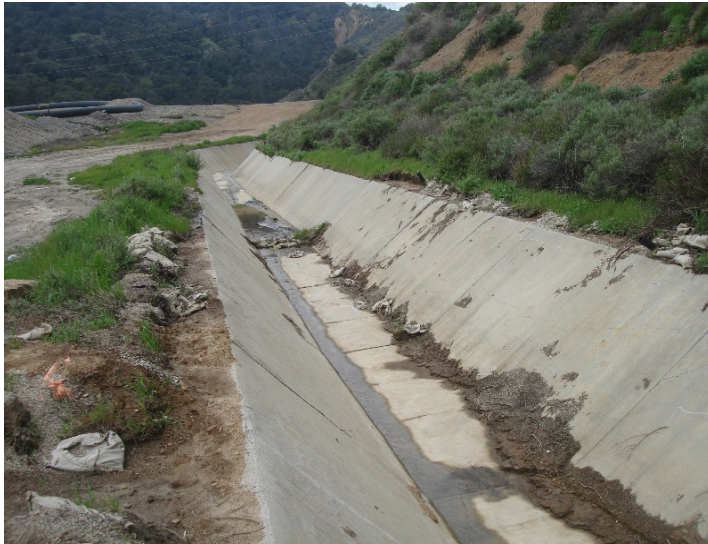
Photo 181: Waste Material on Old Flare 8 Site: March 5, 2019

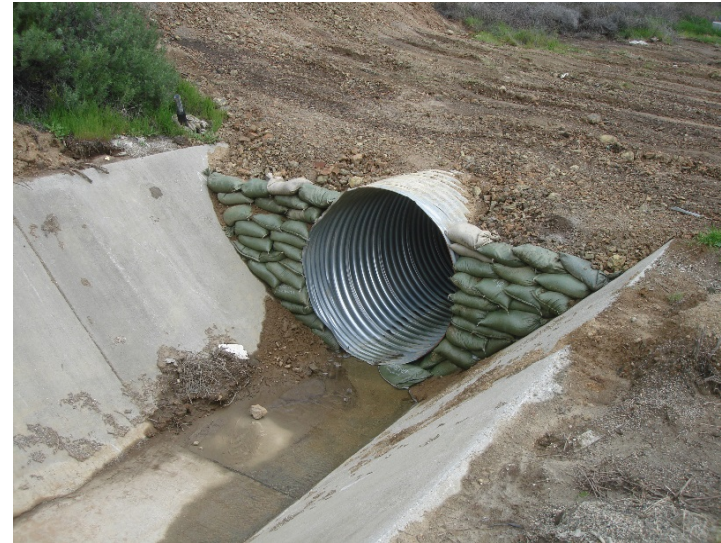
Photo 182: Waste Material on Old Flare 8 Site: March 5, 2019

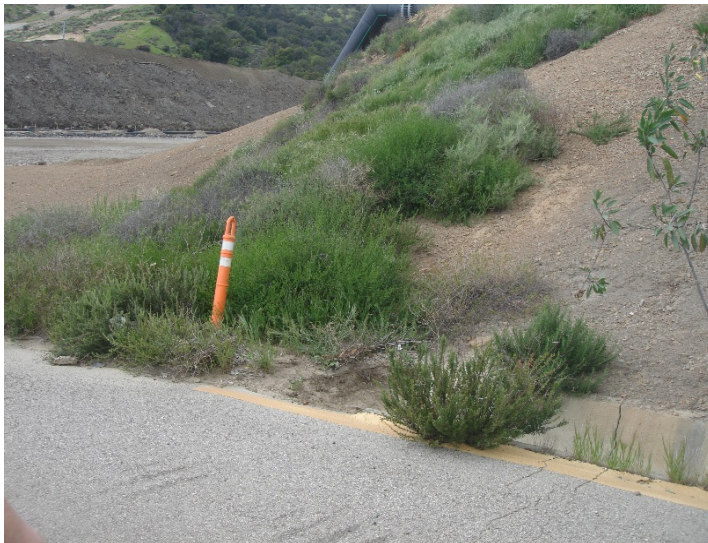
Photo 183: County Flare Road Plugged Drainage: March 28, 2019

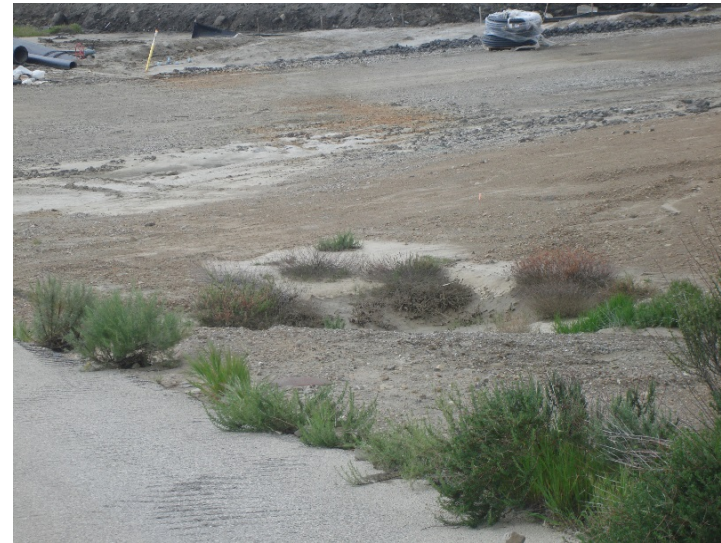
Photo 184: County Flare Road Plugged Drainage: March 28, 2019

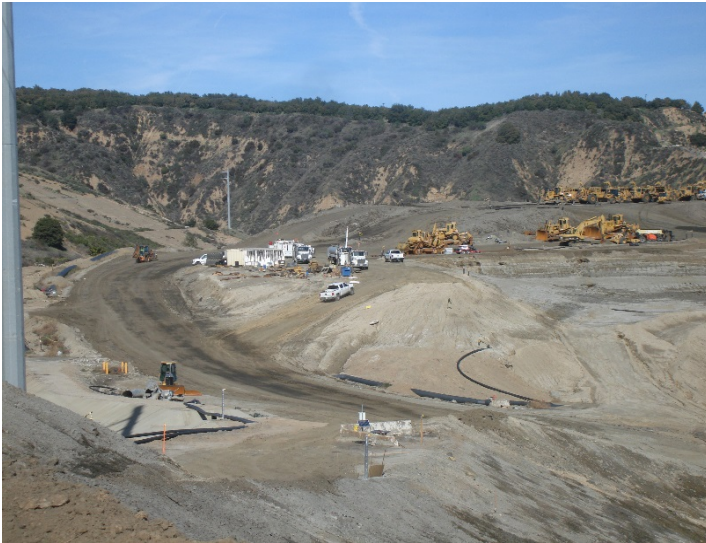
Photo 185: County Top Deck Stockpile Area: January 22, 2019

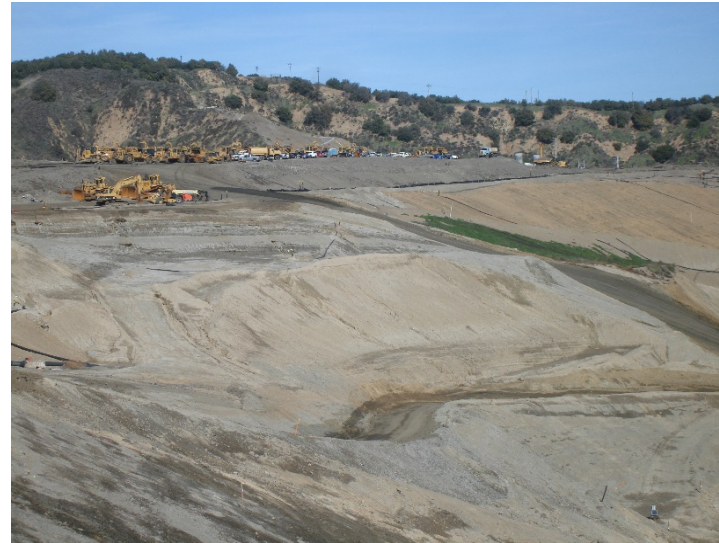
Photo 186: County Top Deck Stockpile Area: January 22, 2019

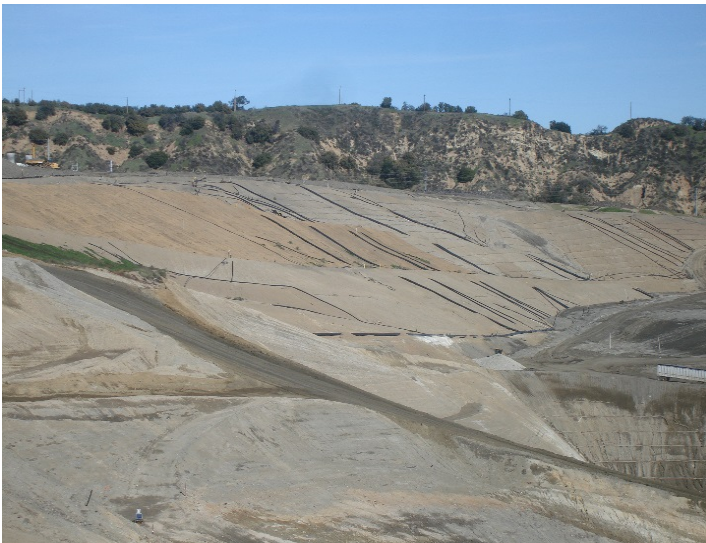
Photo 187: County Top Deck Stockpile Area: January 22, 2019

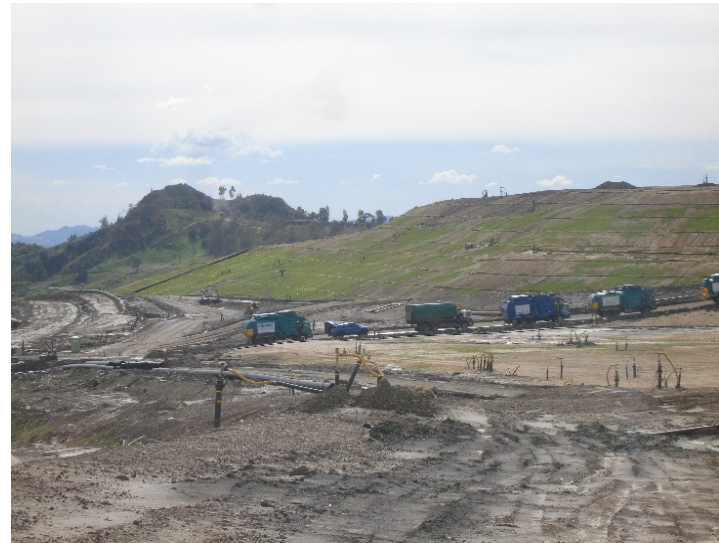
Photo 188: County Bowl Area: February 21, 2019

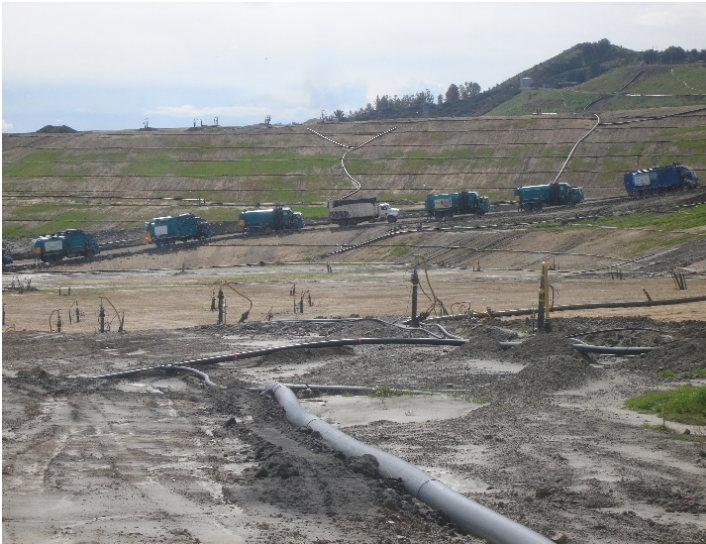
Photo 189: County Bowl Area: February 21, 2019

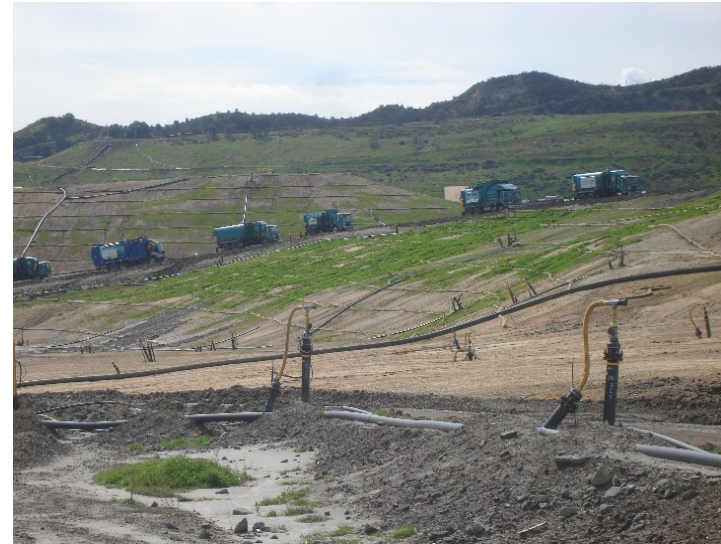
Photo 190: County Bowl Area: February 21, 2019

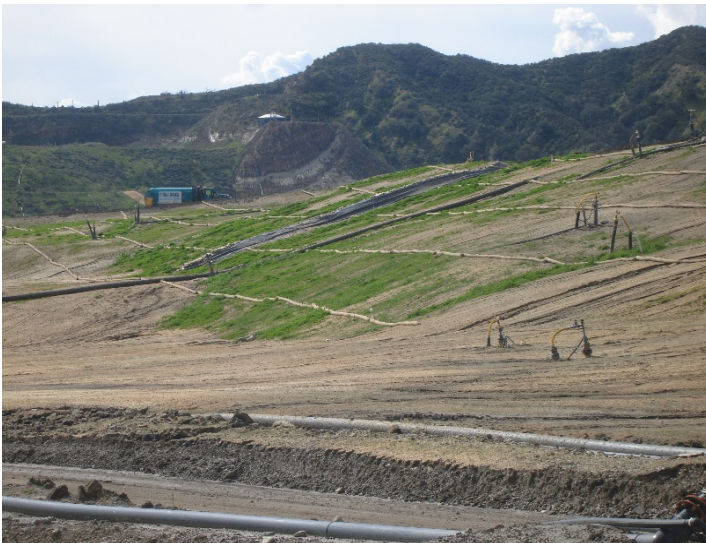
Photo 191: County Bowl Area: February 21, 2019

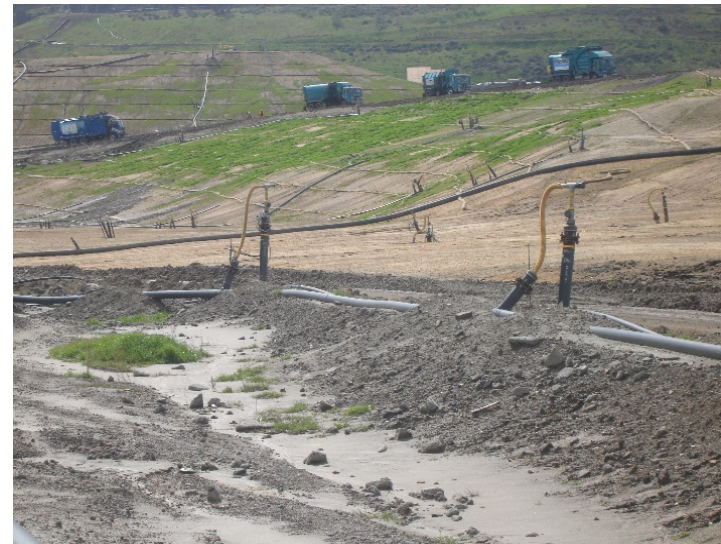
Photo 192: County Bowl Area: February 21, 2019

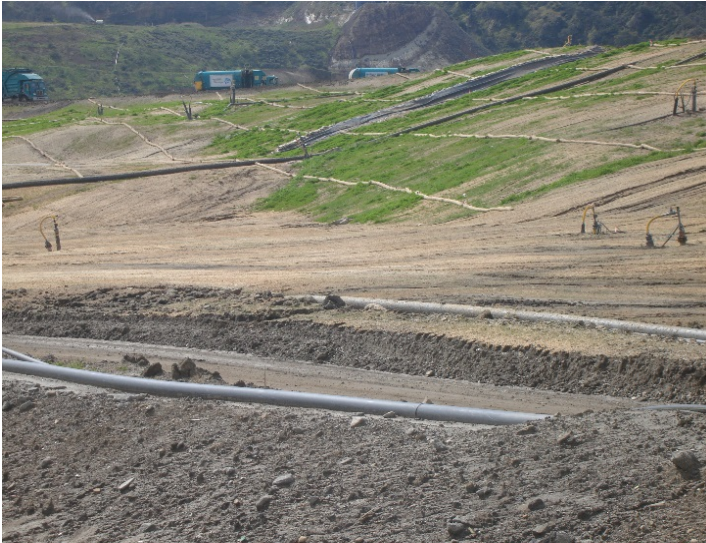
Photo 193: County Bowl Area: February 21, 2019

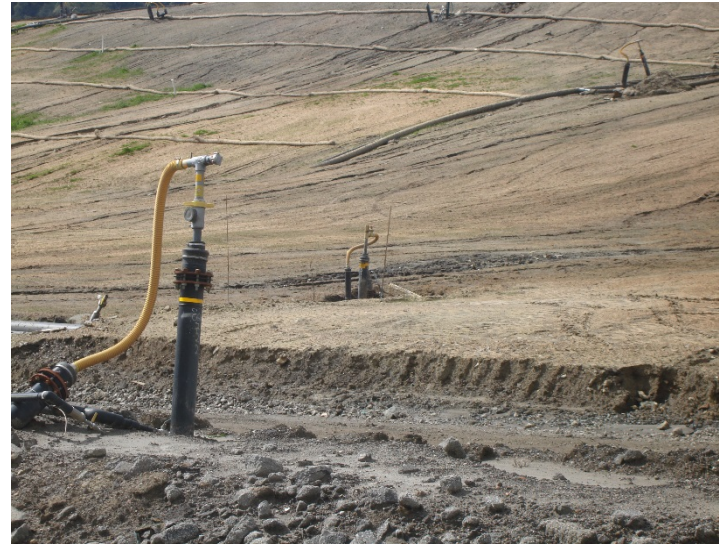
Photo 194: County Bowl Area: February 21, 2019

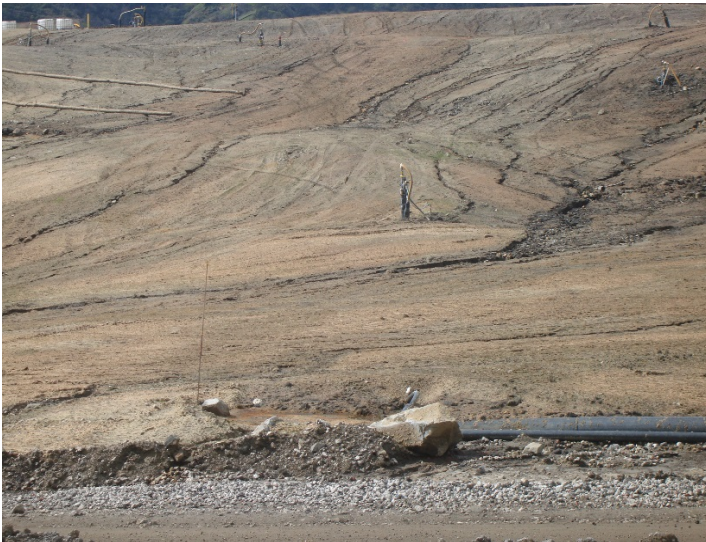
Photo 195: County Bowl Area: February 21, 2019

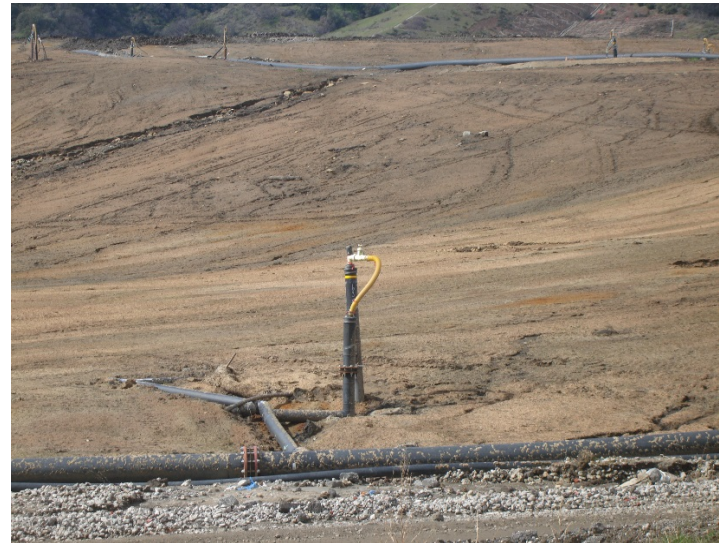
Photo 196: County Bowl Area: February 21, 2019

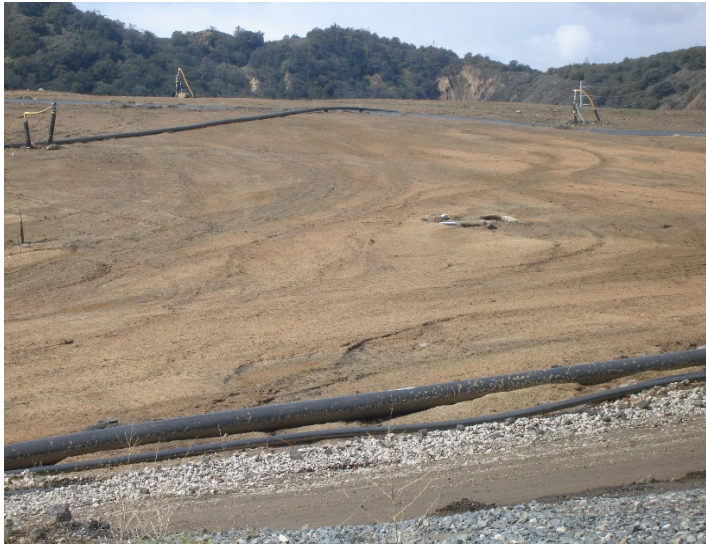
Photo 197: County Bowl Area: February 21, 2019

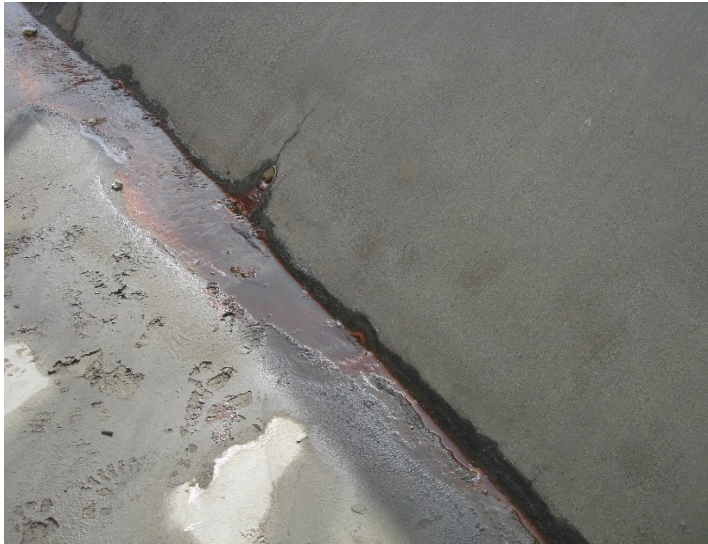
**Photo 316: Terminal Basin Area Alluvial Pumps Not Running:
March 28, 2019**

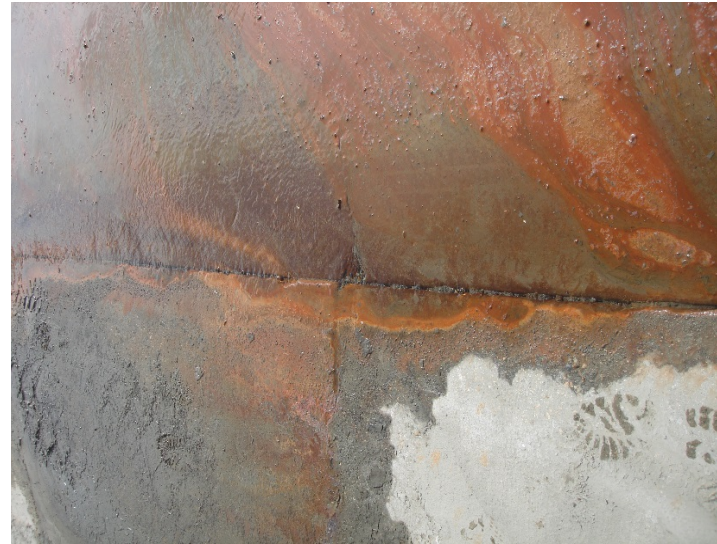
**Photo 317: Terminal Basin Area Alluvial Pumps Not Running:
March 28, 2019**

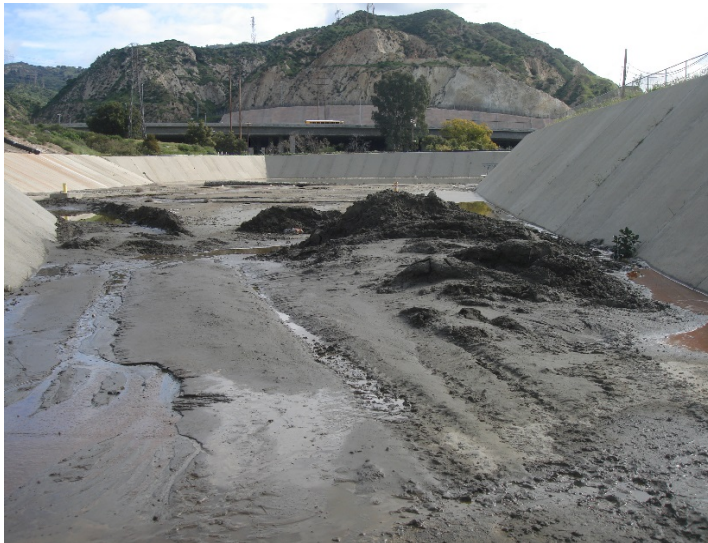
**Photo 318: Terminal Basin Area Alluvial Pumps Not Running:
March 28, 2019**

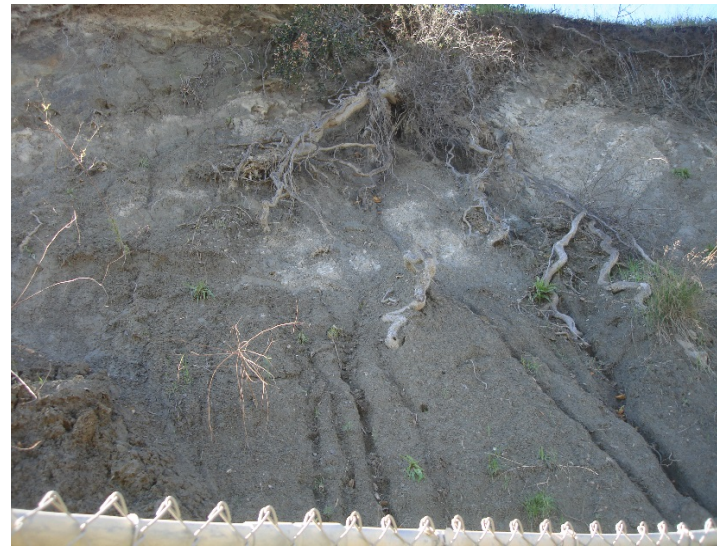
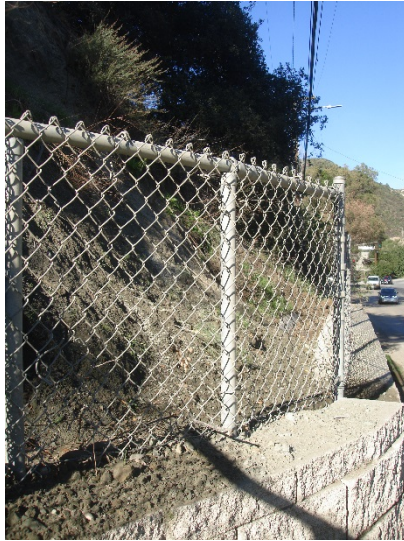
Photo 331: San Fernando Road Retaining Wall Slope: January 22, 2019

Photo 332: San Fernando Road Retaining Wall Slope: January 22, 2019

1. Remove soil from retaining wall drainage ditch.
2. Repair slope erosion below haul road at terminal basin.
3. Eliminate leachate odors at sediment basin 3B sump area.
4. Eliminate landfill gas odors near well 709.

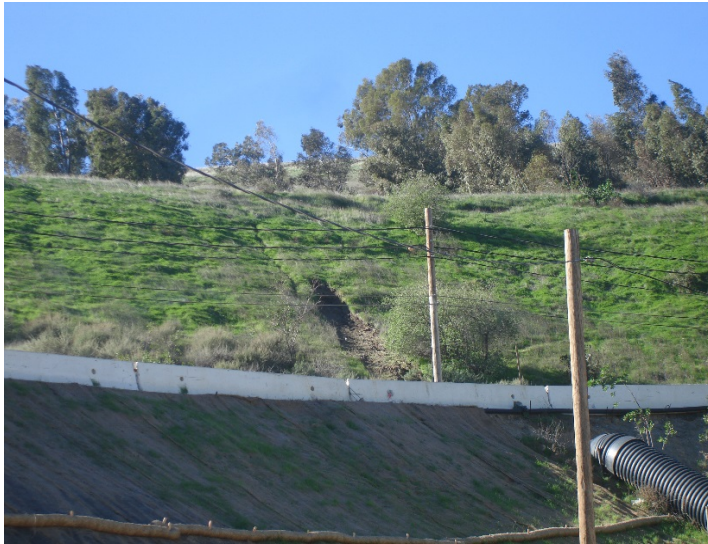
Photo 380: Main Access Road Slopes Near Terminal Basin: January 22, 2019

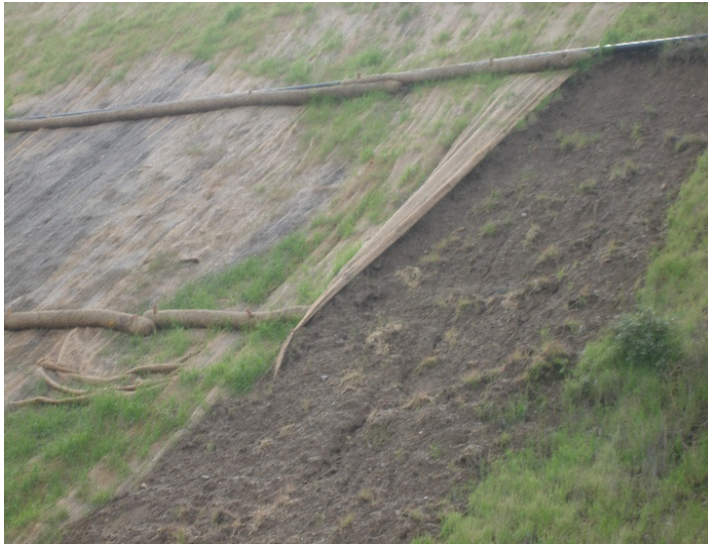
Photo 384: Main Access Road Slopes Near Terminal Basin: February 21, 2019

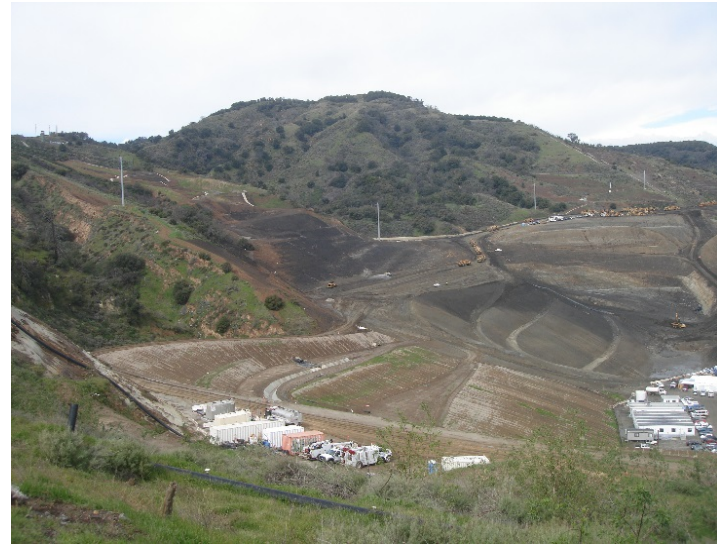
**Photo 385: Main Access Road Slopes Near Terminal Basin:
February 21, 2019**

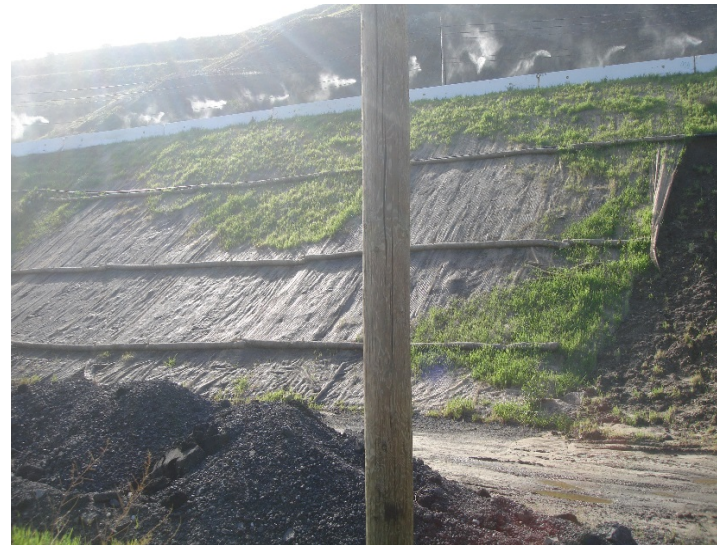
Photo 393: Main Access Road Slopes Near Terminal Basin: March 5, 2019

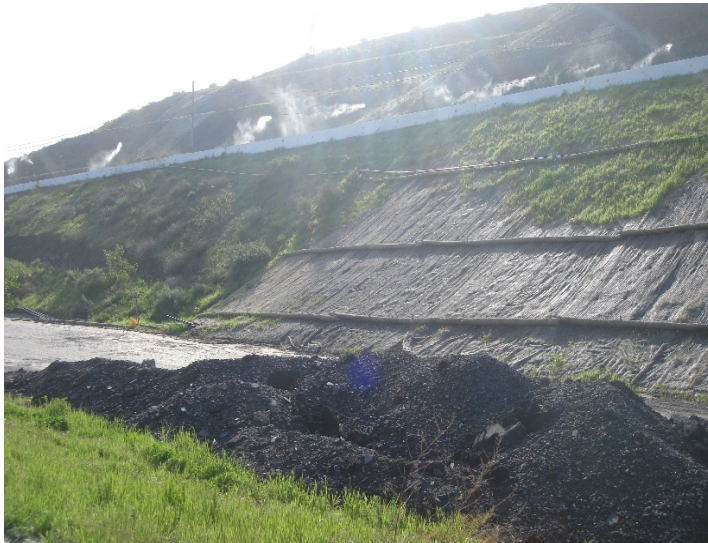
Photo 394: Main Access Road Slopes Near Terminal Basin: March 5, 2019

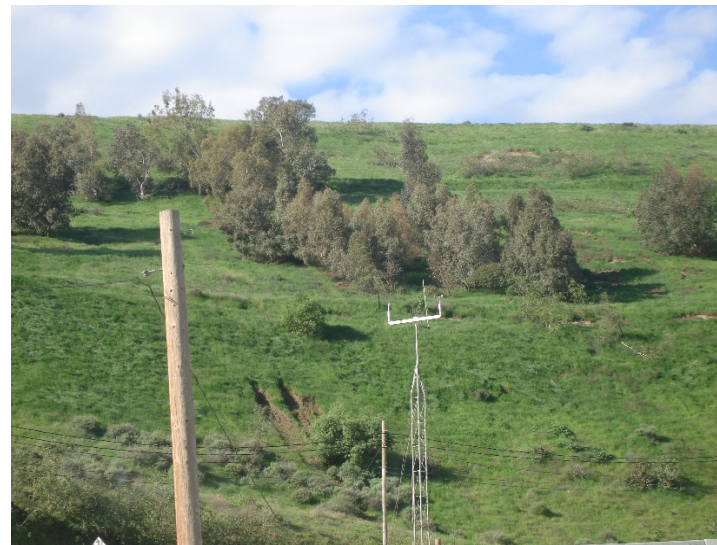
Photo 395: Main Access Road Slopes Near Terminal Basin: March 5, 2019

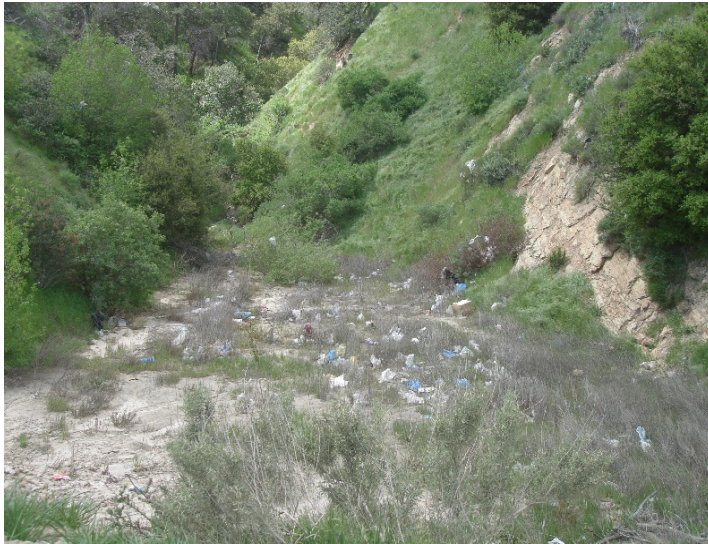
Photo 412: Windblown Litter in Canyon South of Basin A: March 28, 2019

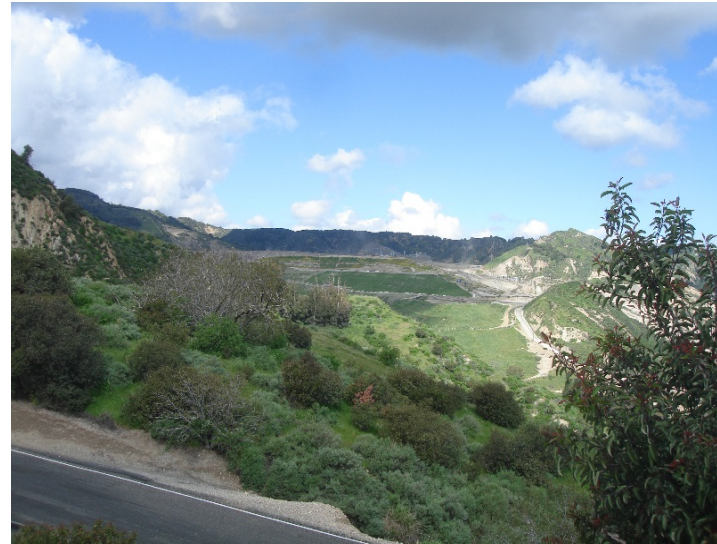
Photo 413: Windblown Litter in Canyon South of Basin A: March 28, 2019

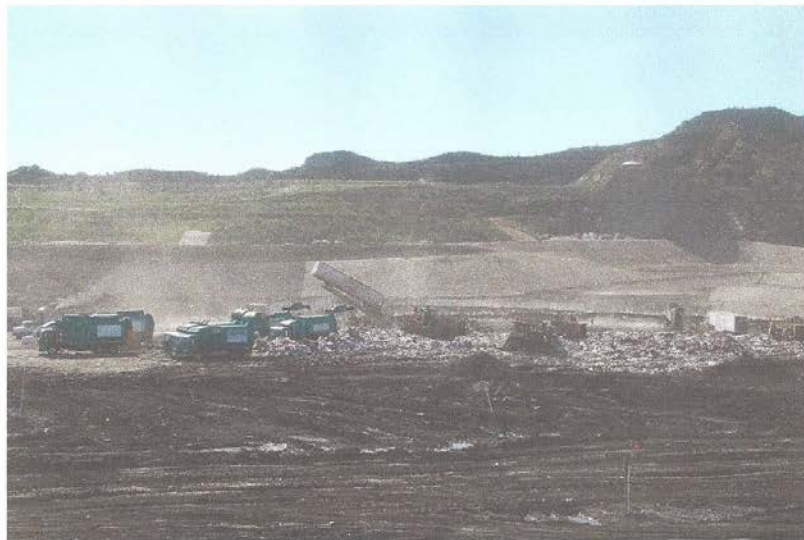
Photo 1: Soil sloughing on slope of embankment of main access road
