**Sunshine Canyon Landfill
Independent Monitor
Quarterly Site Monitoring Status Report
January 1, 2019 – March 31, 2019**

April 29, 2019

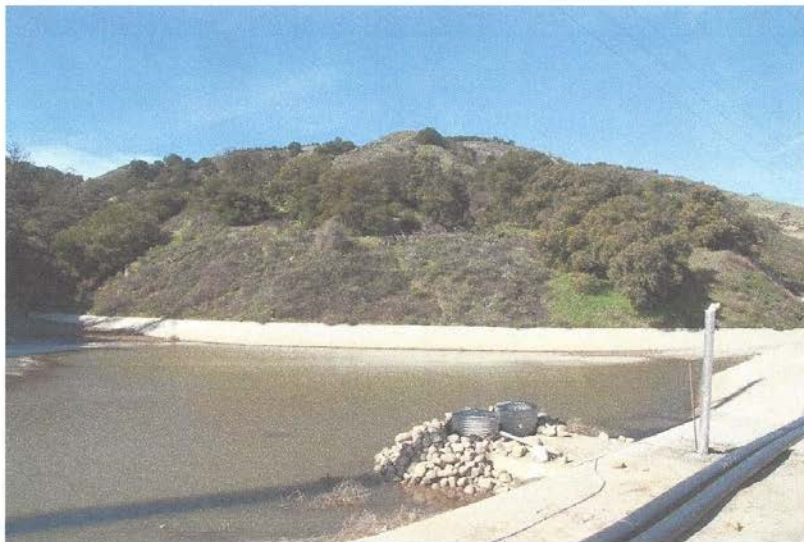
Photo 7: Erosion on slope of embankment for basin CC3

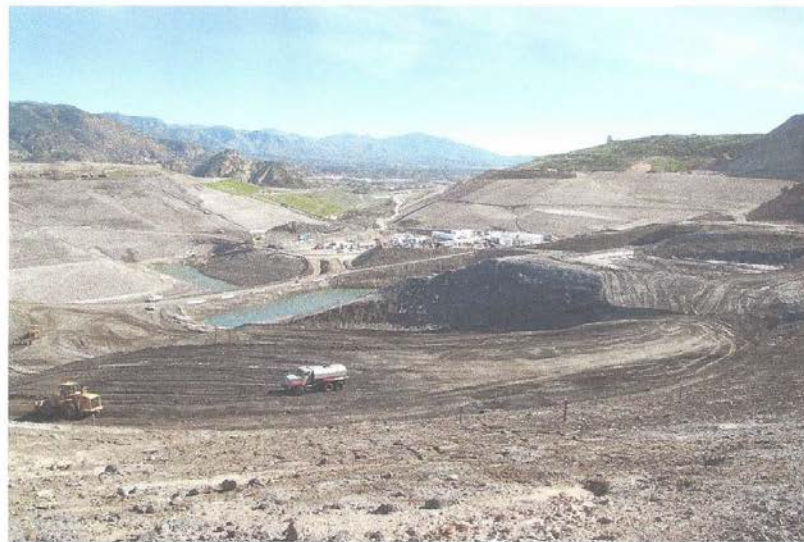
<p>a new channel will be rebuilt when earthwork is completed. It is our understanding from Republic staff, that when a storm occur the contractor (Sukut) is responsible for managing the stormwater and whatever erosion results. Their plan is to direct the water toward a retention basin at the toe of the buttress (Photo 10) and pump the water out into the main concrete channel connected to the terminal basin. The plan worked well during the earlier storm.</p> <ul style="list-style-type: none"> • Basin D <ul style="list-style-type: none"> – Basin is clean • Basin B <ul style="list-style-type: none"> – Basin is essentially clean with small amount of sediment at the back on side due to minor sloughing (Photos 11 and 12) • Ditch along access road to Flare 9-11 <ul style="list-style-type: none"> – The drain at the end of the concrete on side of road is plugged by sediments (Photo 13) • Channels <ul style="list-style-type: none"> – First segment west of the access road to Flare Outlet. the geomembrane has been partly uplifted by water flowing under and weeds have accumulated thereby reducing the flow area (Photo 14) of the channel – Second segment west of the access road to Flare Outlet. The geomembrane was uplifted and bunched-up reducing the area for water flow. Water flowing under the geomembrane uplifted the corrugate steel pipe placed in the channel to go under the power pole (Photo 15) • Moat around Cell CC3 Part 2 <ul style="list-style-type: none"> – water accumulated and was pumped out (Photo 16)

Photo 9: Sediments at back of Basin A

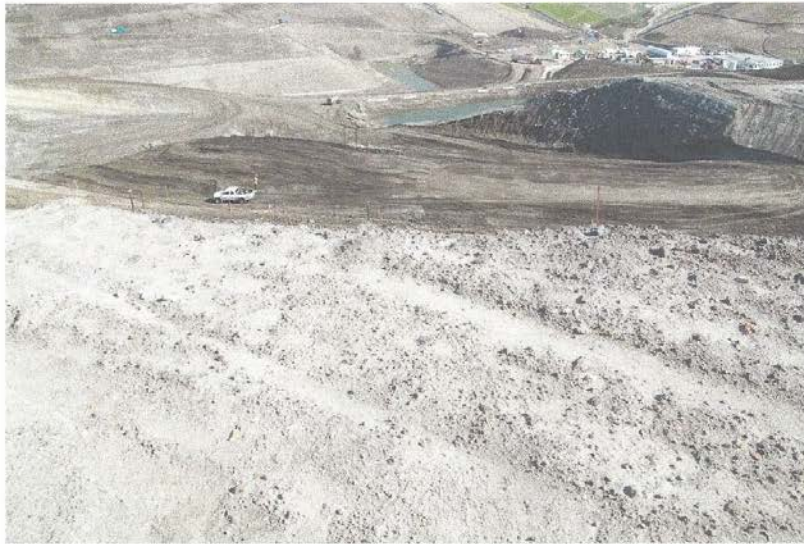
<p>Excavation for Cell 4 Phase 3</p> <ul style="list-style-type: none"> • No Excavation/fill placement work was ongoing at time of our inspection • Compaction was monitored by a technician using a nuclear gauge (Photo 17) • Additional prisms have been installed on the slope - Notes the stakes on the slope on Photo 17. • Other instruments have also been installed to monitor the slope at depth (Photo 18)
<p>Erosion Protection Systems</p> <ul style="list-style-type: none"> • Some erosion gullies have developed despite the protection blankets and wattles installed on numerous slopes. On Slope of Cell 4 Phase 3, a deep gully exposes some waste (Photo 19). • In general all the systems have held quite well during the last storm
<p>Other Observations</p> <ul style="list-style-type: none"> • Wall along San Fernando Road <ul style="list-style-type: none"> – Some erosion and sloughing have occurred and filled up the drainage swale (Photo 20) – More roots of a tree at top of slope have been exposed and the tree may be at risk of toppling (Photo 21) • Close-out meeting with Republic Staff representative to discuss findings of visit

Figure 17: CQA monitoring of buttress – Note stakes for new movement monitoring prisms

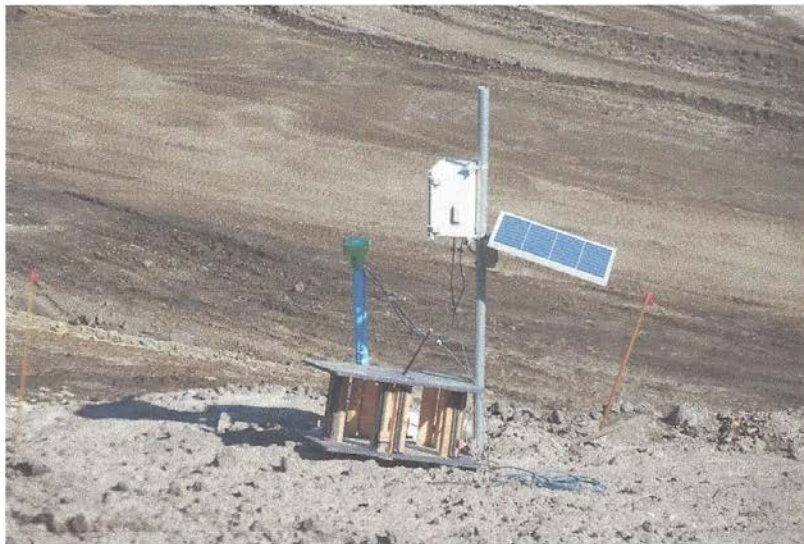
Figure 18: additional monitoring instrument on slope of excavated area of future buttress

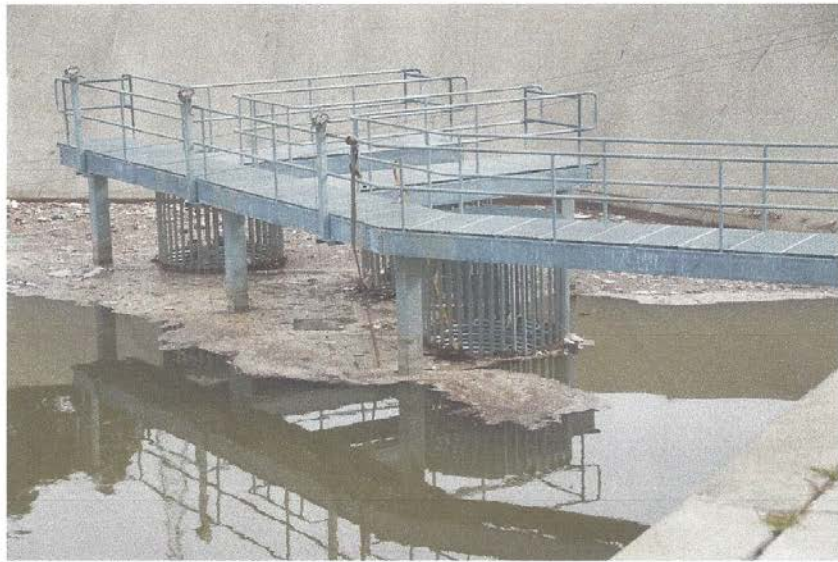
Photo 5: Water level and waste accumulation near decant towers at Terminal basin

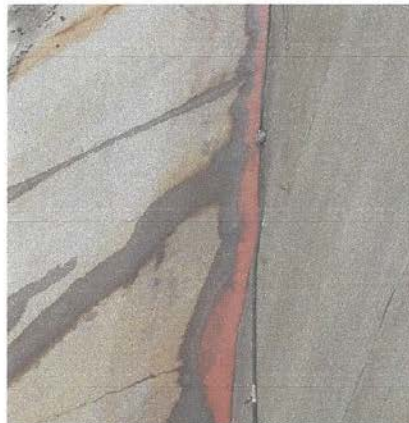
Photo 6: Reddish deposit from water seeping through weep holes at the bottom of the wall

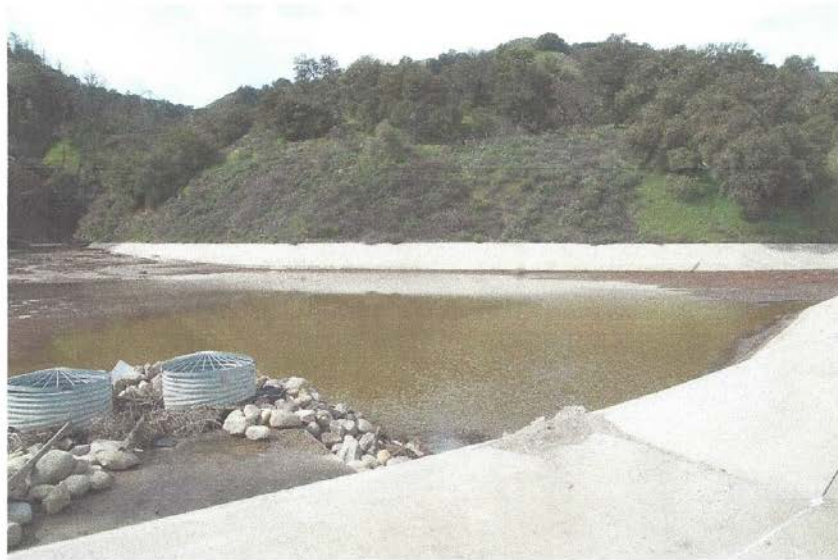
- Basin A
 - Basin held some water (Photo 13) but provide enough capacity for a large storm.
 - Sediments have accumulated at the back, but volume is small enough and should not impact the overall storage capacity of the basin (Photo 13)

Photo 13: Low water volume and limited sediment accumulation in Basin A

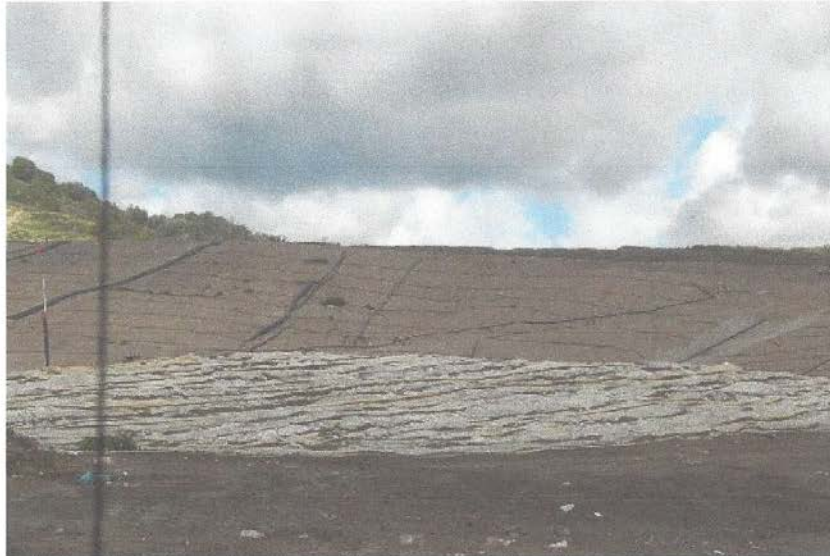
Photo 1: Use of ADC at the waste face in Cell CC4

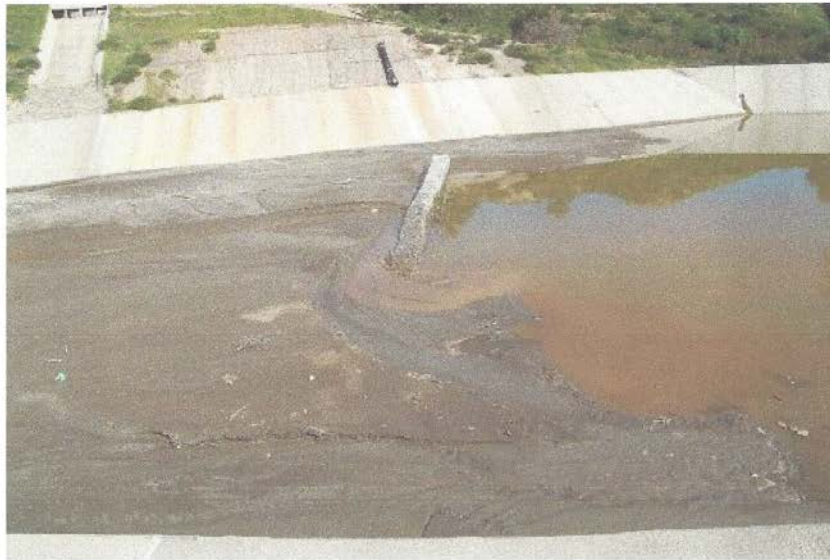
Photo 3: Sediment level in Terminal Basin

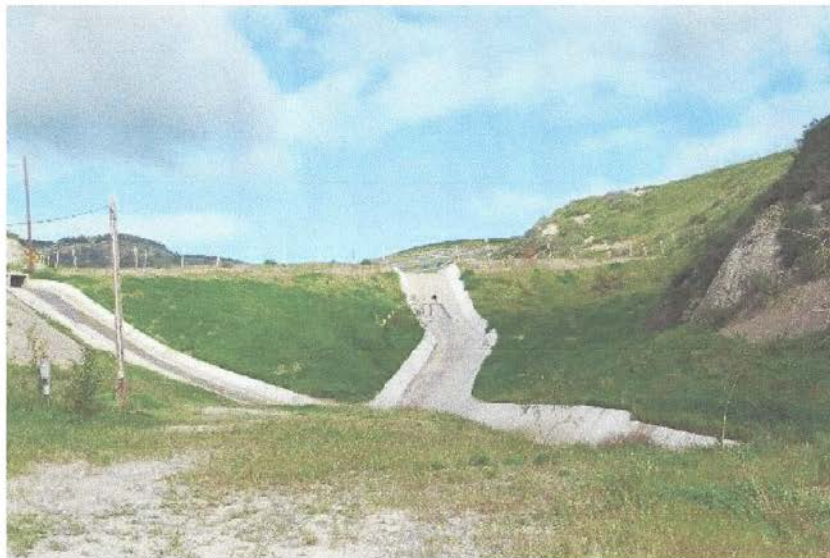
- the erosion gullies on downstream side of the earth embankment observed in previous visits have not worsened and are protected by heavy vegetation and do not pose a stability risk (Photo 8)

Photo 8: Vegetation covering erosion gullies on slope of embankment for earthen basin CC3

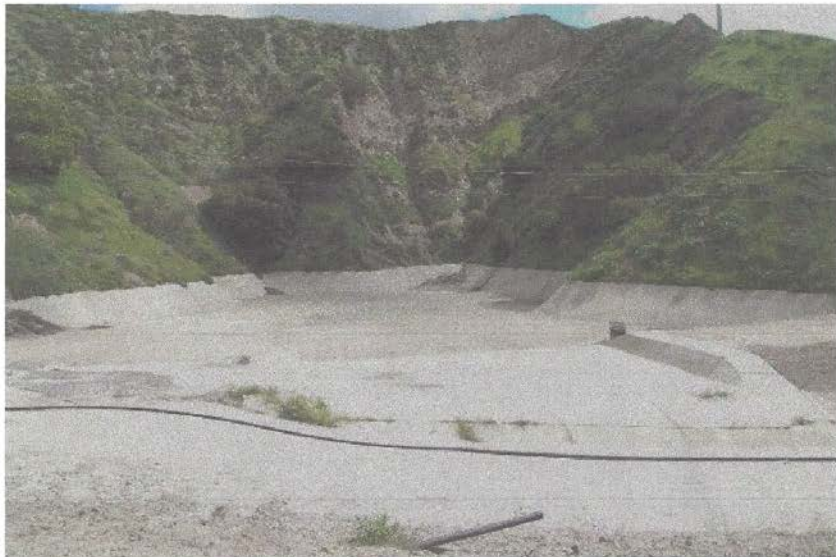
- Basin B
 - Basin empty of water but contains a small amount of sediment but not enough to affect the anticipated performance of the basin to store stormwater. (Photo 10)

Photo 10: Sediments in basin B

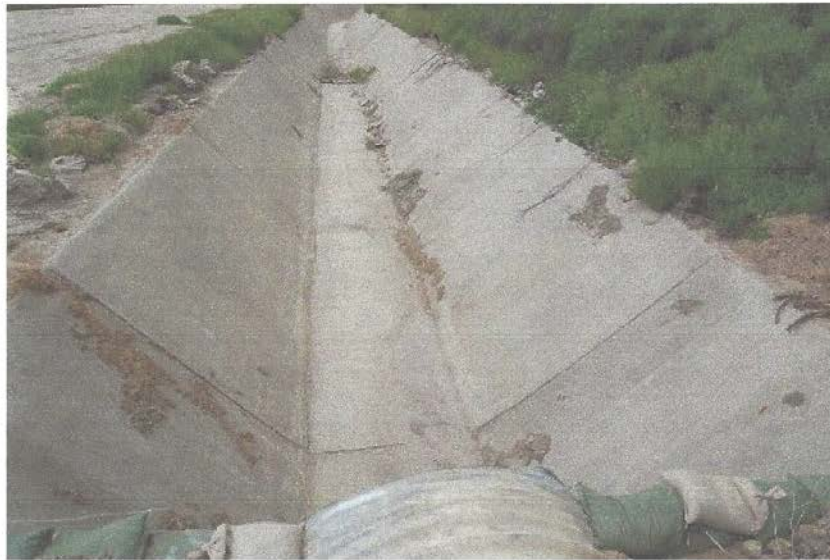
- Channels between Basin B and Basin D
 - Segment between Basin D and power pole: The CMP pipe has been reinstalled, and the geomembrane removed providing full flow capacity (Photo 13)

Photo 13: Reinstalled CMP in channel segment between Basin D and power pole

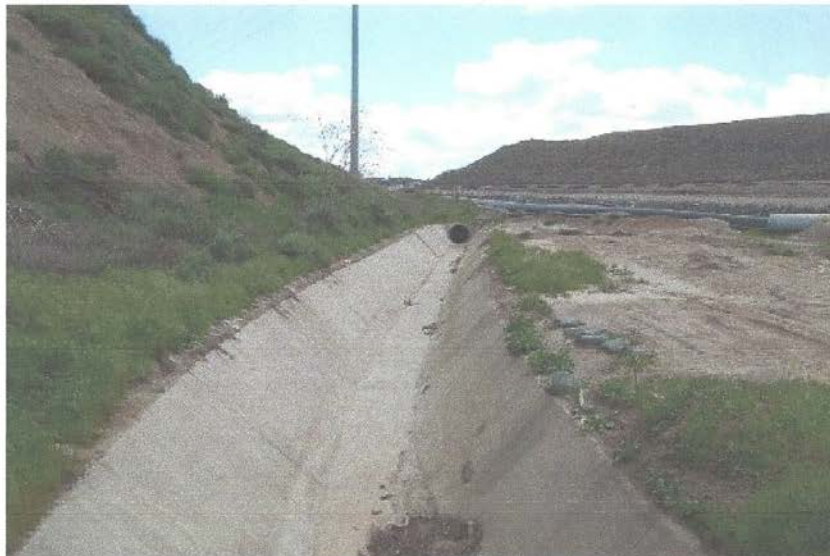
- Segment between power pole access road to Flare Outlet: rumpled geomembrane observed during previous visit has been removed providing full flow capacity in channel (Photo 14)

Photo 14: Cleaned up channel between power pole and access road to Flares 9-11

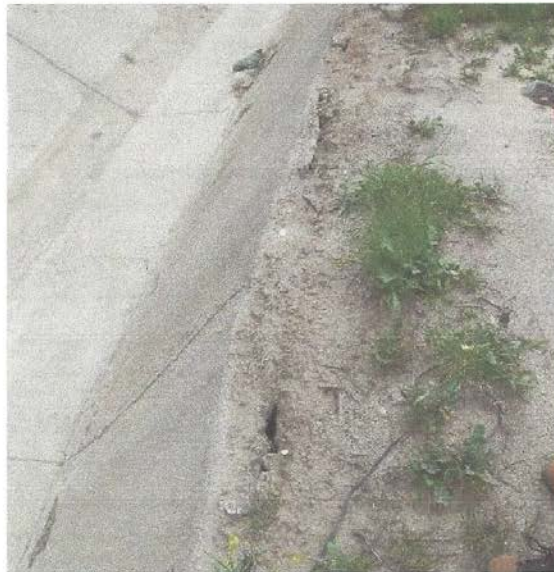
Phot 15: erosion along the edge of concrete channel between power pole and access road to Flares 9-11

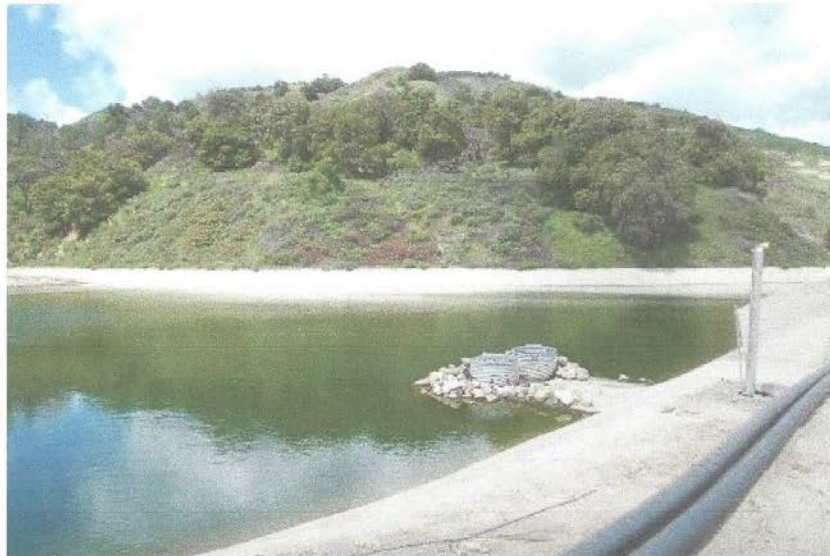
- Basin A
 - Basin held water (Photo 16) but active management approach agreed upon should permit to act in case of a large storm forecast. Due to the excavation for cell CC4 Phase 4, the channel out of Basin A was removed but a new channel will be rebuilt when earthwork is completed. It is our understanding from Republic staff, that when a storm occurs the contractor (Sukut) is responsible for managing the stormwater and whatever resulting erosion. As for previous storms the water would be directed toward a retention basin at the toe of the buttress and pumped out into the main concrete channel connected to the terminal basin.

Photo 16: High water level in Basin A

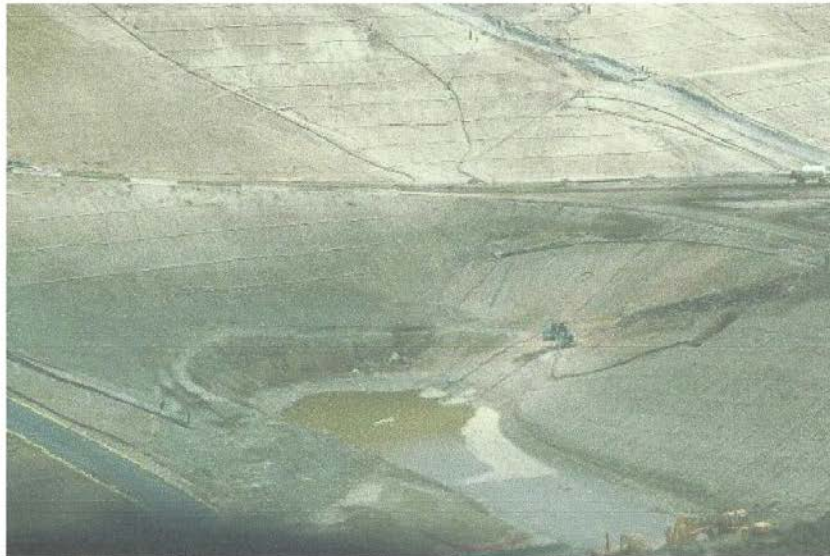
- Moat around Cell CC3 Part 2
 - No water in the moat but a fair amount of sediment. However, the maximum elevation of the water would still be under the elevation of the bottom of the waste in Cell CC4 Phase 3 therefore there is no issue (Photo 18)

Photo 18: Nearly empty moat around Cell CC4 Phase 3

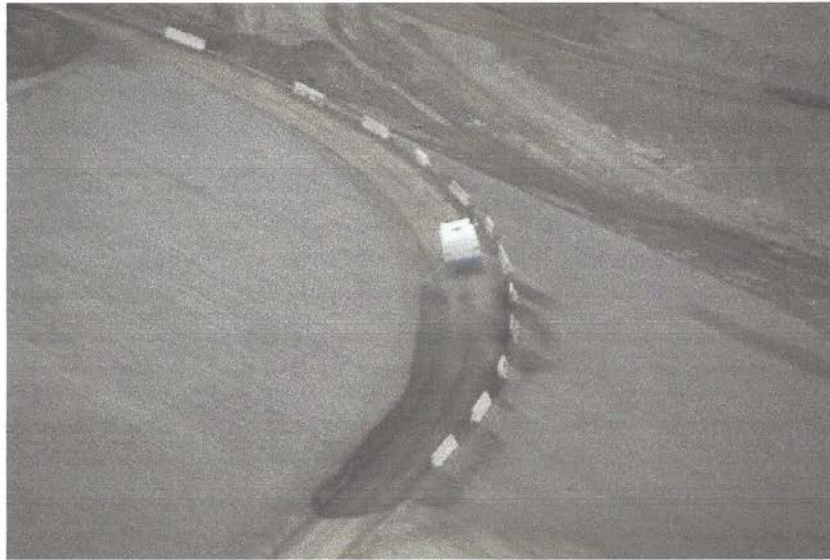
- Fill placement work was ongoing at time of our inspection
- Compaction was monitored by a technician
- Moisture condition and watering of the access roads was on-going throughout the duration of our visit (Photo 19)

Figure 19: Moisture conditioning on roads
