**Sunshine Canyon Landfill
Independent Monitor
Quarterly Site Monitoring Status Report
October 1, 2019 – December 31, 2019**

City of Los Angeles Department of City Planning

County of Los Angeles Department of Regional Planning

April 3, 2020

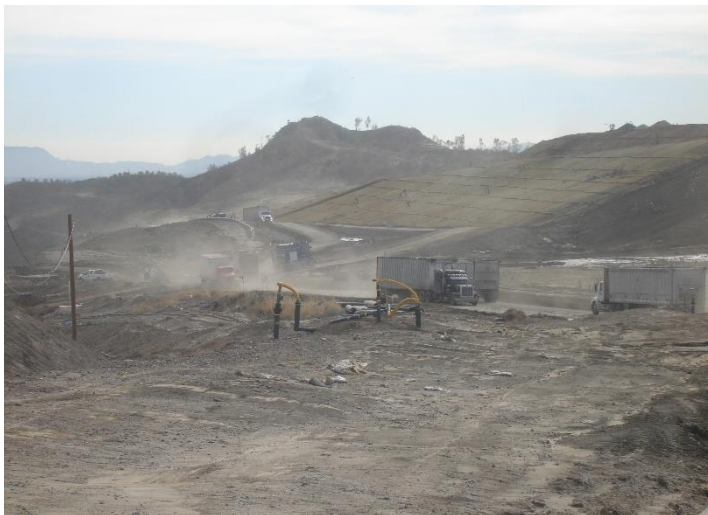
Photo 123: Site Working Area CC4 Part 1&2 Haul Road Dust: December 11, 2019

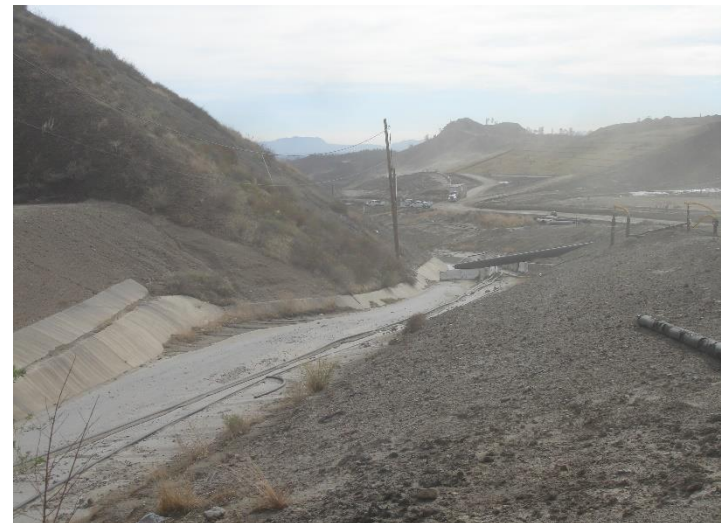
Photo 124: Site Working Area CC4 Part 1&2 Haul Road Dust: December 11, 2019

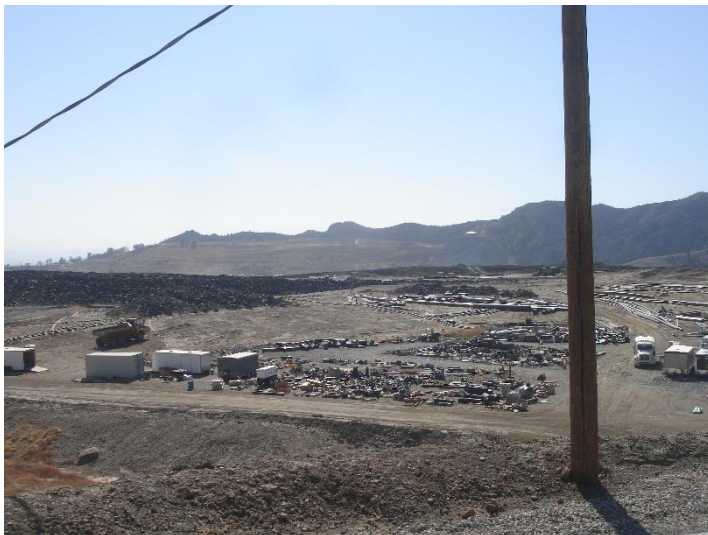
Photo 199: County Top Deck: October 29, 2019

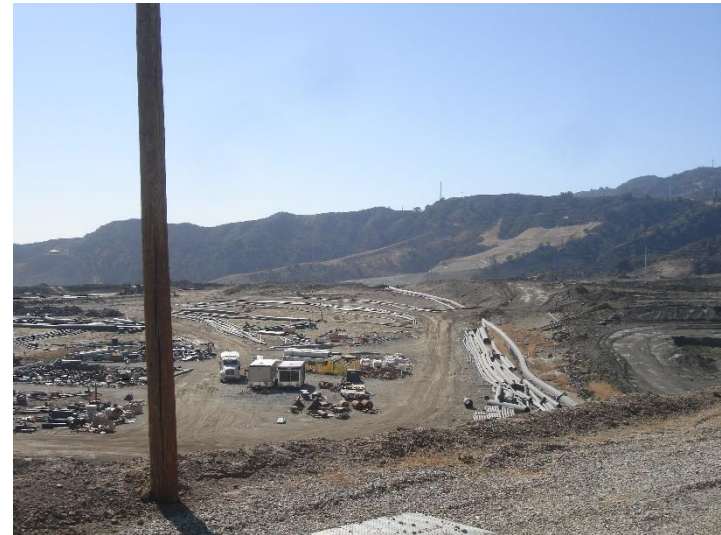
Photo 200: County Top Deck: October 29, 2019

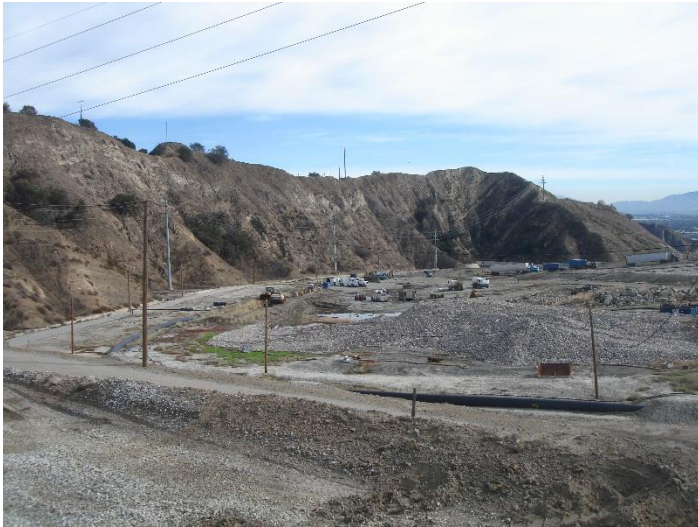
Photo 201: County Top Deck: December 11, 2019

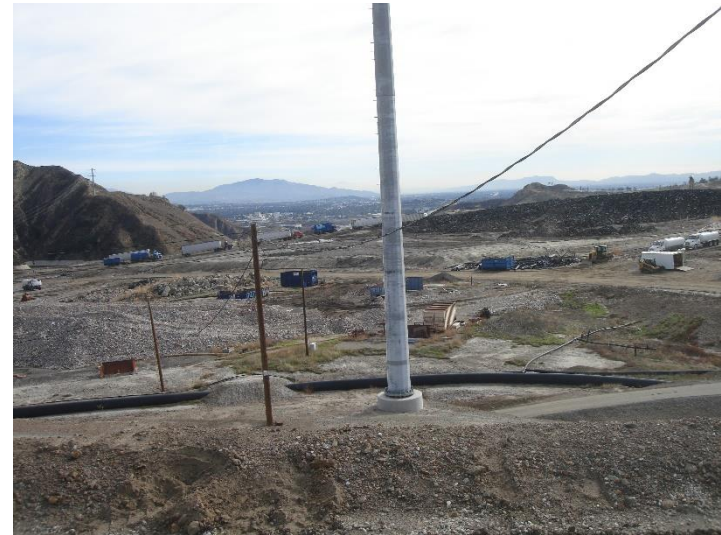
Photo 202: County Top Deck: December 11, 2019

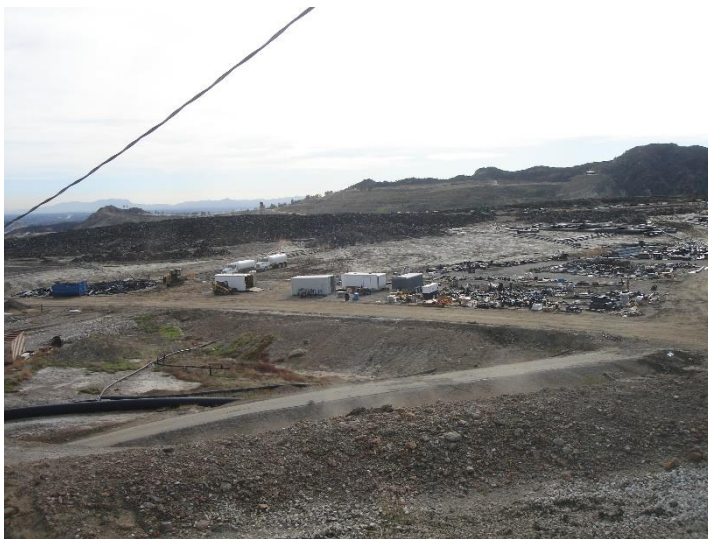
Photo 203: County Top Deck: December 11, 2019

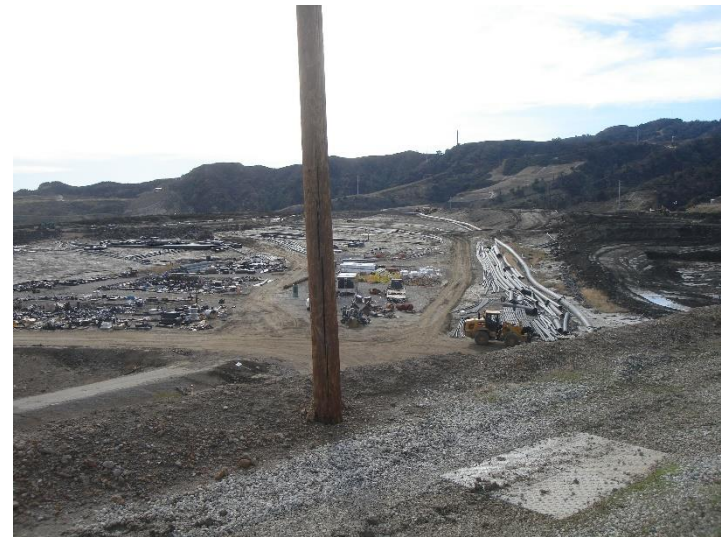
Photo 204: County Top Deck: December 11, 2019

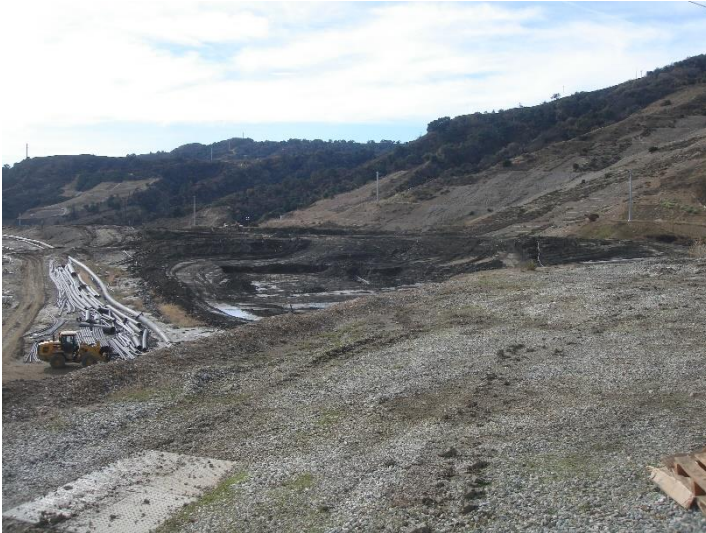
Photo 205: County Top Deck: December 11, 2019

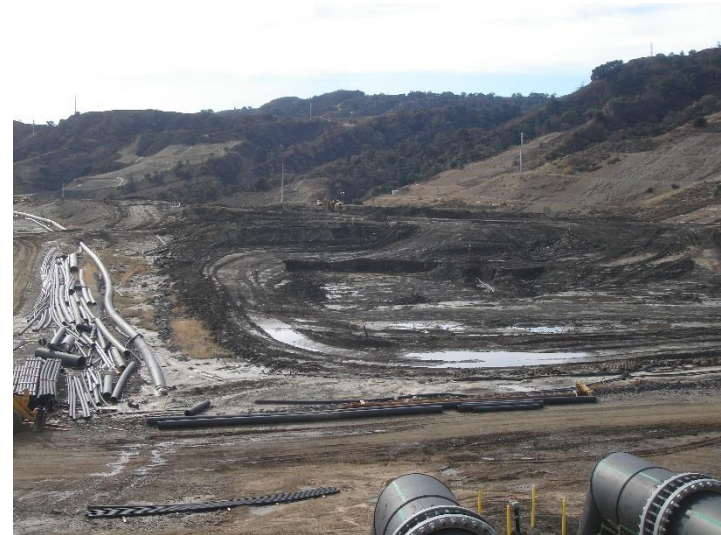
Photo 206: County Top Deck: December 11, 2019

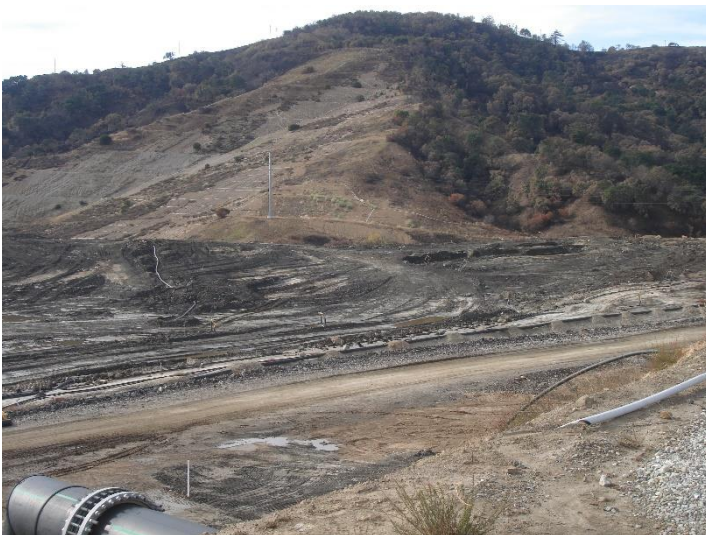
Photo 207: County Top Deck: December 11, 2019

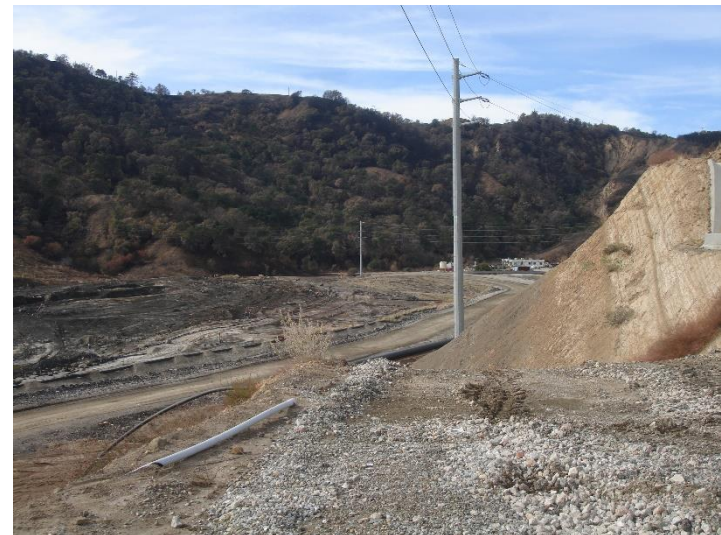
Photo 208: County Top Deck: December 11, 2019

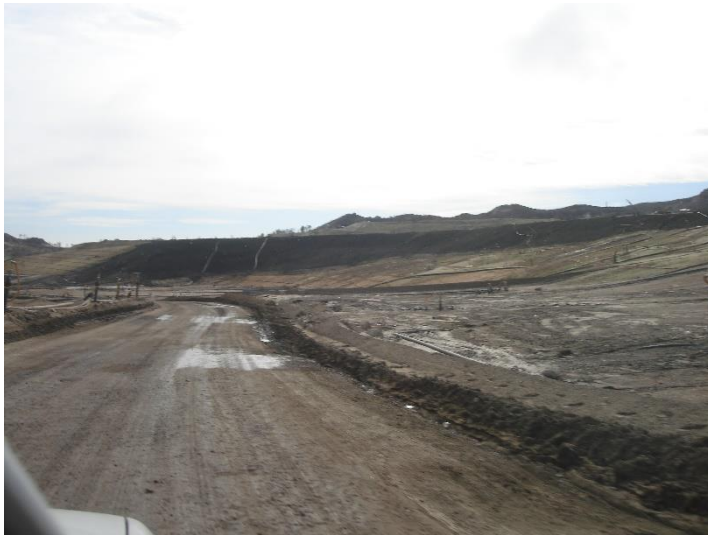
Photo 209: County Bowl Area: December 11, 2019

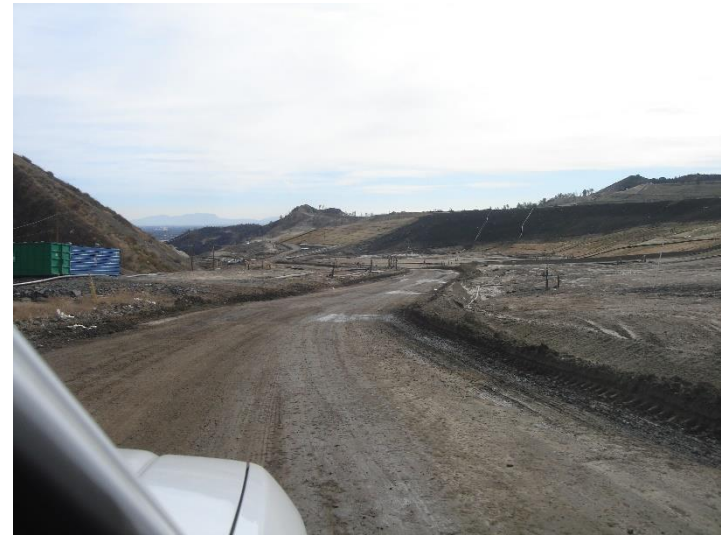
Photo 210: County Bowl Area: December 11, 2019

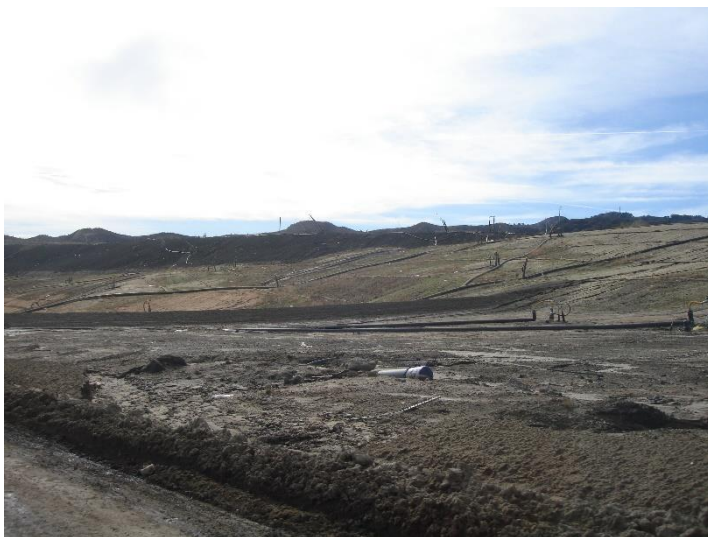
Photo 211: County Bowl Area: December 11, 2019

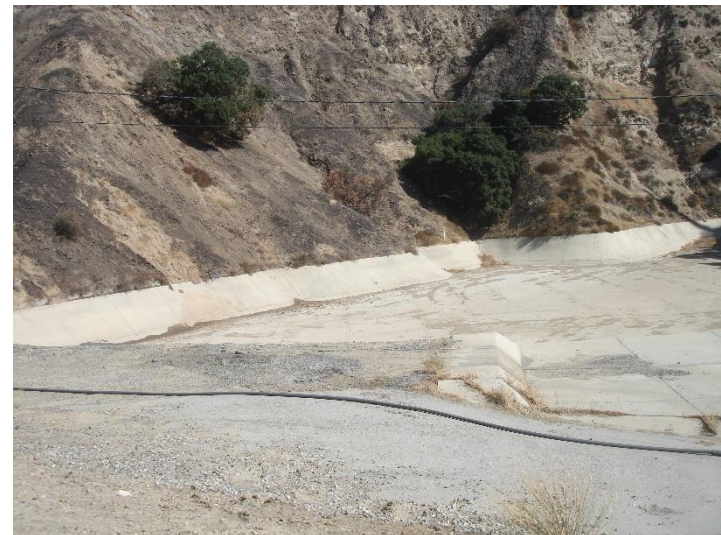
Photo 212: Basin B: October 29, 2019

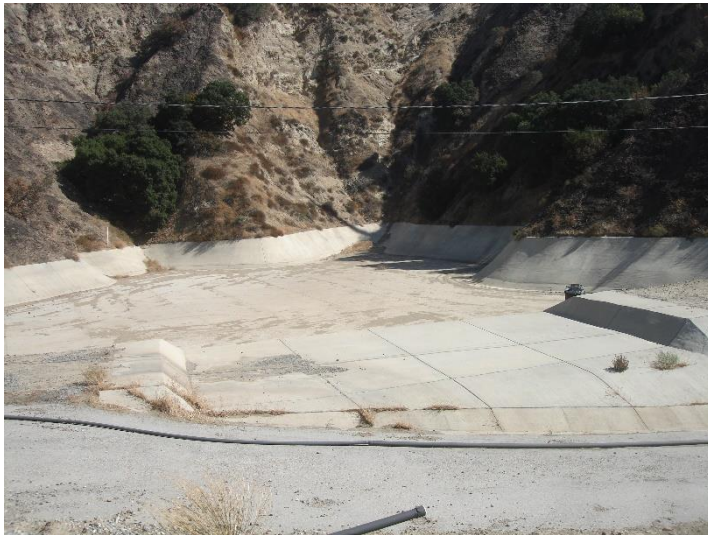
Photo 213: Basin B: October 29, 2019

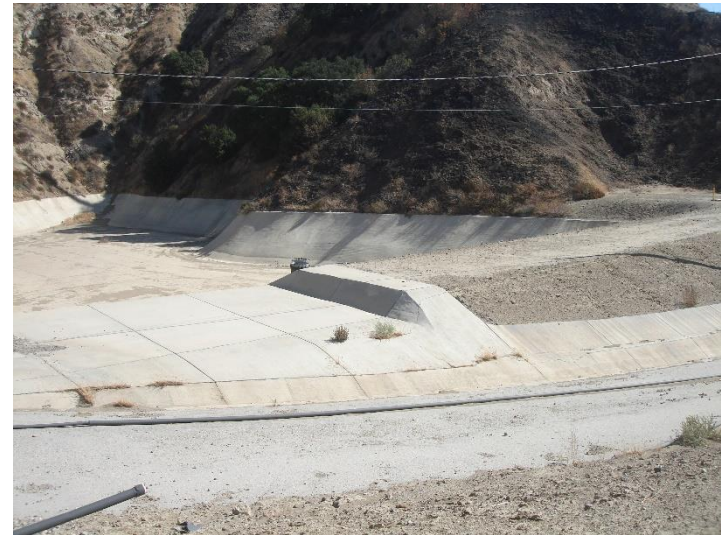
Photo 214: Basin B: October 29, 2019

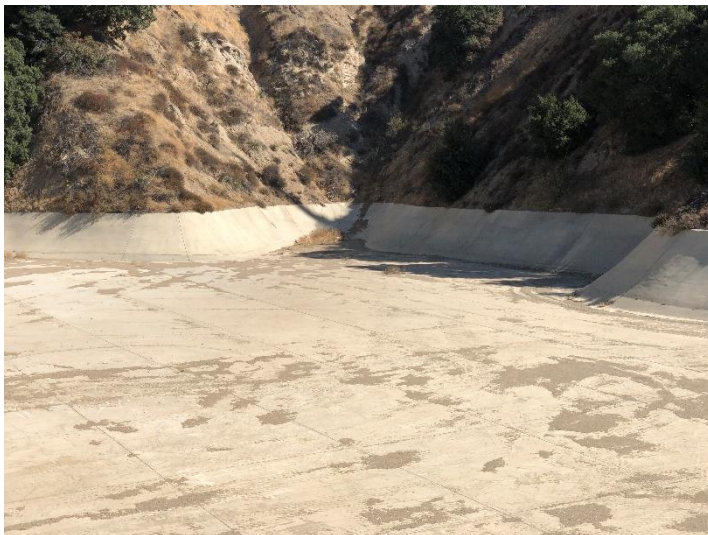
Photo 215: Basin B: October 29, 2019

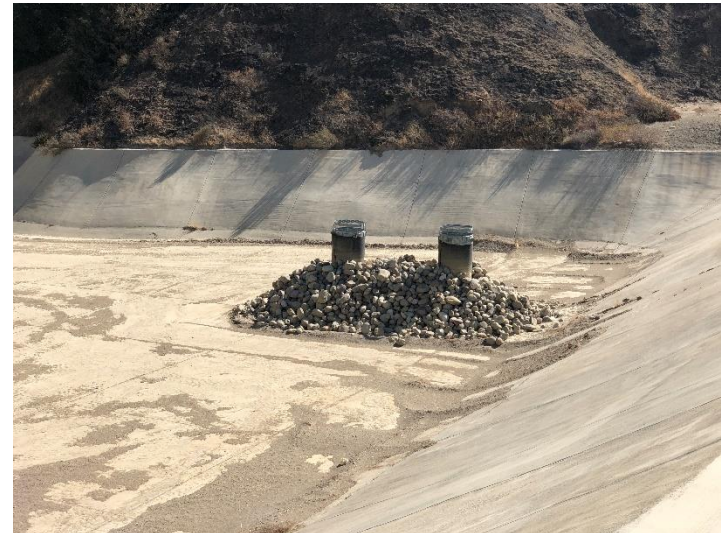
Photo 216: Basin B: October 29, 2019

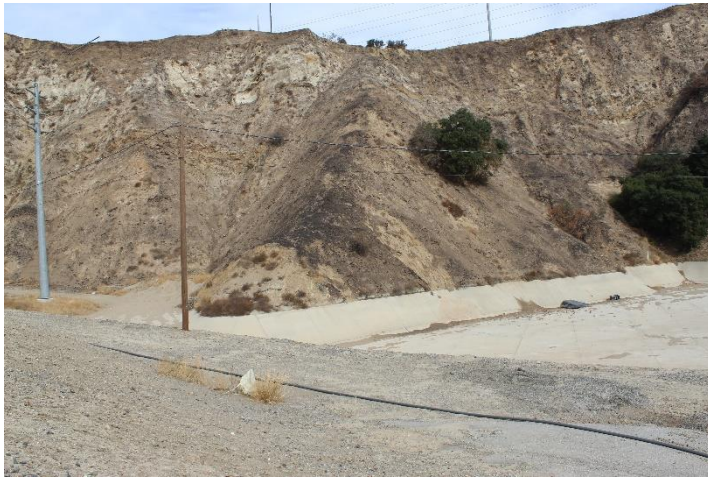
Photo 217: Basin B: November 19, 2019

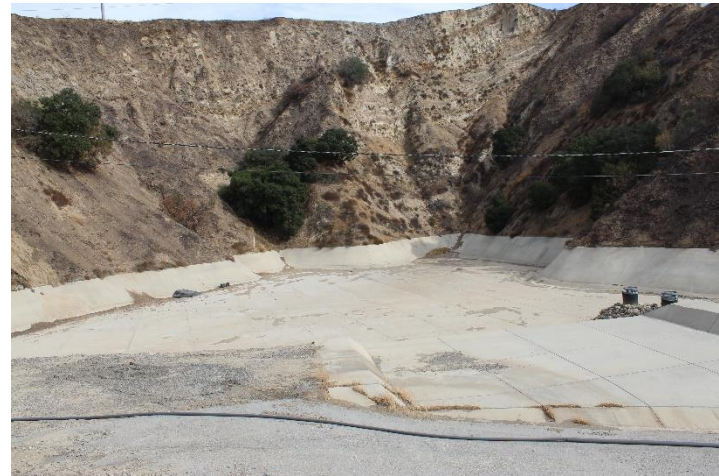
Photo 218: Basin B: November 19, 2019

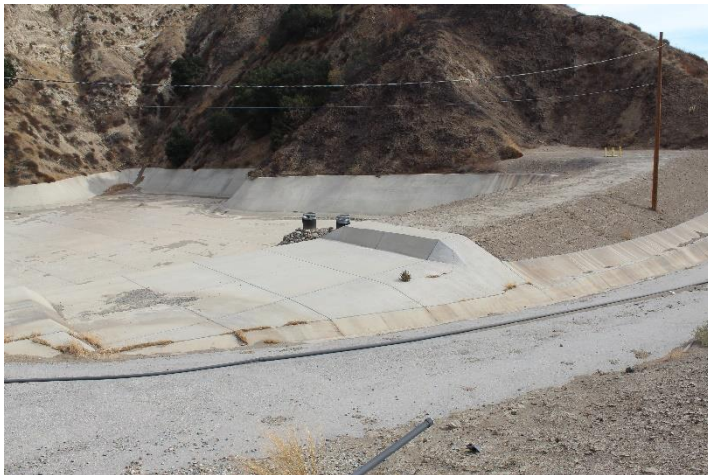
Photo 219: Basin B: November 19, 2019

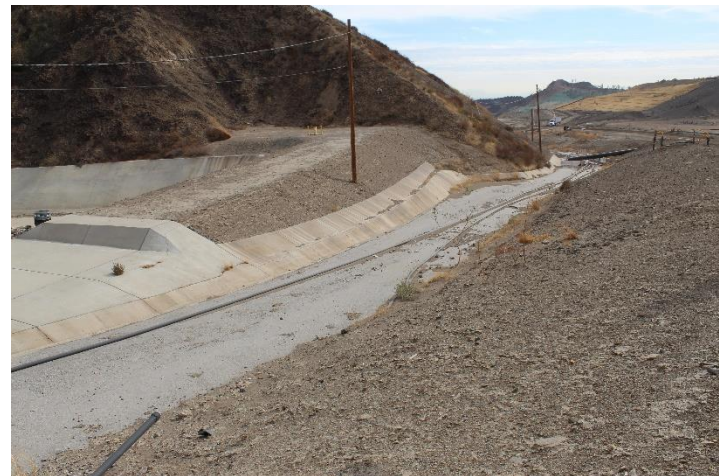
Photo 220: Basin B: November 19, 2019

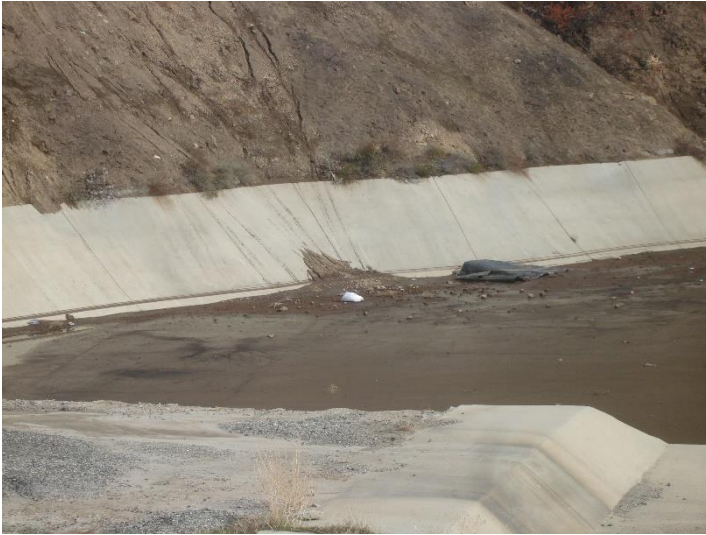
Photo 221: Basin B: December 11, 2019

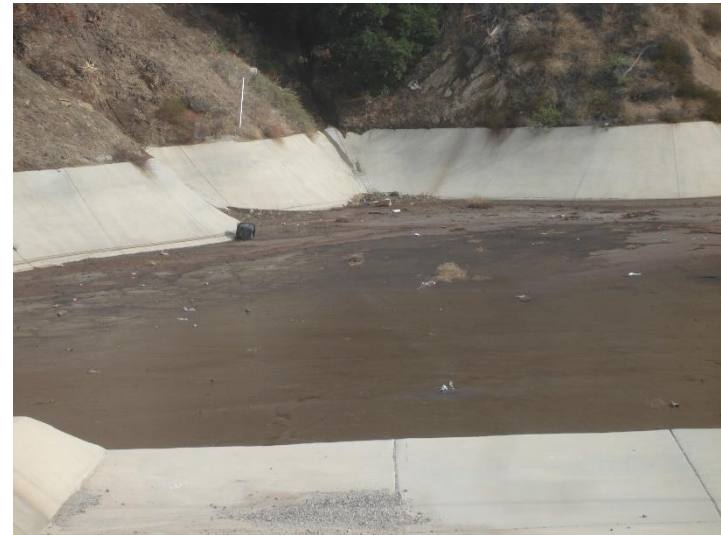
Photo 222: Basin B: December 11, 2019

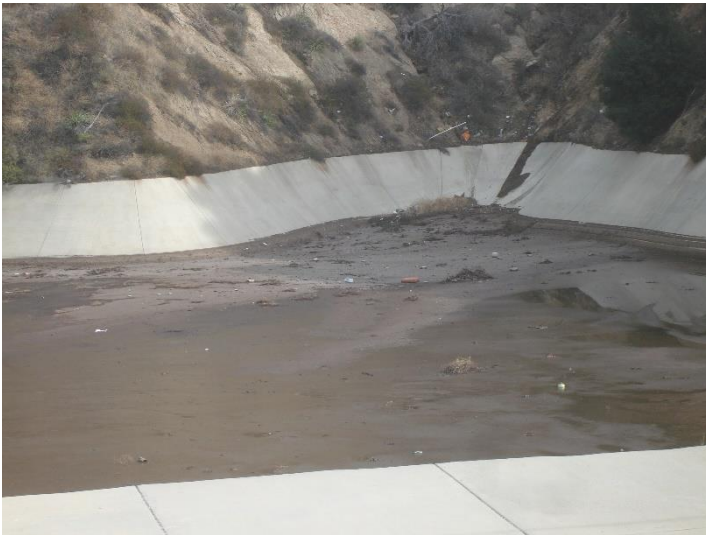
Photo 223: Basin B: December 11, 2019

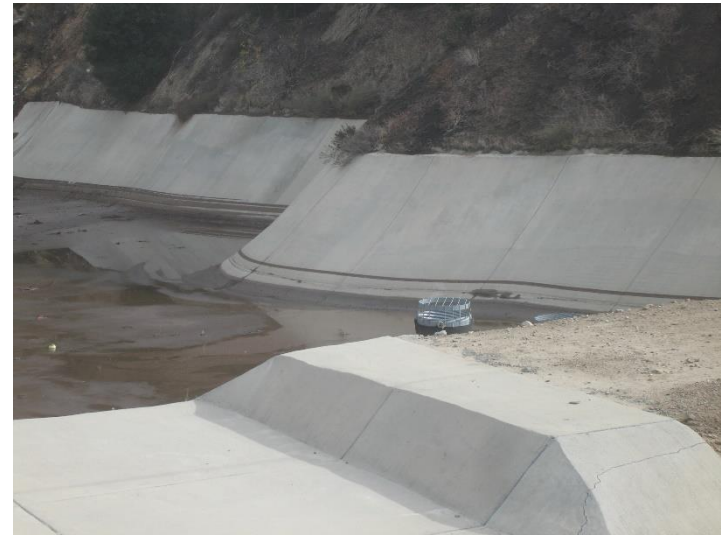
Photo 224: Basin B: December 11, 2019

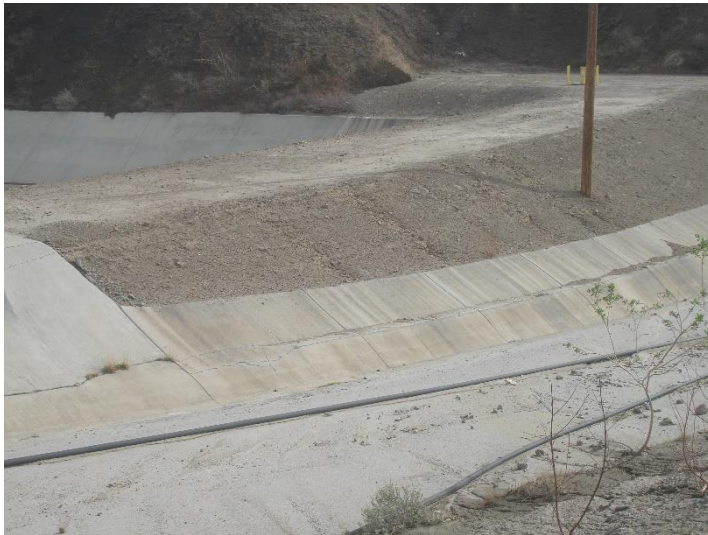
Photo 225: Basin B: December 11, 2019

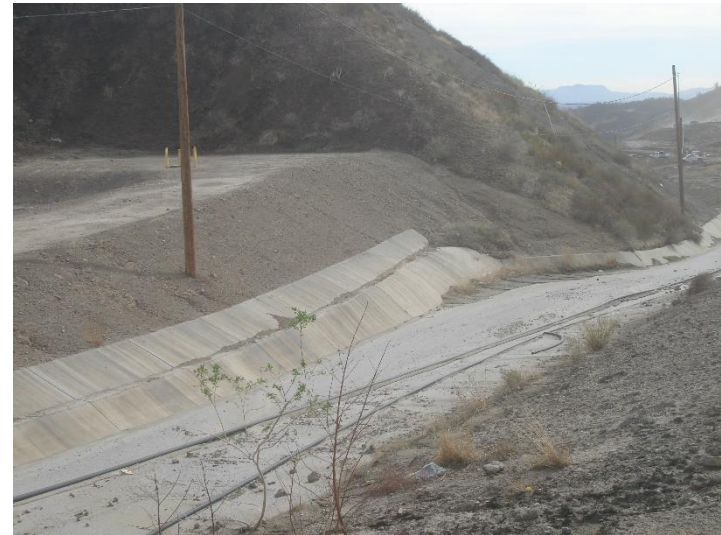
Photo 226: Basin B: December 11, 2019

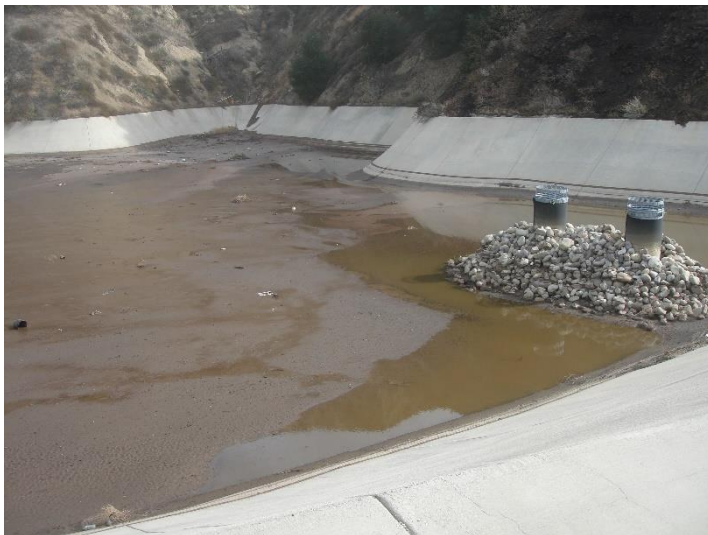
Photo 227: Basin B: December 11, 2019

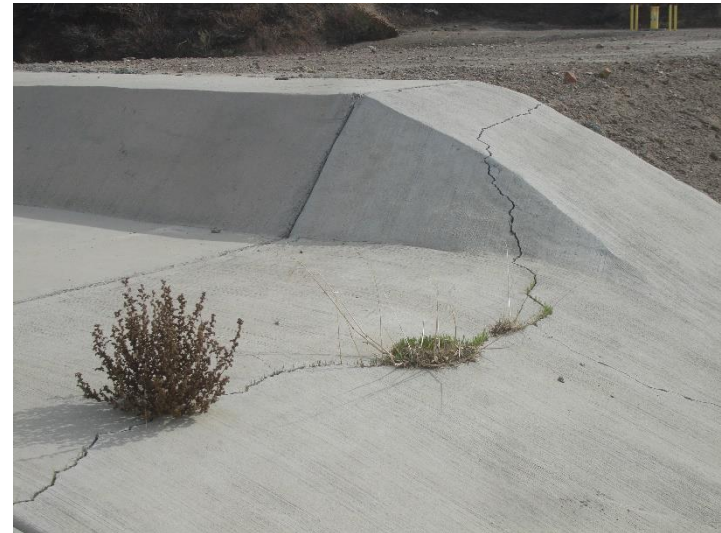
Photo 228: Basin B: December 11, 2019

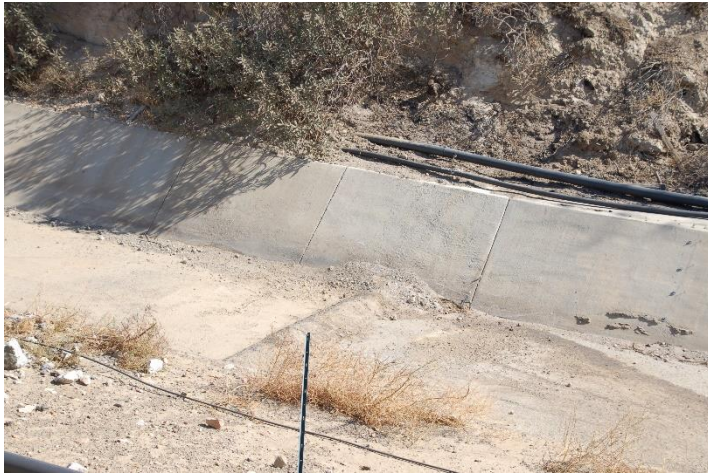
Photo 229: Eastside Drainage: October 29, 2019

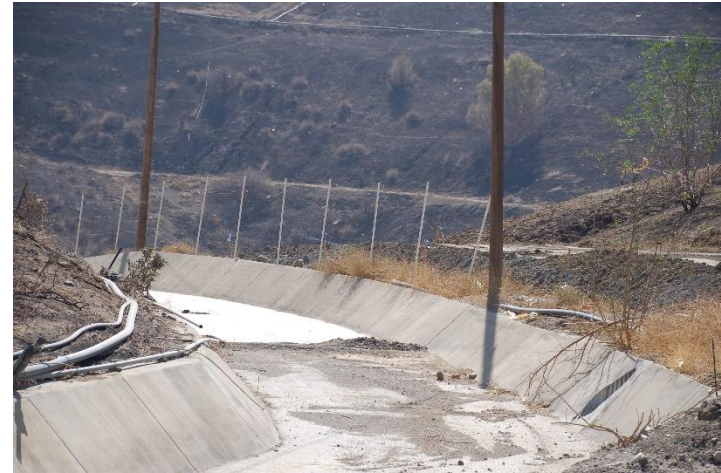
Photo 230: Eastside Drainage: October 29, 2019

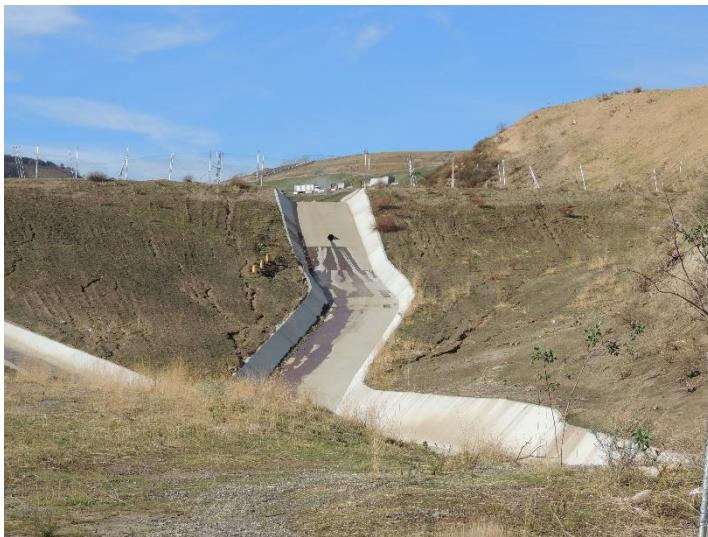
Photo 231: Terminal Basin Inlet: December 11, 2019

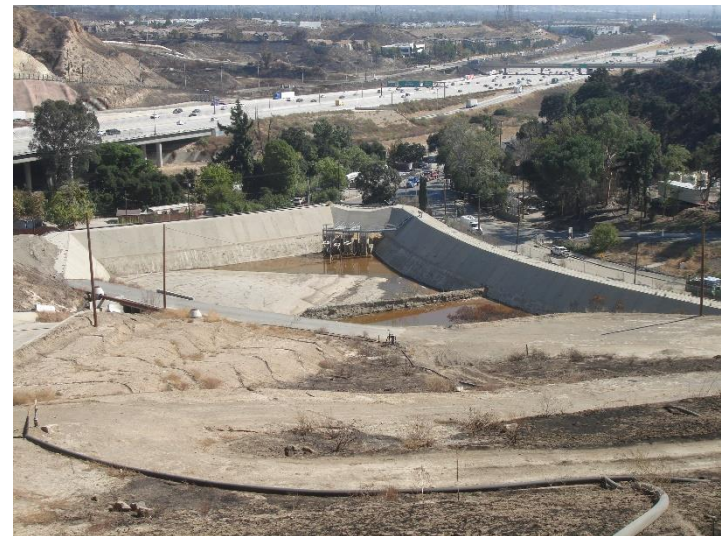
Photo 232: Terminal Basin: October 29, 2019

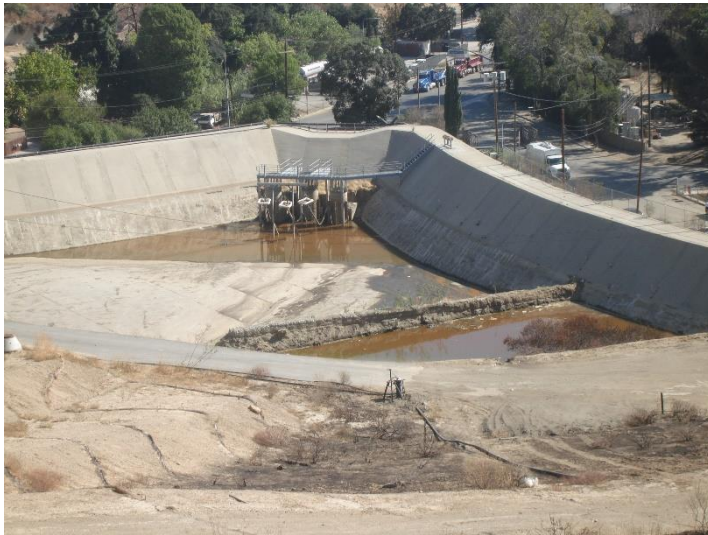
Photo 233: Terminal Basin: October 29, 2019

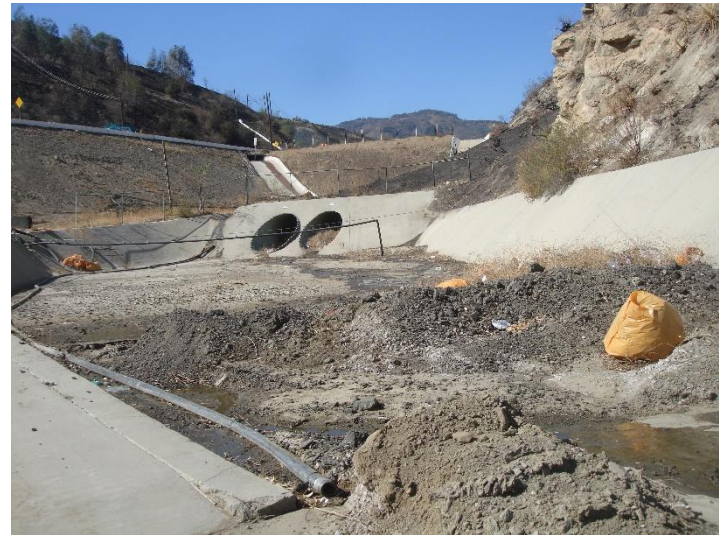
Photo 234: Terminal Basin Westside Drainage Channel: October 29, 2019

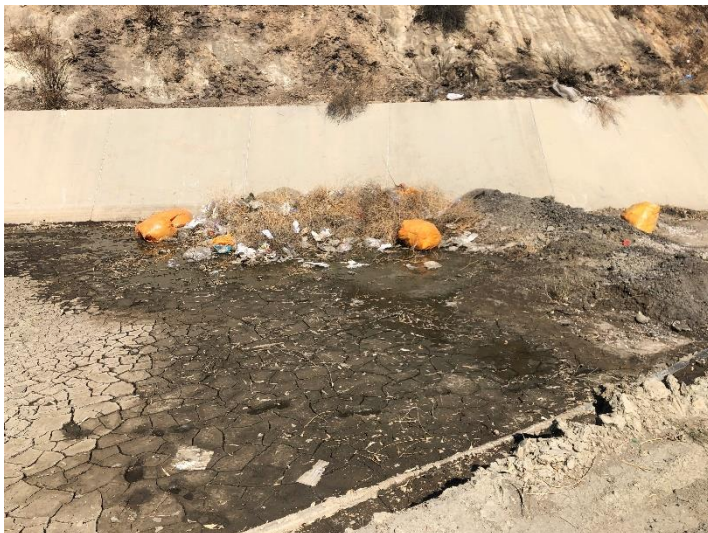
Photo 235: Terminal Basin: October 29, 2019

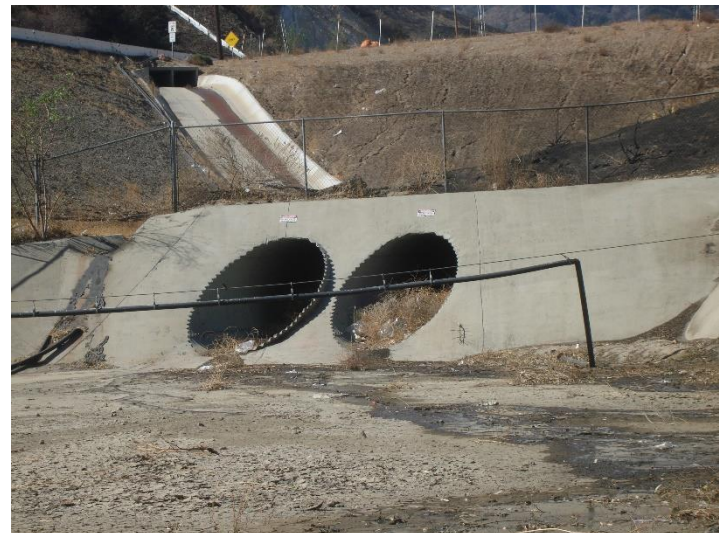
Photo 236: Terminal Basin Westside Drainage Channel: October 29, 2019

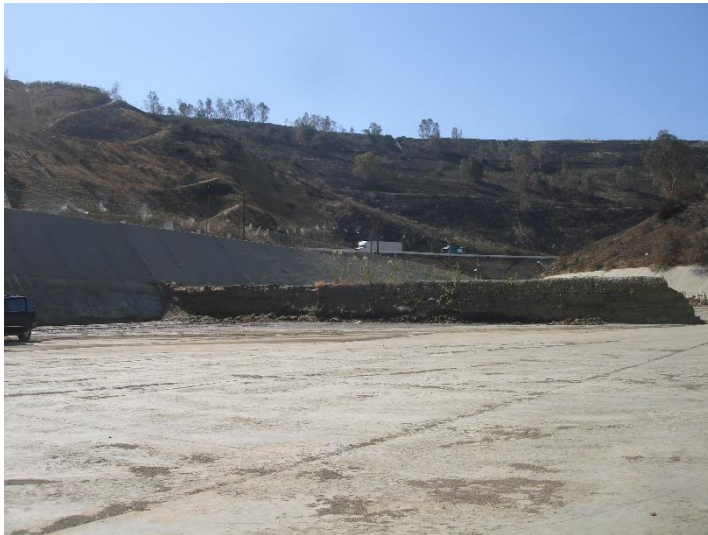
Photo 237: Terminal Basin: October 29, 2019

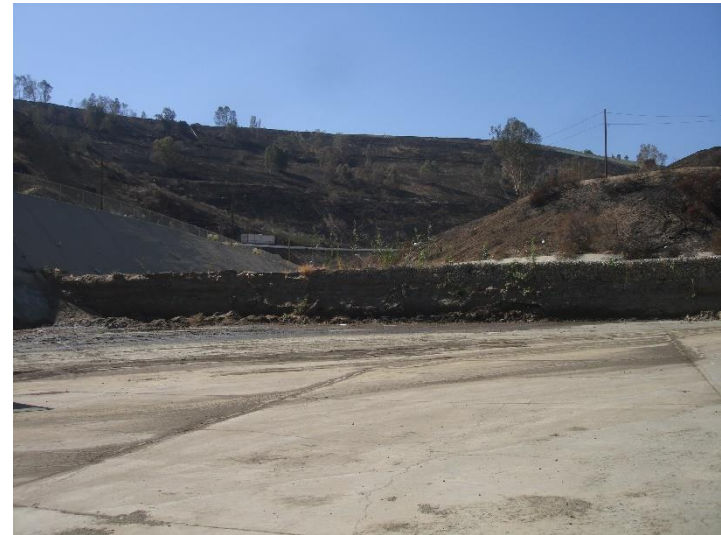
Photo 238: Terminal Basin: October 29, 2019

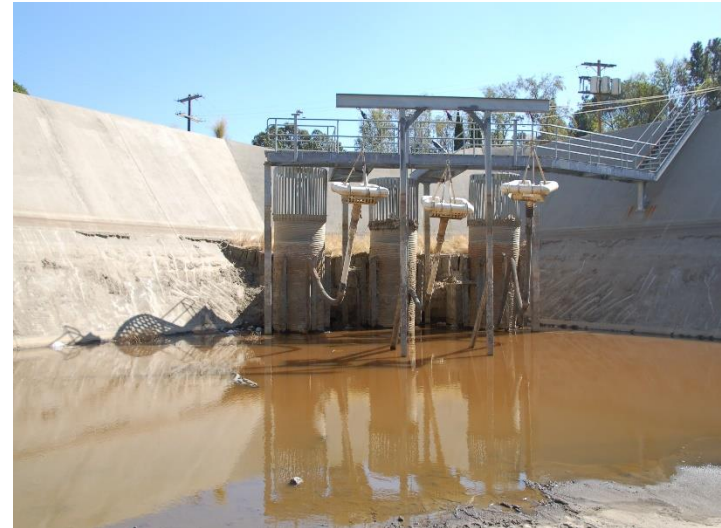
Photo 241: Terminal Basin Outlet Risers: October 29, 2019

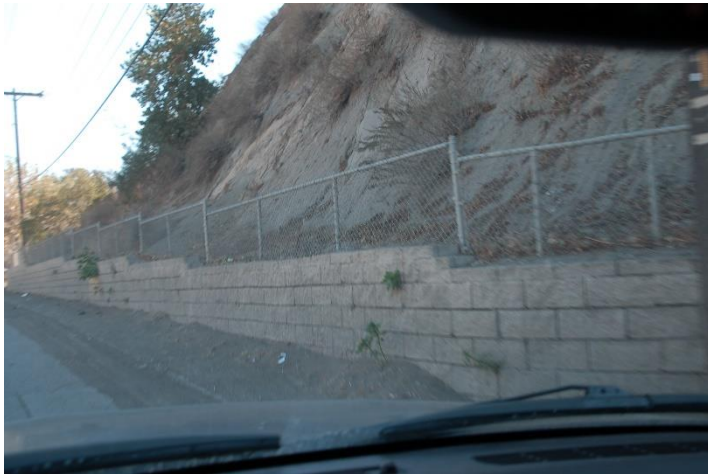
Photo 270: Terminal Basin Outlet: December 11, 2019

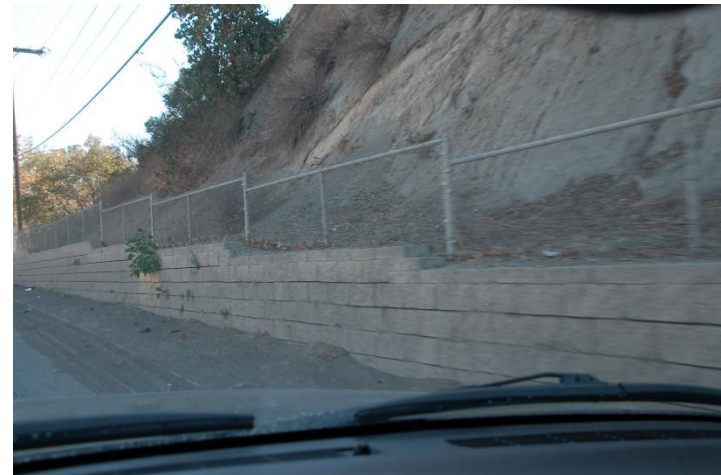
Photo 271: San Fernando Road Retaining Wall Slope: October 29, 2019

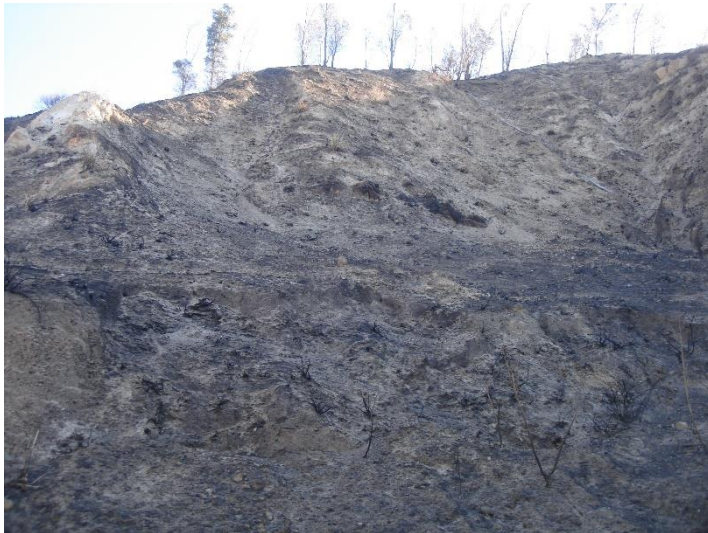
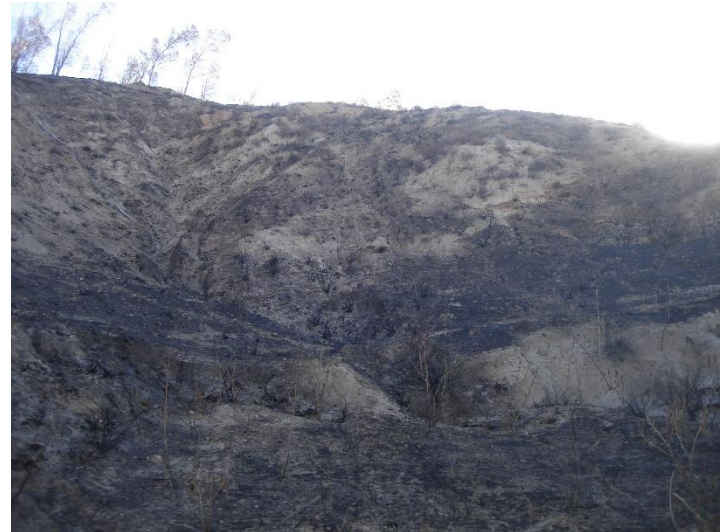
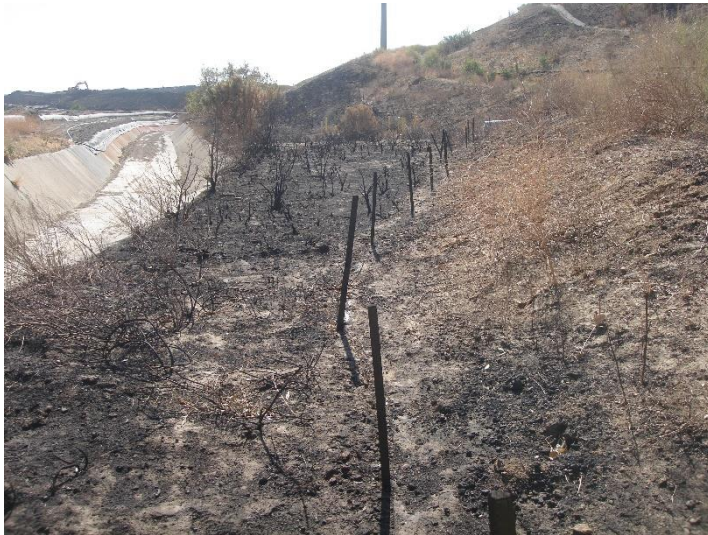
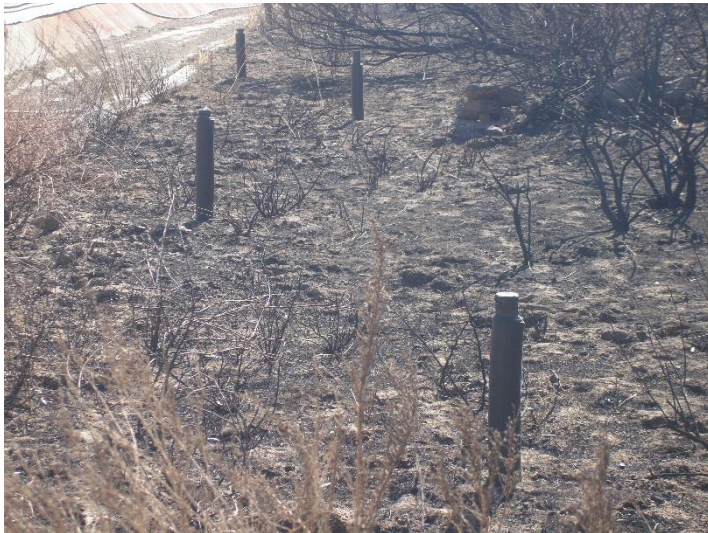
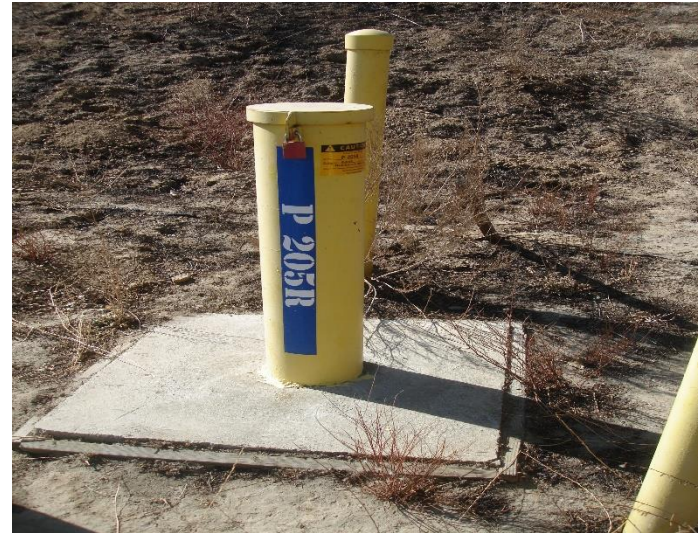
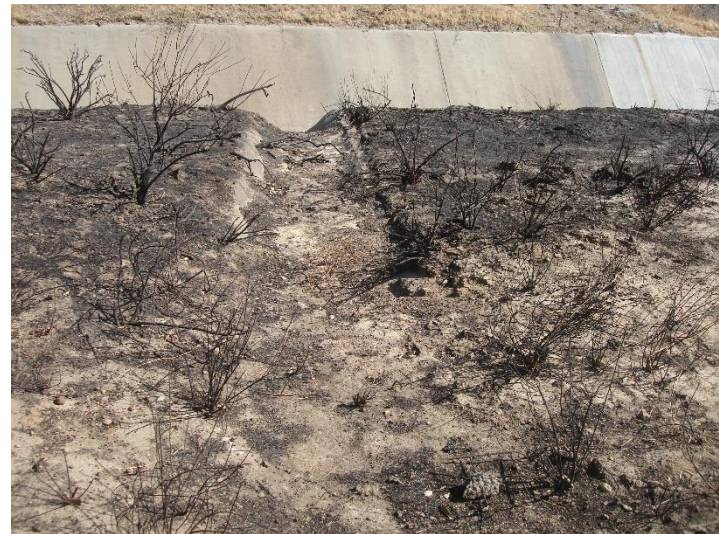
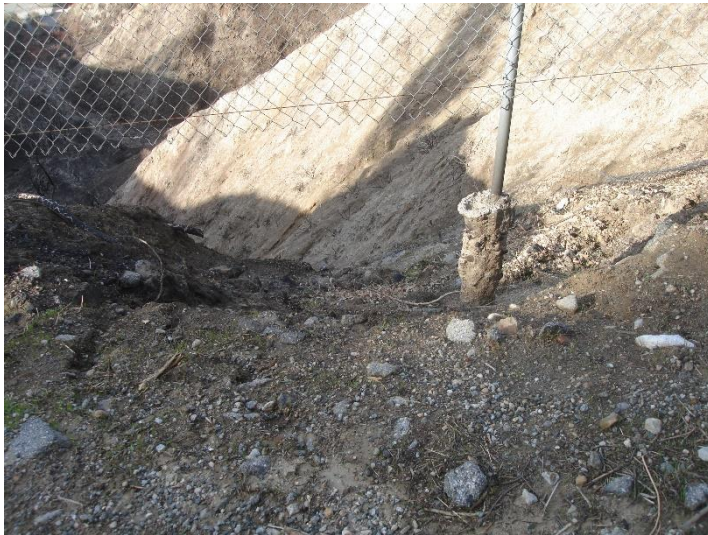
Photo 326: Fire Impacts Near P 205 R: October 29, 2019

Photo 327: Fire Impacts Near P 205 R: October 29, 2019

Photo 328: Fire Impacts Near P 205 R: October 29, 2019

Photo 329: Fire Impacts Near P 205 R: October 29, 2019

Photo 331: Fire Impacts Near P 205 R: October 29, 2019

Photo 330: Fire Impacts Near P 205 R: October 29, 2019

Photo 332: Fire Impacts Near P 205 R: October 29, 2019

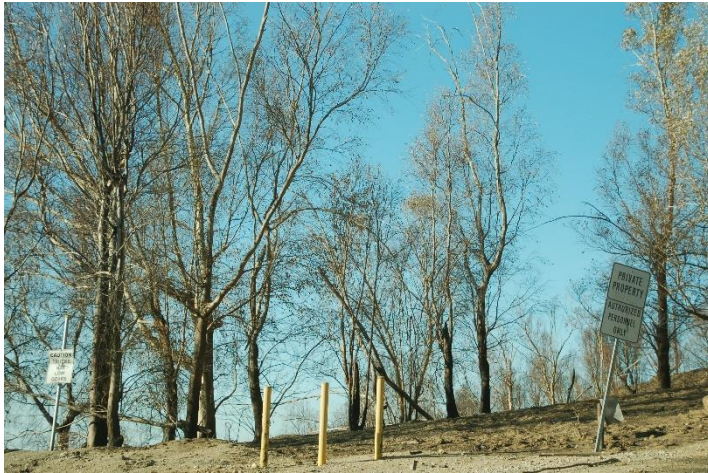
**Photo 357: Vegetation Fire Impacts Southern Oil Field and Road:
October 29, 2019**

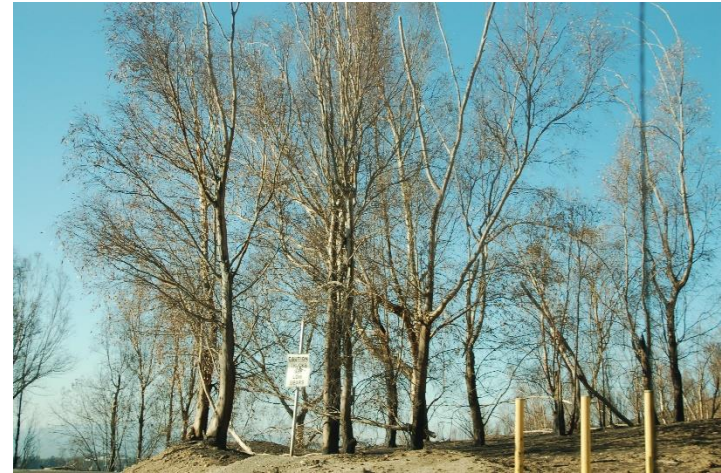
**Photo 358: Vegetation Fire Impacts Southern Oil Field and Road:
October 29, 2019**
