**Sunshine Canyon Landfill
Independent Monitor
Quarterly Site Monitoring Status Report
October 1, 2019 – December 31, 2019**

City of Los Angeles Department of City Planning

County of Los Angeles Department of Regional Planning

April 3, 2020

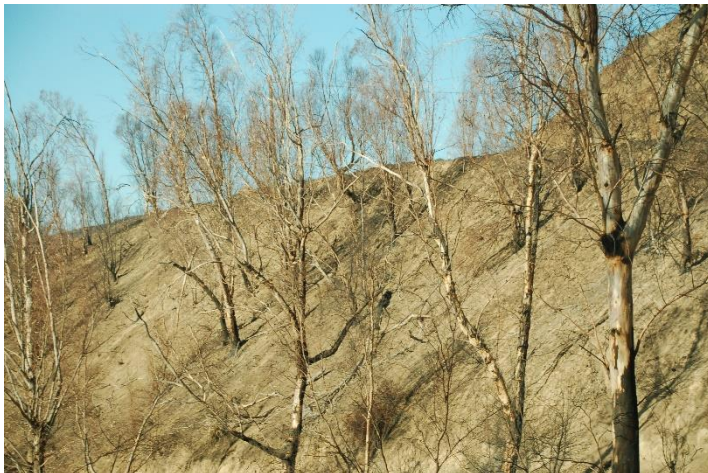
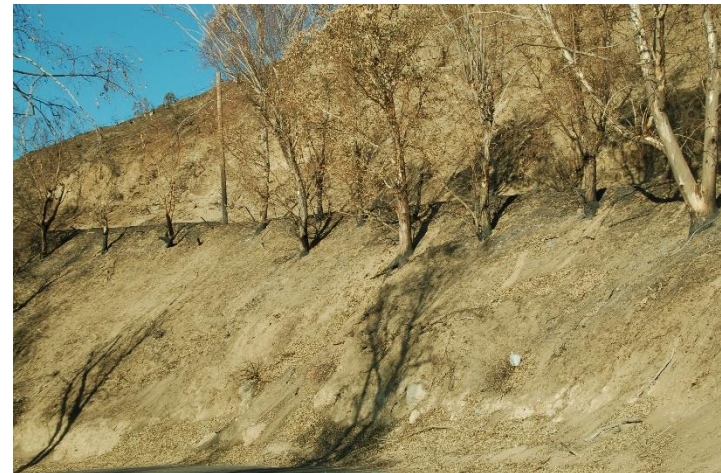
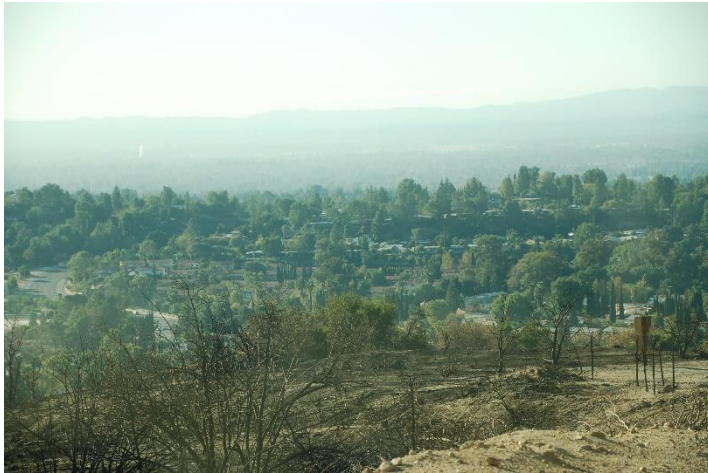
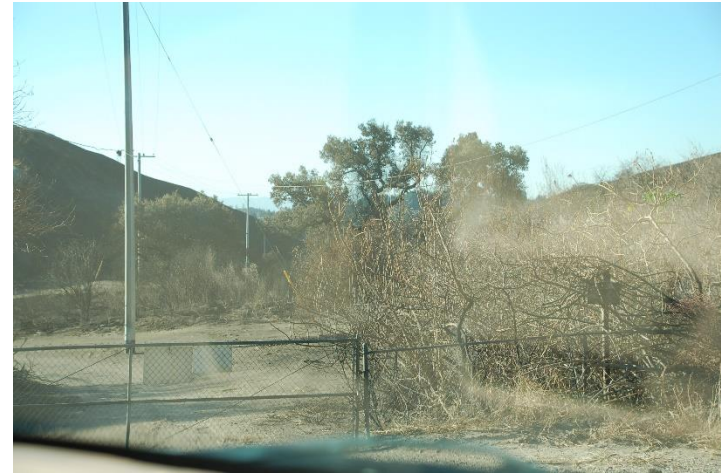
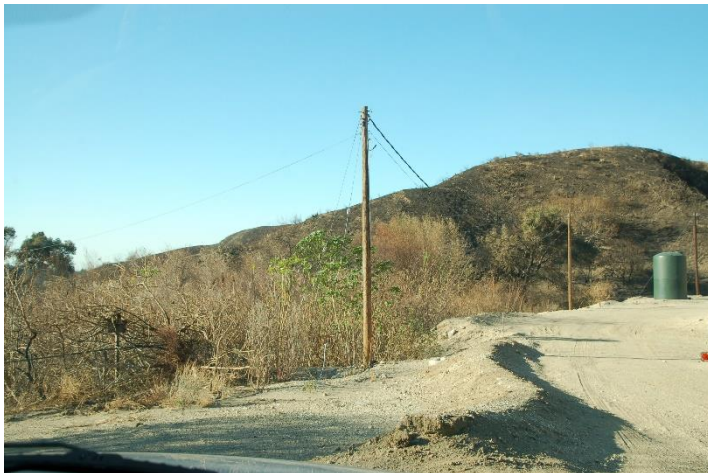
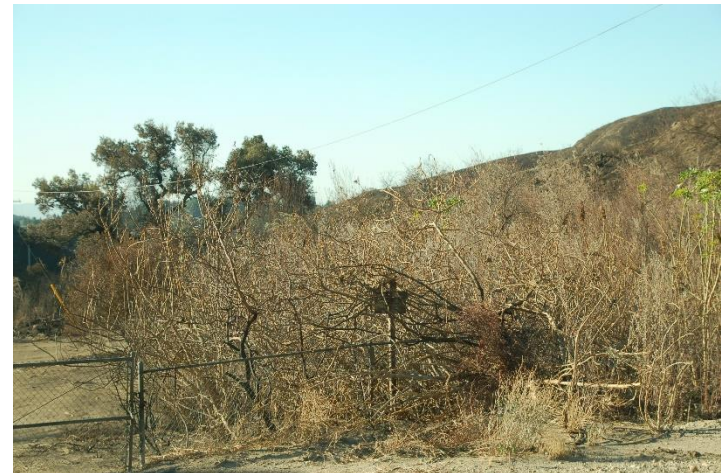
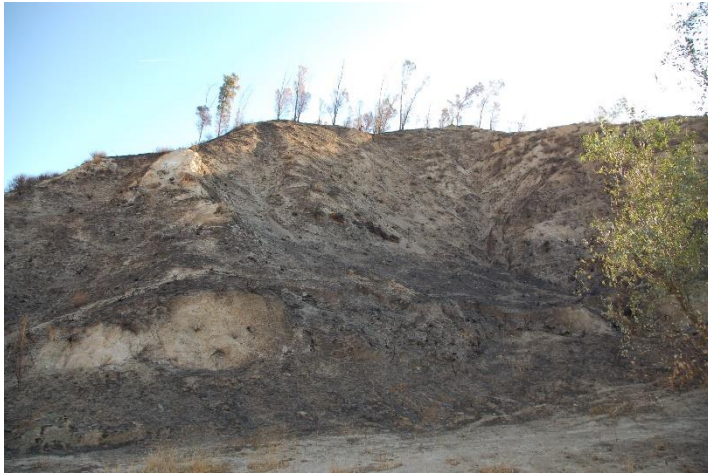
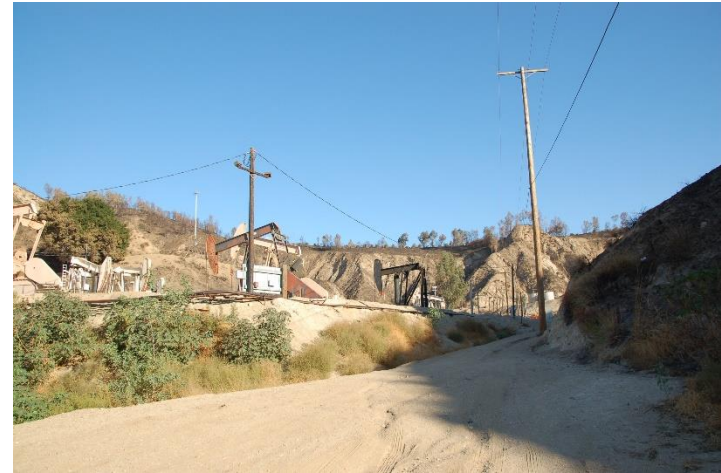
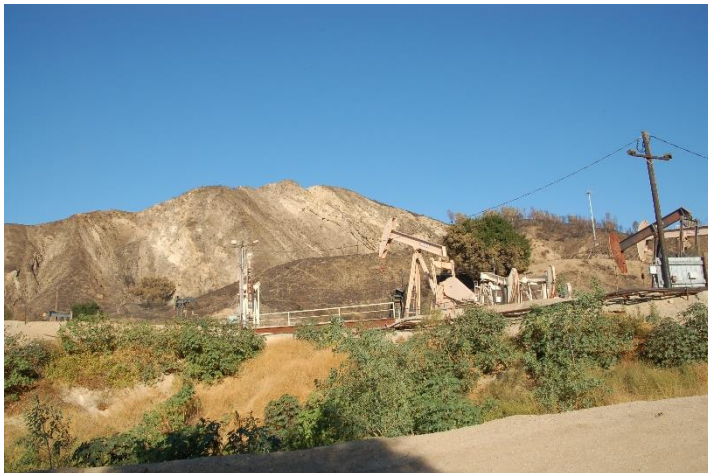
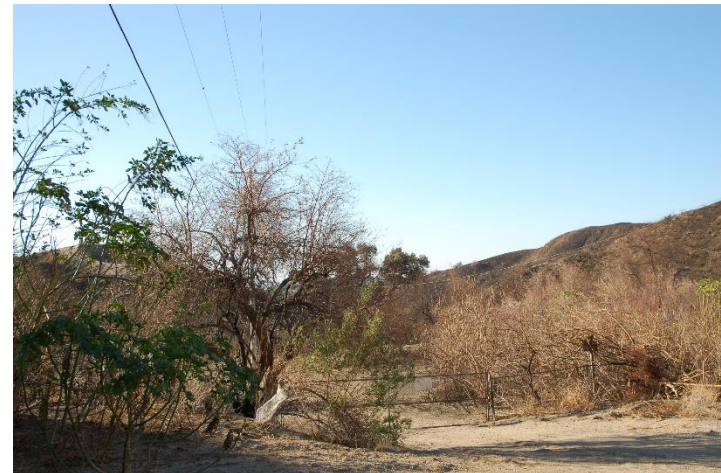
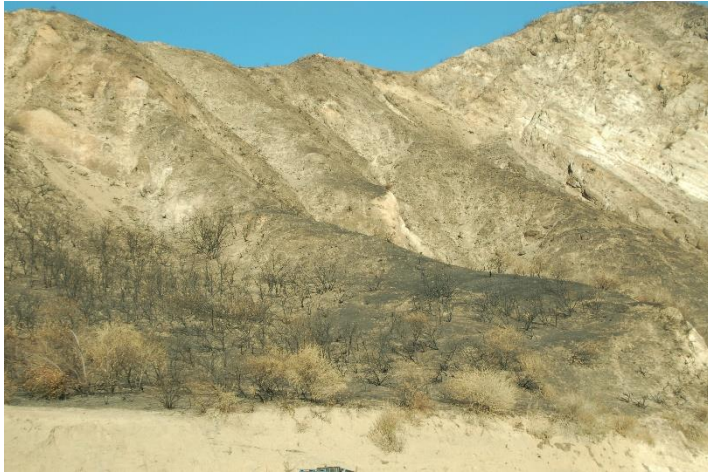
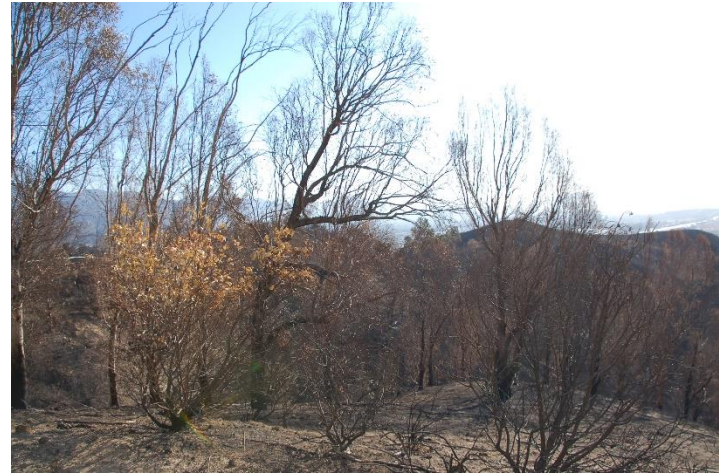
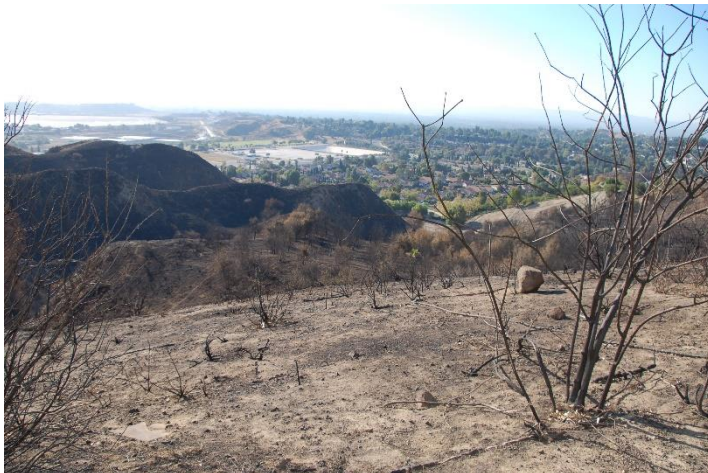
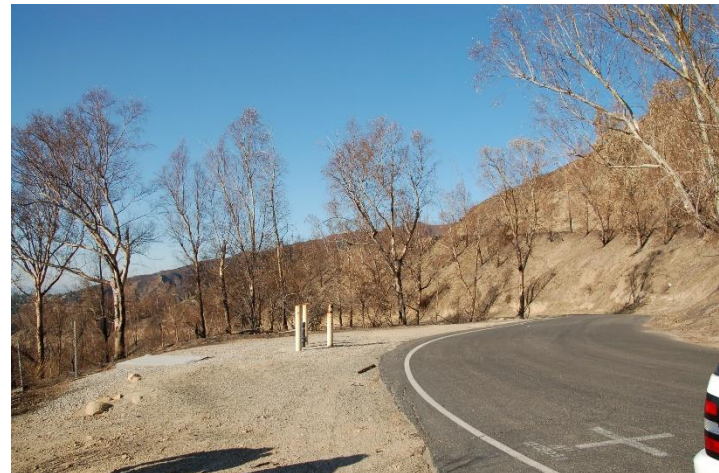
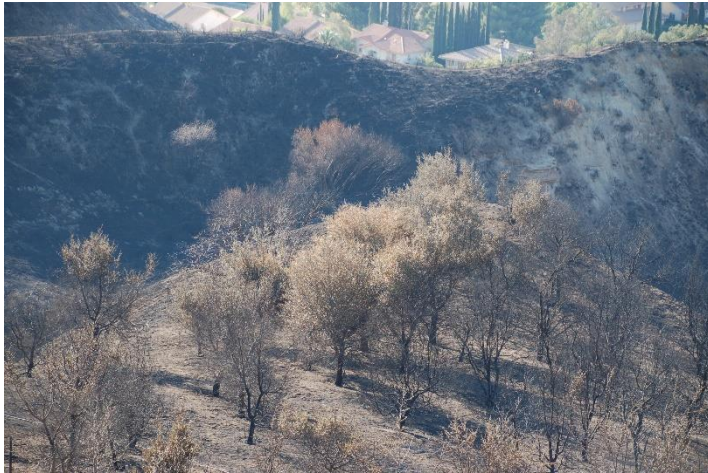
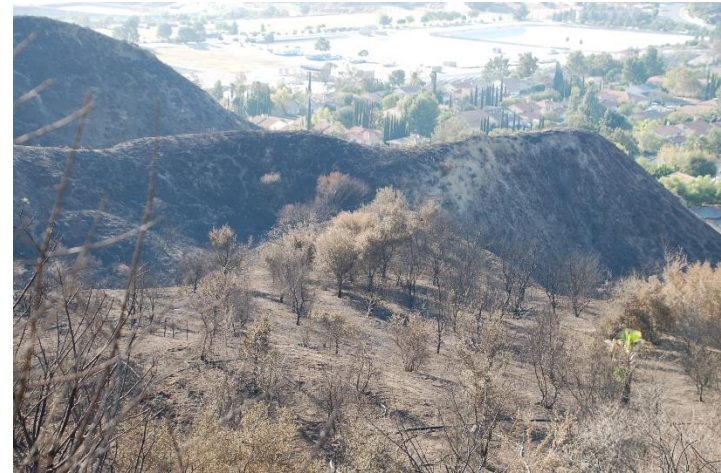
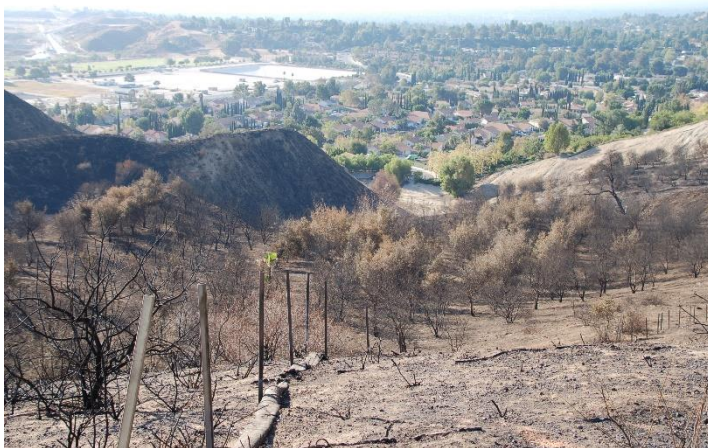
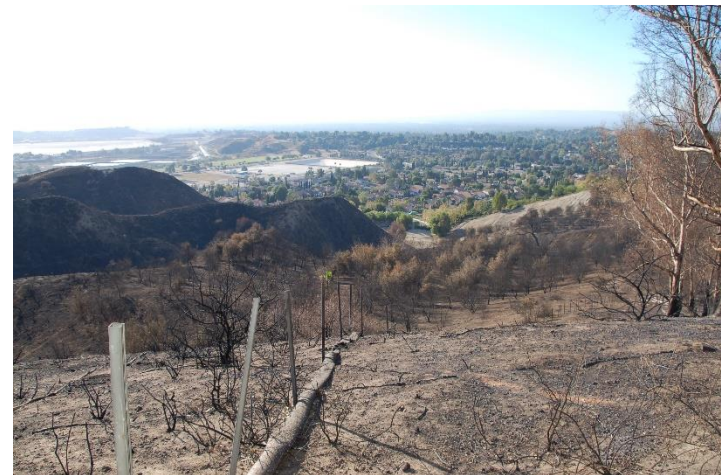
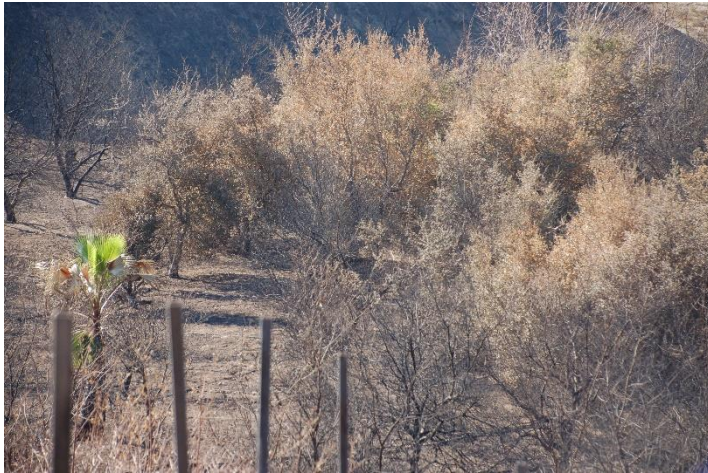
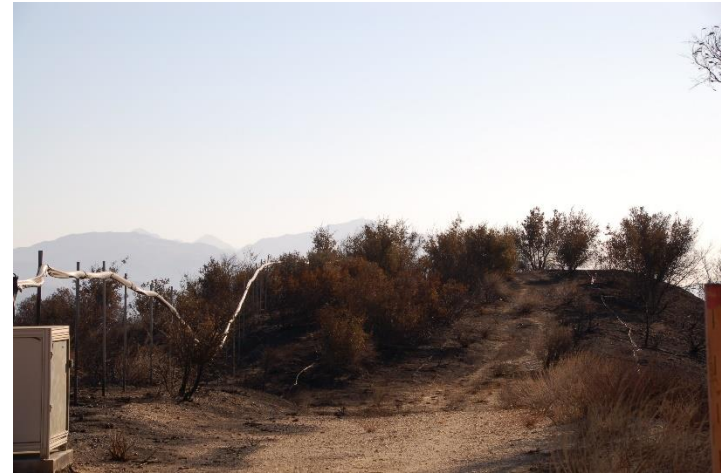
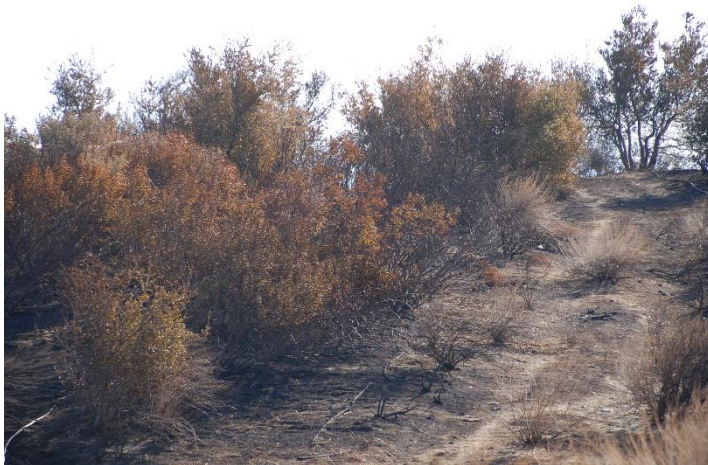
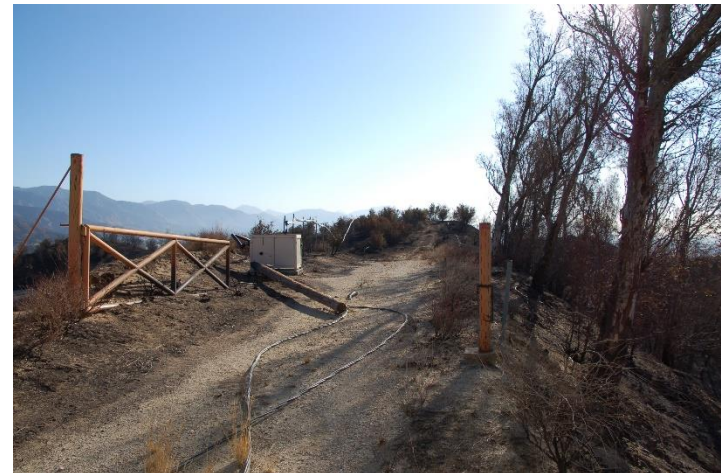
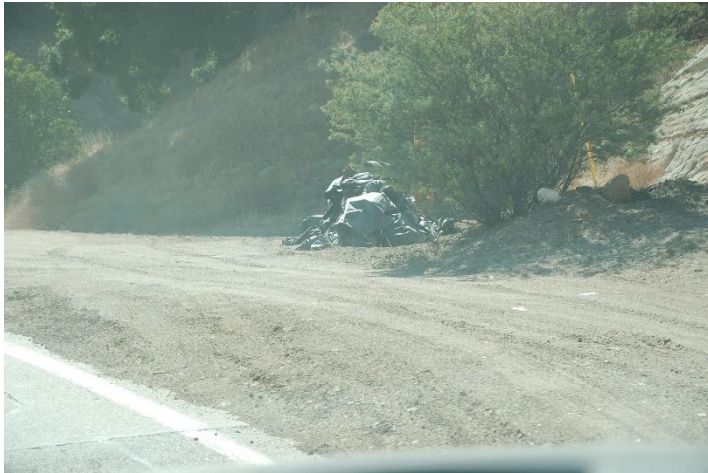
**Photo 358: Vegetation Fire Impacts Southern Oil Field and Road:
October 29, 2019**

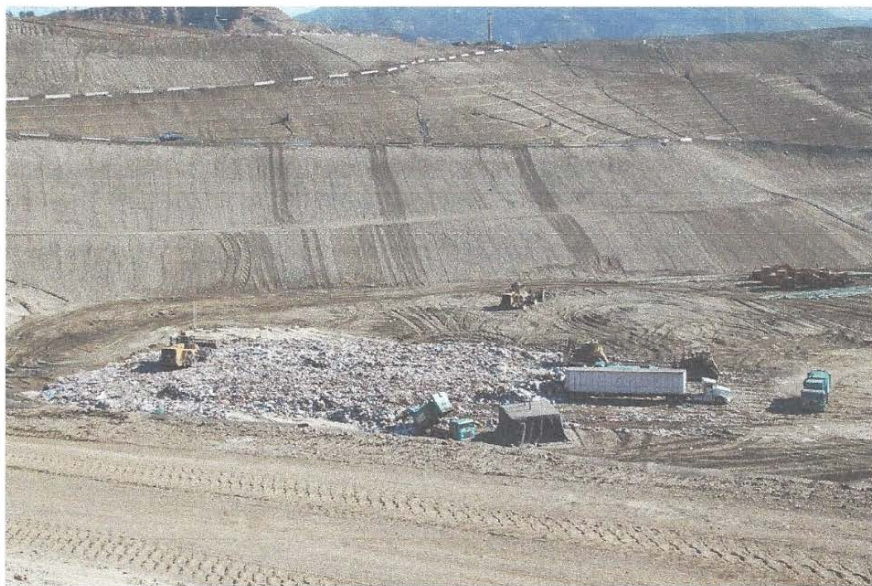
8:00– 2:30 Site inspection	
<ul style="list-style-type: none"> Tour neighborhood to check for odor and illegal waste dumping Tour of landfill Access Roads including oil road Waste placement Drainage systems (Basins, channels) Construction at Cell CC4 Erosion protection system Landfill for geotechnical and hydrological issues Other observations Review documentation Meet with Republic staff 	
Access Roads Including Oil Road.	
<ul style="list-style-type: none"> Main access road: No stability concerns Access road to administration pad – no additional depression/settlement observed on slope Oil Road. The access road to the oil field was in good shape although vegetation and trees on both sides have been seriously damaged by the fire (Photo 1) 	
Waste Placement	
<ul style="list-style-type: none"> two waste face was were active in Cells CC3/CC4. Tilters were set-up on top of Cell CC4 – (Top of Photo 2) Regular trucks were dumping on the floor of the new cell CC4 Phase 3 (bottom of Photo 2)

Photo 2: Waste disposal at Cell CC4

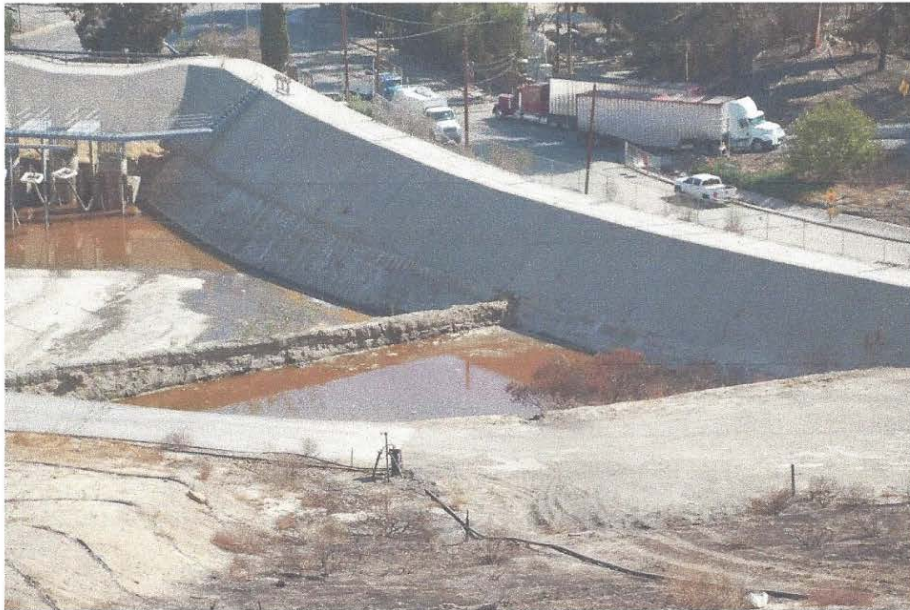
Drainage System	
<ul style="list-style-type: none"> Terminal Basin (Photo 3) <ul style="list-style-type: none"> Basin is essentially clean The sediments accumulated behind the decant towers will not impact he performance There is water accumulated behind the gabion wall. Note that the gabion wall id totally silted and does not allow flow of water. It is not a problem as the purpose of the wall was to control sediment deposition within the basin and protect the decant towers Cell CC3 Earthen basin <ul style="list-style-type: none"> The basin has been regraded cleaned and available for storage

Photo 3: Overall view of the Terminal Basin

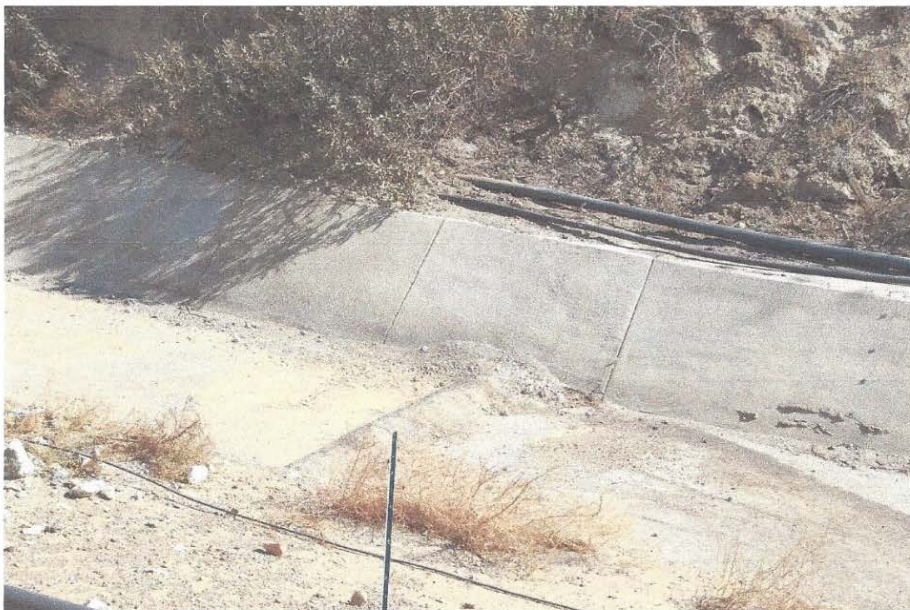
<ul style="list-style-type: none"> • East portion of the perimeter channel between Basin B and Terminal basin <ul style="list-style-type: none"> – Sediments and some detritus that had accumulated at the location of the asphalt berm have been removed (Photo 4) • Basin B <ul style="list-style-type: none"> – Basin empty of water and the pile of sediments noted during the last visit has been removed (Photo 5). • Basin D <ul style="list-style-type: none"> – Basin is clean and available for water storage – The maintenance issues noted during the previous visit still need to be addressed: <ul style="list-style-type: none"> ✓ Gap between the shotcrete and the soil at the spillway which may cause problem is additional undermining occurs. ✓ Vegetation growing through crack in downstream side of spillway ✓ Safety bars are missing on top of the decant towers • Ditch along access road to Flare 9-11 <ul style="list-style-type: none"> – The drain at the end of the concrete on side of road is plugged by sediments. • Basin A <ul style="list-style-type: none"> – The sediments gathered in the middle of the basin and observed during last visit have been removed and the basin is empty removal (Photo 6) – Sediments have accumulated against the rock placed around the decant towers. These sediments may hamper the flow of water out of the basin (Photo 7). – The connection between the basin and the new drainage channel on the west side of the landfill (Photo 8) has been reinstated (Photo 9) – Residue of the melted LFG header can be seen on the wall of the basin • Perimeter Channel between Basin A and Basin D <ul style="list-style-type: none"> – Channel in very good shape and clean, no vegetation and no cracks • Channel along the main access road <ul style="list-style-type: none"> – Clean • Basin at Cell CC4 Phase 3 <ul style="list-style-type: none"> – A geosynthetics lined temporary basin has been installed in the southeast corner of the cell (Photo 10)

Photo 4: Clean channel connecting to the Terminal Basin

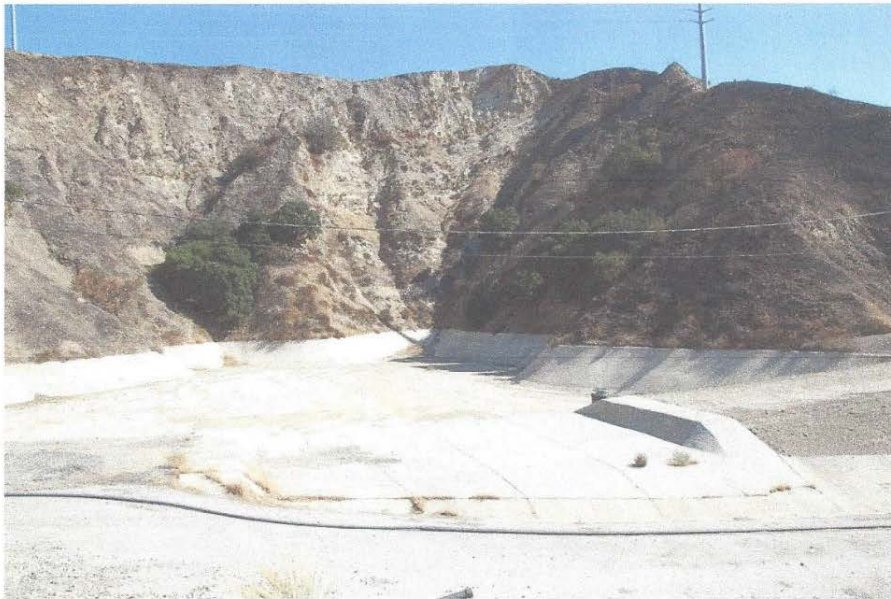
Photo 5: Clean Basin B

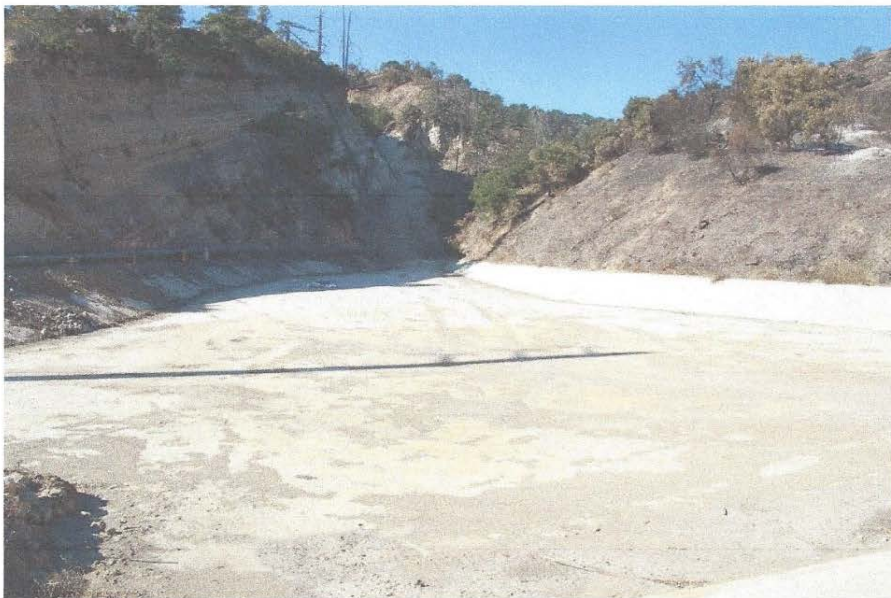
Photo 6: Clean Basin A

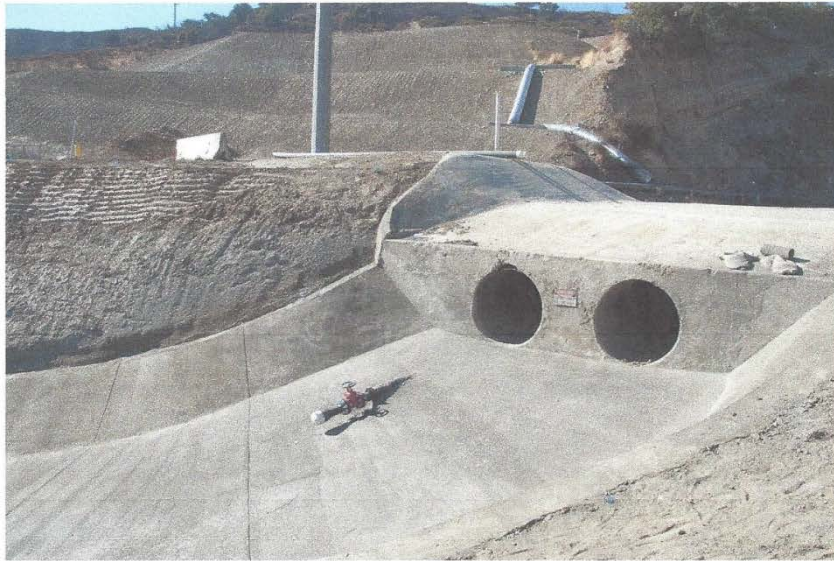
Photo 9: Outlet at Basin A

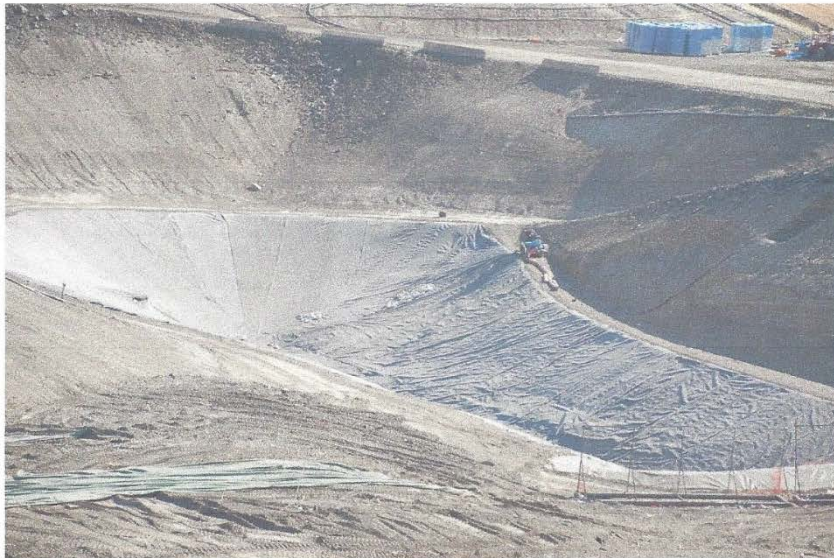
Photo 10: Temporary lined basin at Cell CC4 – Phase 3

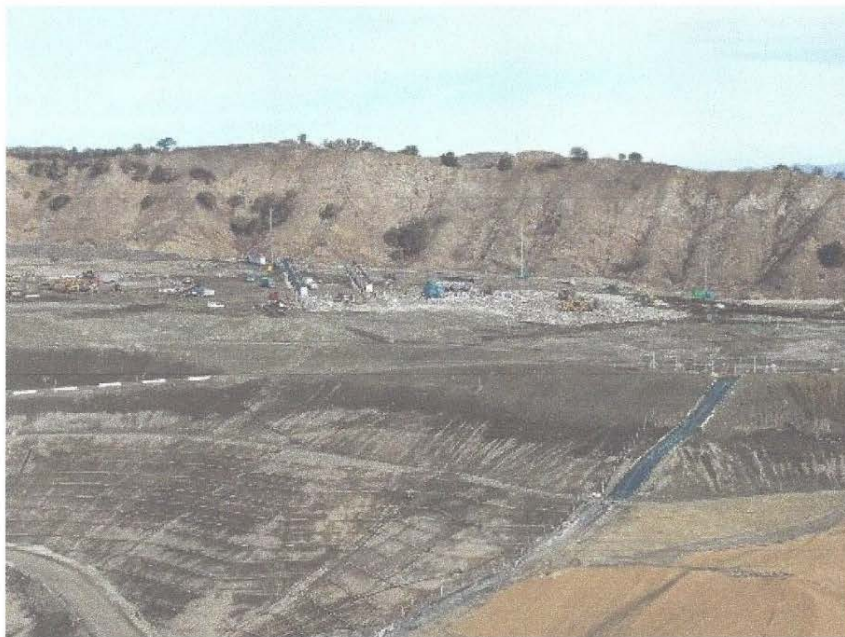
8:00– 2:30 Site inspection	
<ul style="list-style-type: none"> Tour neighborhood to check for odor and illegal waste dumping Tour of landfill Access Roads including oil road Waste placement Drainage systems (Basins, channels) Construction at Cell CC4 Erosion protection system Landfill for geotechnical and hydrological issues Other observations Review documentation Meet with Republic staff 	
Access Roads Including Oil Road.	
<ul style="list-style-type: none"> Main access road: No stability concerns Access road to administration pad – no additional depression/settlement observed on slope Emergency Exit Road near remediation area at Deck A of City landfill <ul style="list-style-type: none"> Following heavy rain erosion along the edge of the road took place (Photo 1) and poses a threat 	
Waste Placement	
<ul style="list-style-type: none"> Only one waste face was in operation 4 Tilters were set-up on top of Cell CC4 – (Photo 2)

Photo 2: Waste disposal at Cell CC4

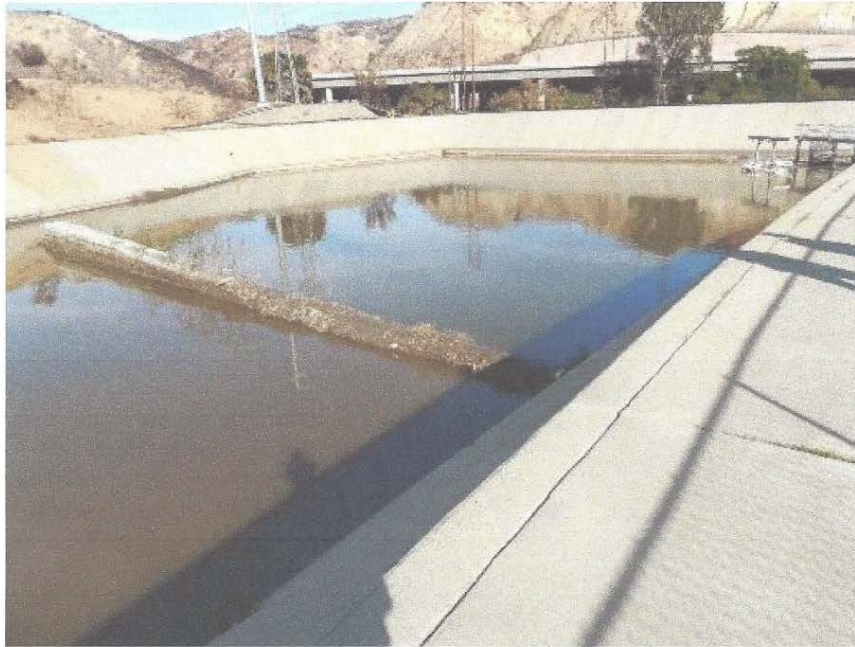
Drainage System	
<ul style="list-style-type: none"> Terminal Basin (Photo 3) <ul style="list-style-type: none"> Basin is partially full One skimmer was in operation (Photo 4) The sediments accumulated behind the decant towers will not impact he performance Cell CC3 Earthen basin <ul style="list-style-type: none"> The basin has been regraded cleaned and available for storage The future access road crosses the basin and a culvert has been installed (photo 5) The lack of trash guard on the outlet noted in previous visits has been fixed (Photo 6)

Photo 3: Overall view of the Terminal Basin

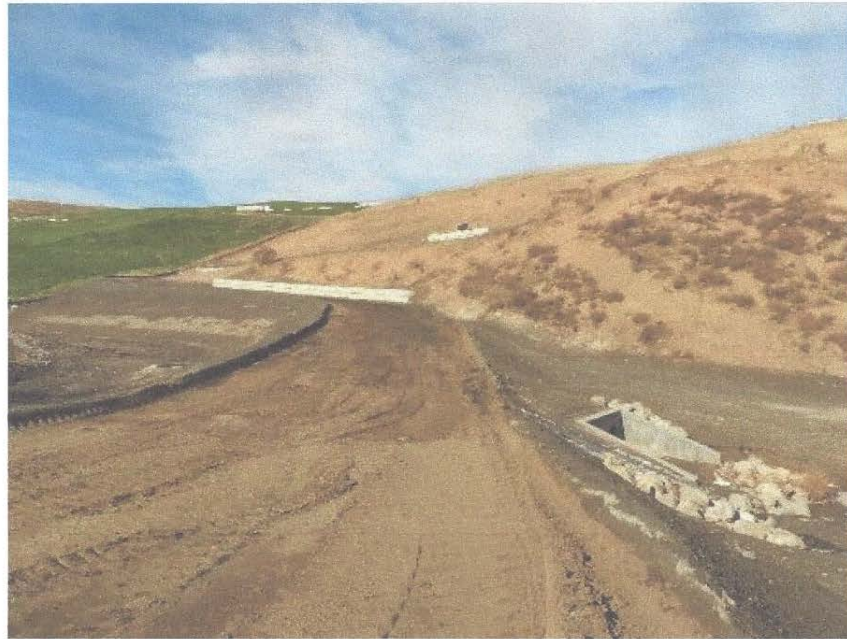
Photo 5: Access road crossing of Cell CC3 earthen basin

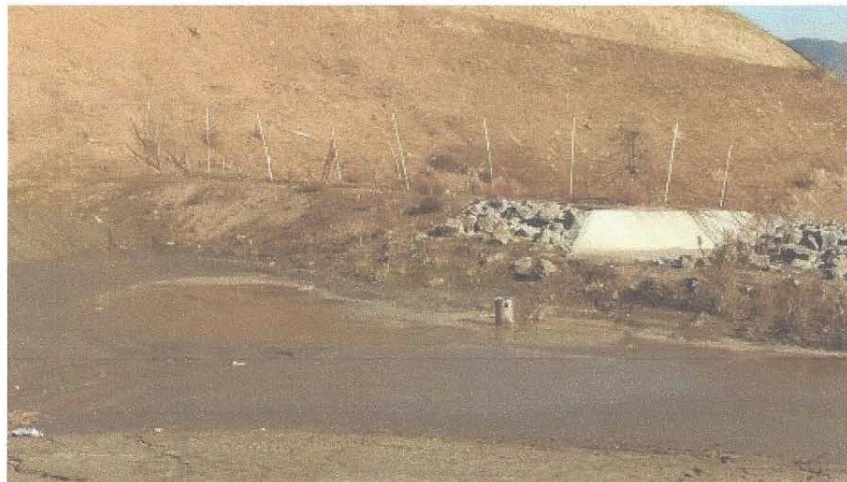
Photo 6: Trash Gard on outlet of Cell CC3 earthen basin

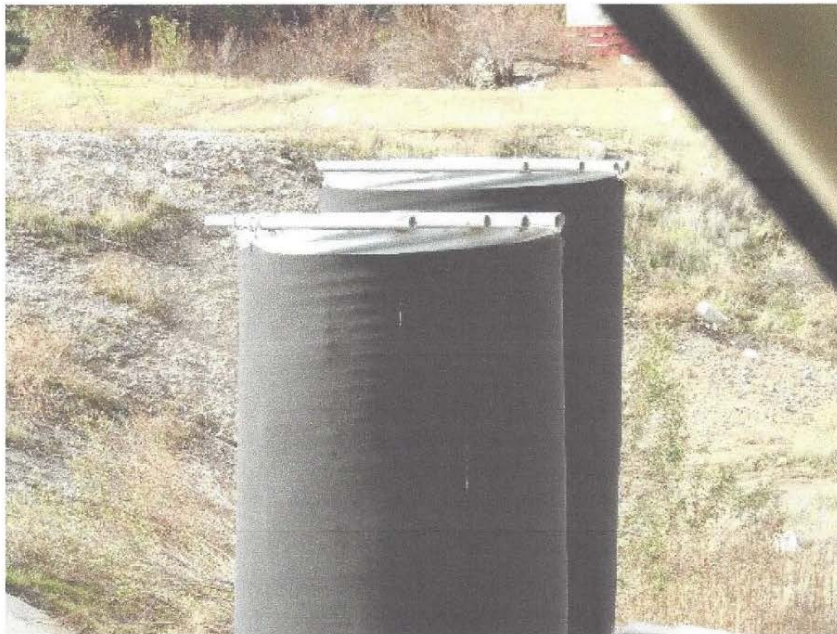
Photo 9: Decant towers at Basin D Equipped with safety bars

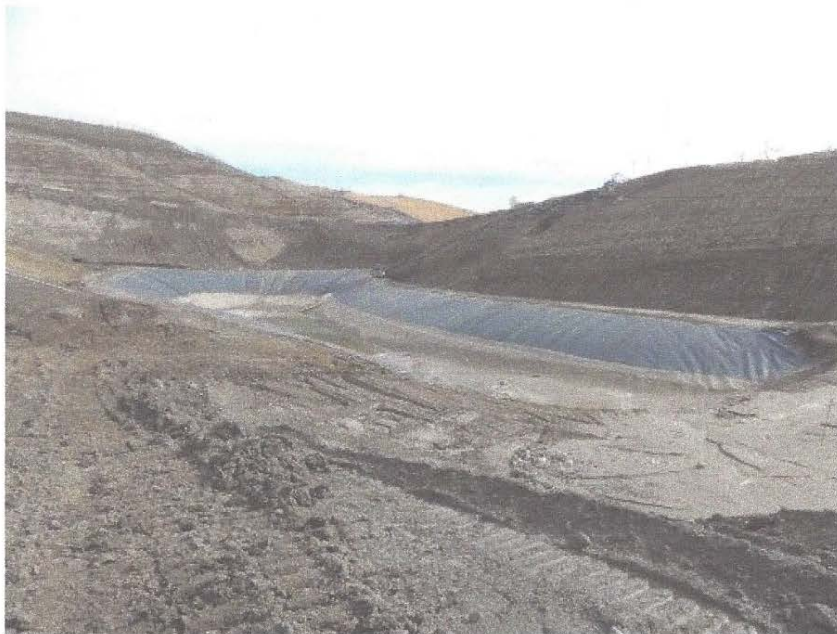
<ul style="list-style-type: none"> • Basin B <ul style="list-style-type: none"> – Some sediments have accumulated but not enough to impact the performance of the basin (Photo 7). • Basin D <ul style="list-style-type: none"> – Basin is clean and available for water storage – The maintenance issues noted during the previous visit still need to be addressed: <ul style="list-style-type: none"> ✓ Gap between the shotcrete and the soil at the spillway which may cause problem is additional undermining occurs (Photo 8). ✓ Vegetation growing through crack in downstream side of spillway (Photo 8) • However, the safety bars are missing on top of the decant towers have been installed (Photo 9) • Ditch along access road to Flare 9-11 <ul style="list-style-type: none"> – The drain at the end of the concrete on side of road is plugged by sediments. • Basin A <ul style="list-style-type: none"> – Could be reached because of road conditions • Channel along the main access road <ul style="list-style-type: none"> – Clean • Basin at Cell CC4 Phase 3 <ul style="list-style-type: none"> – Some water accumulated in the geosynthetics lined temporary basin has been installed in the southeast corner of the cell (Photo 10)

Photo 10: Temporary lined basin at Cell CC4 – Phase 3

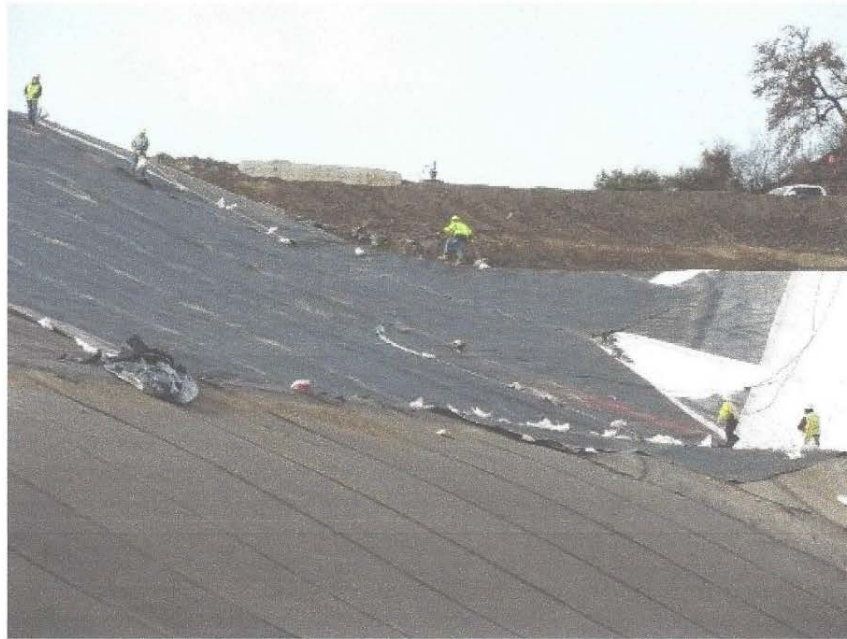
Cell 4 Phase 3 Liner <ul style="list-style-type: none"> • Liner system was being deployed on the upper benches (Photo 11) • The gabion system for LFG/leachate collection was protected by a geotextile (Photo 12) • Minor damage noted on the operation layer (Photo 13) • No damages observed on the slope liner
Erosion Protection Systems <ul style="list-style-type: none"> • Some gullies and ruts were observed on some of the slopes, namely on downstream slope of the earth embankment of the Cell CC3 basin (Photo 14)
Landfill for geotechnical and hydrological issues <ul style="list-style-type: none"> • No fissures or cracks were observed in any of the slope or roads
Other Observations <ul style="list-style-type: none"> • No odor detected outside of landfill
Close-out meeting with Republic Staff representative to discuss findings of visit
FURTHER REVIEW NEEDED
<ul style="list-style-type: none"> • None
COMMENTS

Photo 11: Deployment of geosynthetics on slope at Cell CC4 – Phase 3

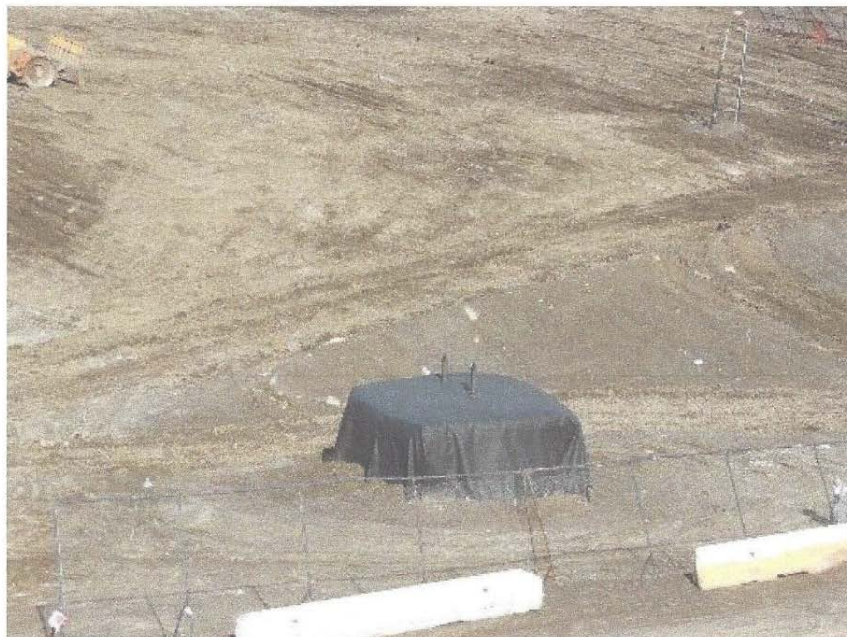
Photo 12: Combined LFG and Leachate collection system at Cell CC4 Phase 3
